EC Harris LLP
Site: Kiln Place, Camden
Job No: GL18084 Date: May 2014
Drawing Title: Fieldwork Location Plan
Drawing No: GL18084 - DR002
Scale: 1:500 @ A3
Drawn by: YN Checked by: GP
Project: F28240 Markings: 195520

EXPLORATORY HOLE RECORDS

Project: Kiln Place

Percussion Borehole Record

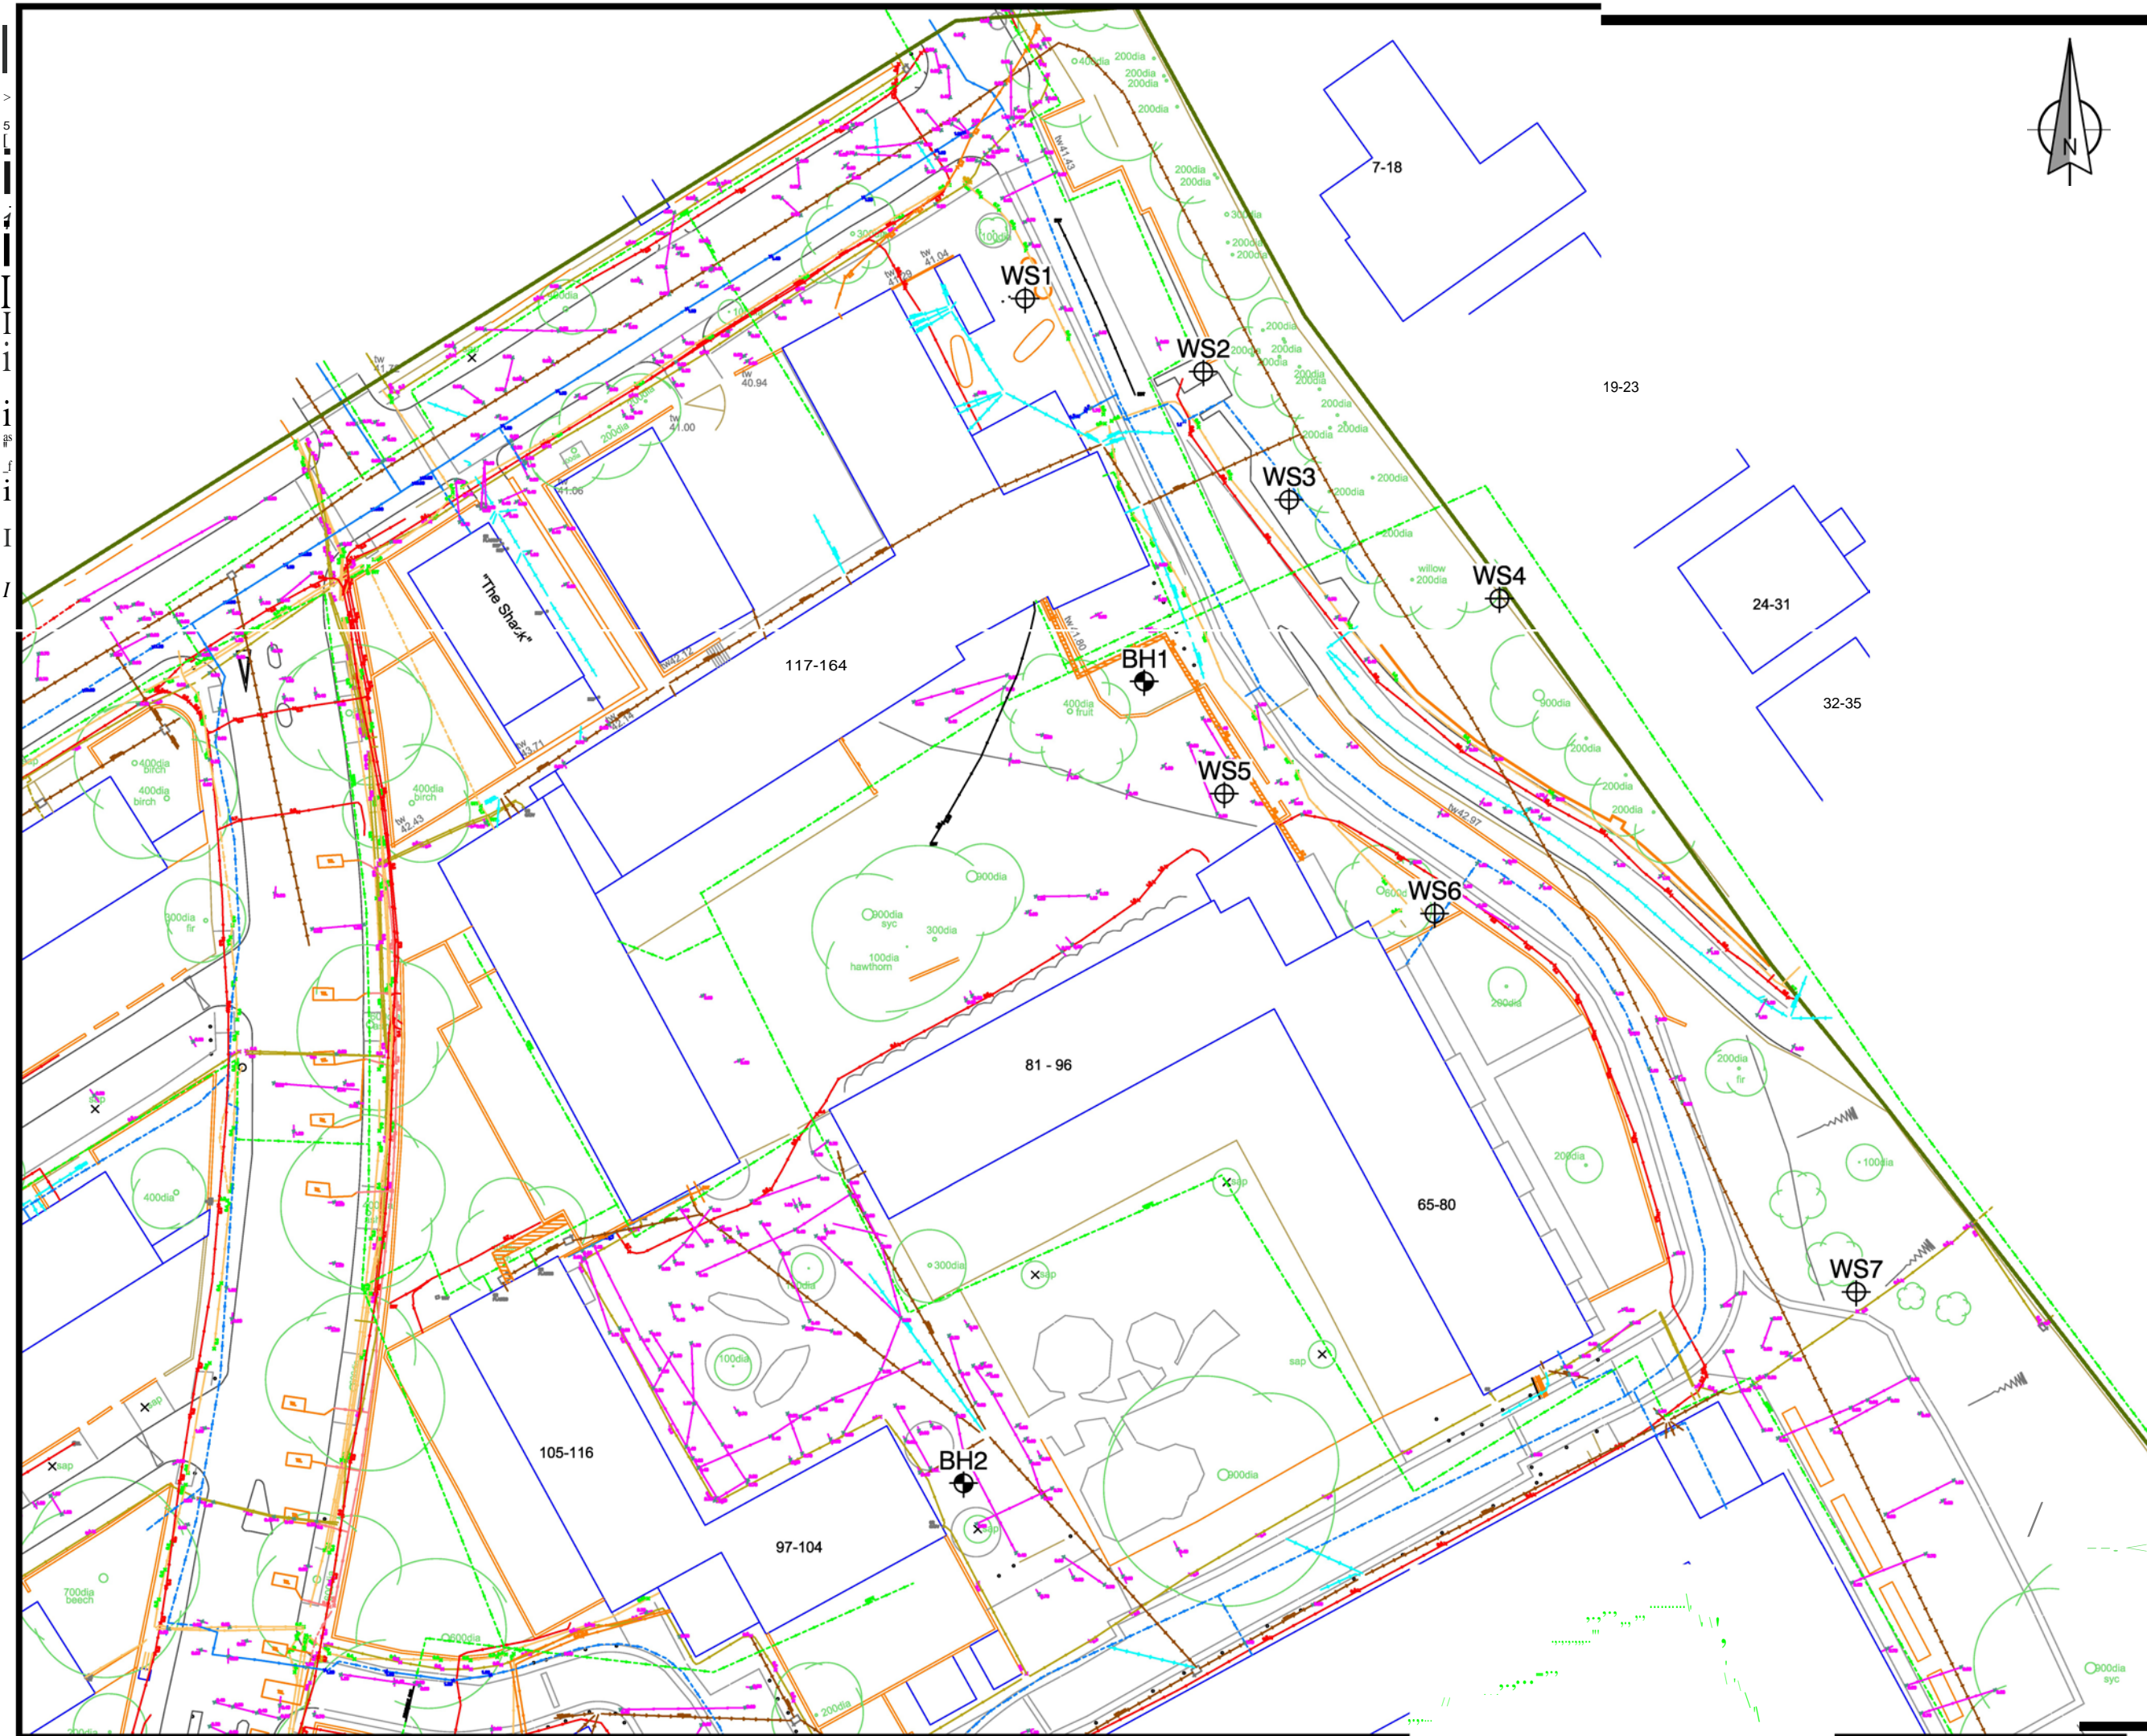
- 1 Window Sample Borehole
- 1 Cable Percussive Borehole
