Intended for  
**Camden Council**

# **KILN PLACE GEOTECHNICAL AND ENVIRONMENTAL DESK STUDY**

Revision **1**  
Date **29.07.2014**  
Made by **Oli Mills, Design Engineer, Geotechnical**  
**Wendy Fergusson, Principal Environmental Scientist**  
Checked by **Steve White, Senior Engineer, Geotechnical**  
**Karen Allso, Senior Environmental Consultant**  
Approved by **Stephen West, Technical Director, Geotechnical**  
**Paul Stubbington, Project Director, Environmental**  
Description **Geotechnical and Environmental Desk Study**  
Ref 61031879-KP-GE/EV-RPT-001

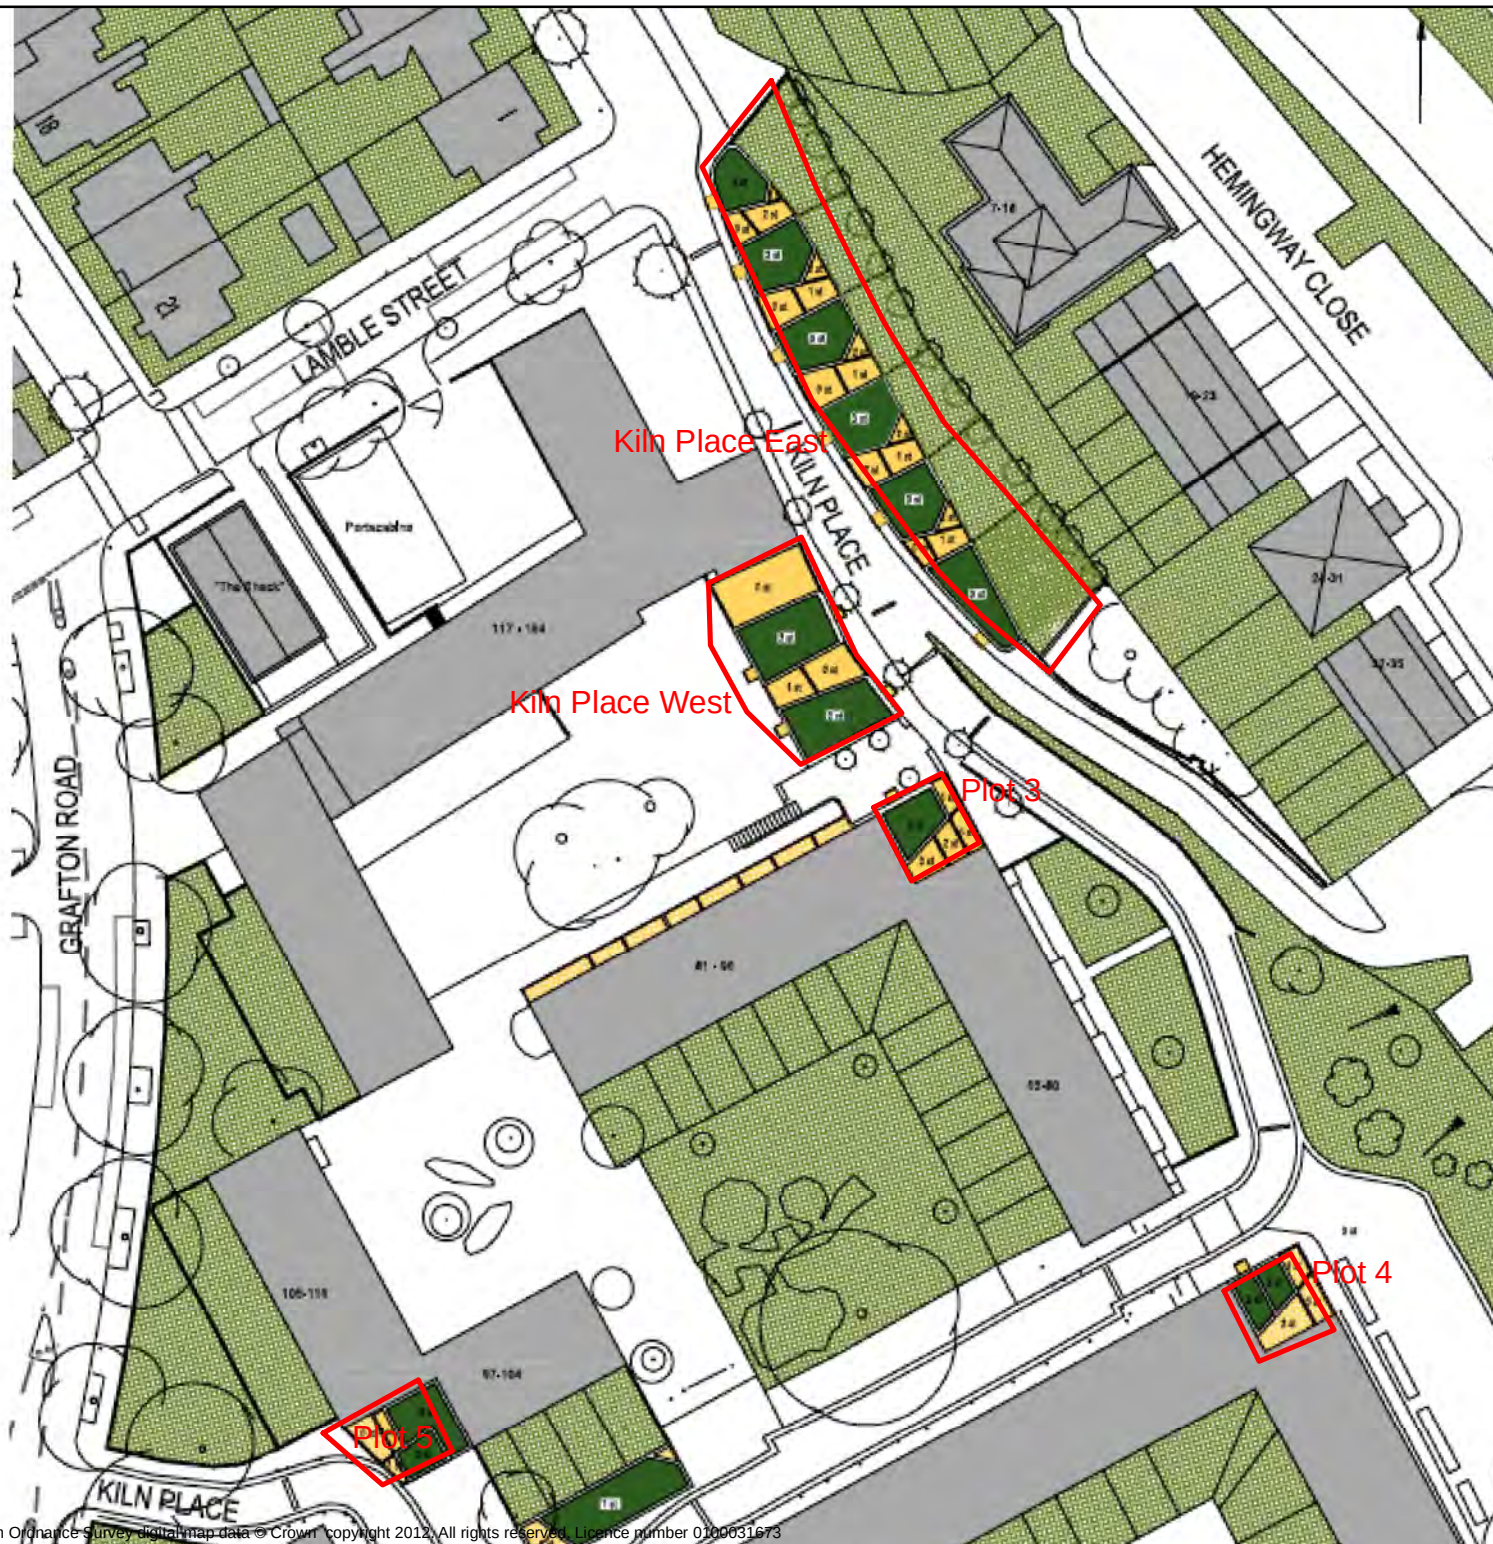
Following the issue of Rev 0 of this document, the proposed development has been updated to accommodate the underlying Thames Water sewer. As a result of the sewer main it is proposed to construct a series of cantilever residential dwelling of up to four storeys as detailed on the latest layout drawing 116\_P\_01P Rev C. Plans of the proposed development options are shown in Figure 3.

It is proposed to construct two and three storey residential dwellings in both stand-alone blocks and infilling of space created by existing buildings. Private gardens are proposed for one row of dwellings in the north of the site. Landscaping is likely to remain unchanged from what is currently on site.

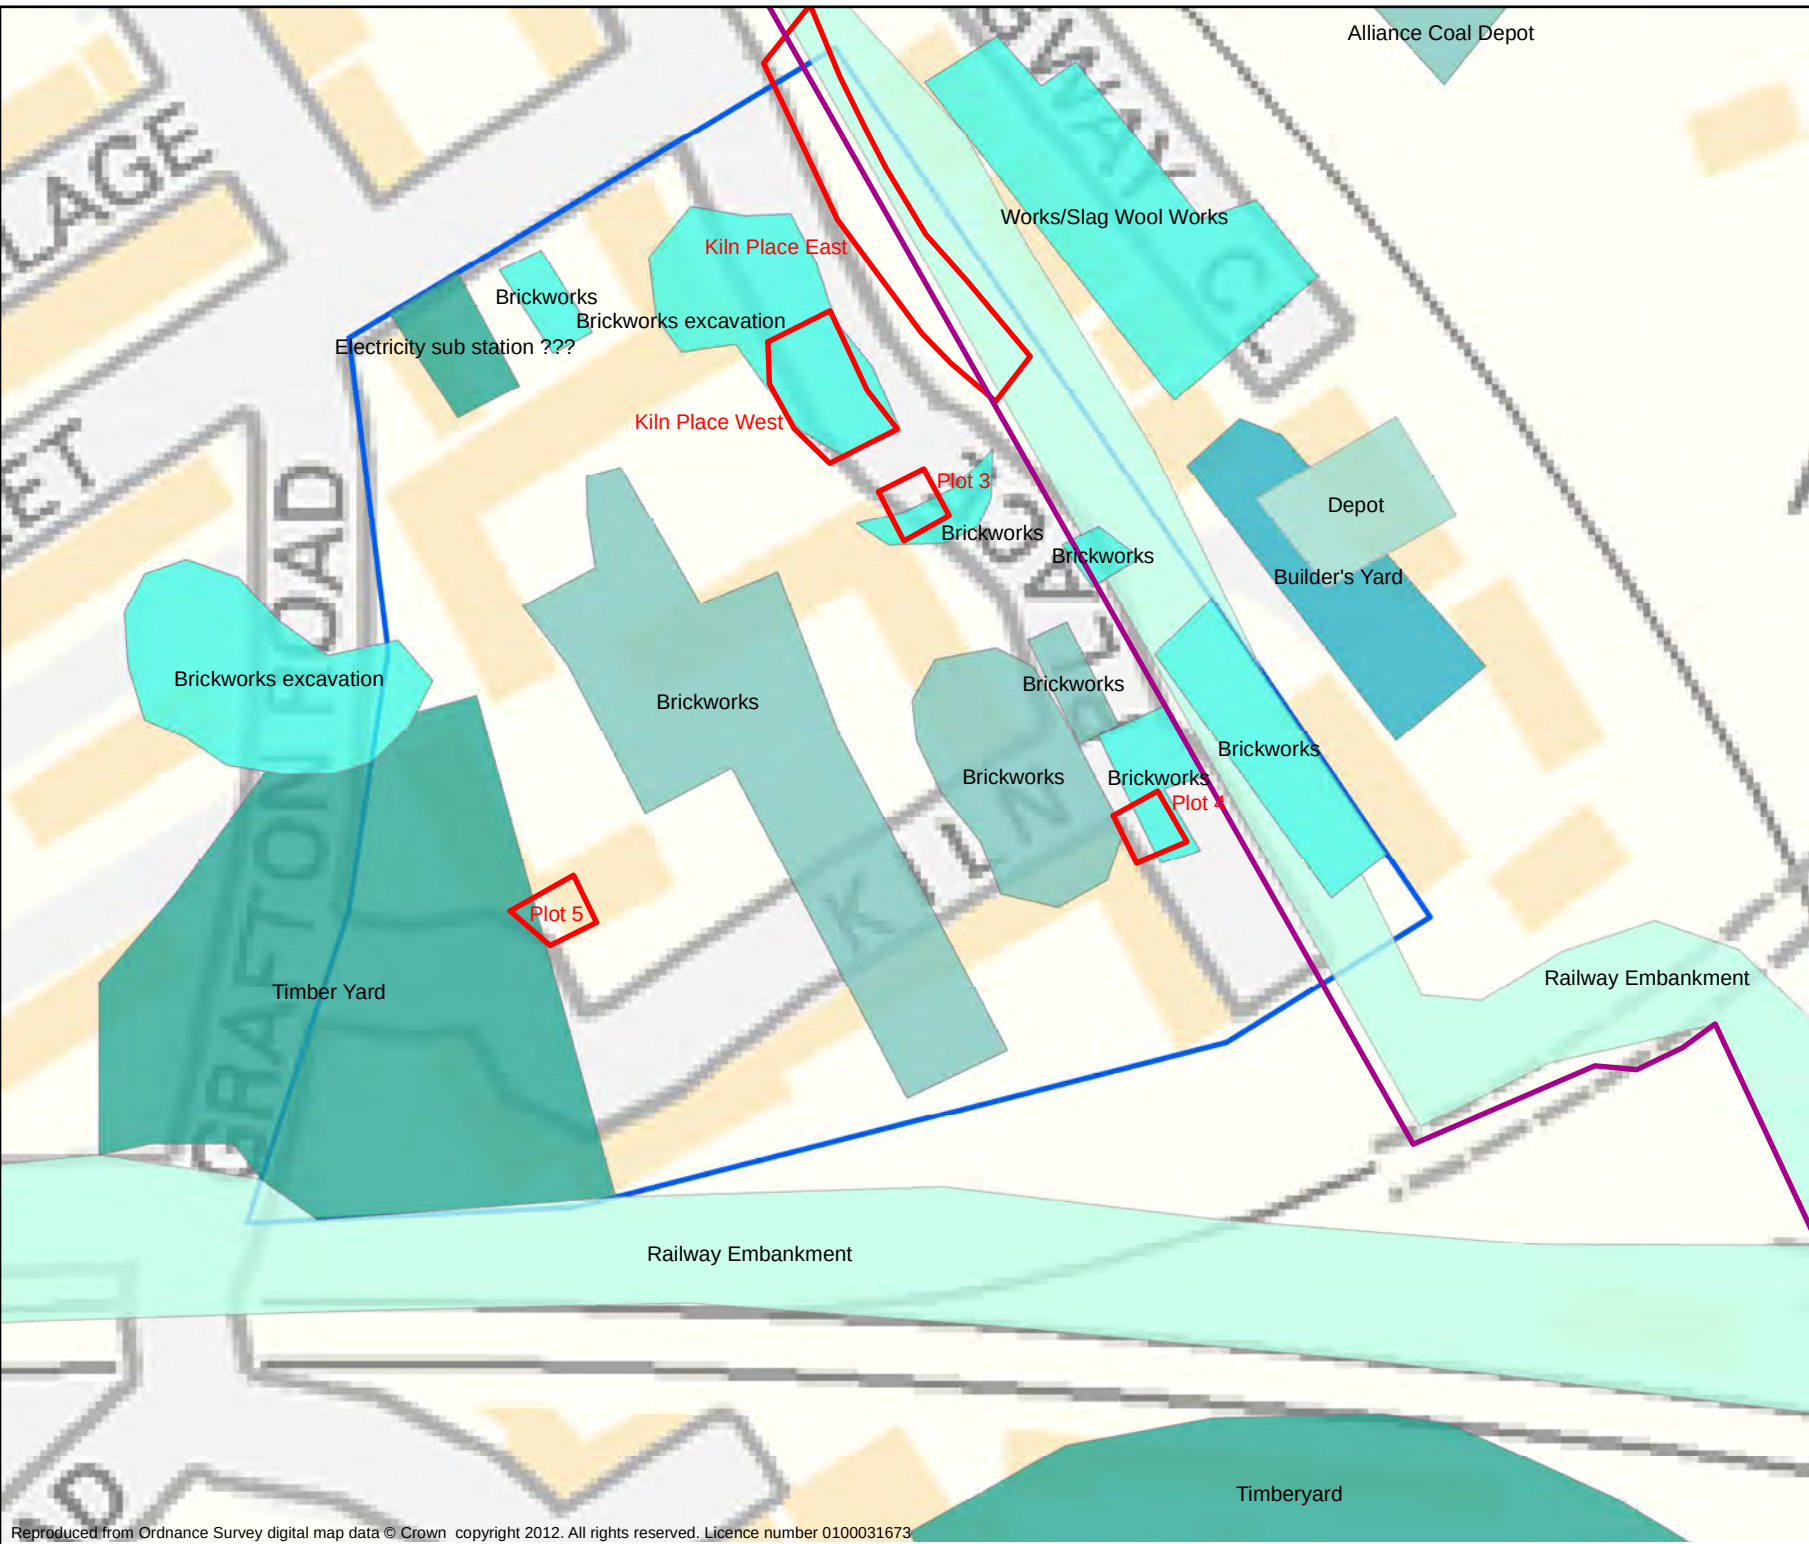
- 1860s drain
- Development Plots
- 1863
- 1894
- 1916
- 1954
- 1970
- 1980
- Site Boundary

From the earliest available maps, dating to the 1860s, the site is open land with a steeply sloping embankment sloping up to the north east, running the entire length of the eastern site boundary. A drain is shown following the toe of the slope crossing the eastern part of the site. Houses are located to the north of the site, fields to the east and west and the Midland Railway to the south. The London and North Western Railway (L & N.W.R) is located further east.

By 1894 – 1896 Gospel Oak Brickworks has been constructed on the site. The area surrounding the brick works is shown as fields. The embankment along the eastern boundary still remains, however the drain is no longer shown and has possibly been culverted. Immediately south of the site, the Tottenham North line of the Midland Railway has been constructed and enters a tunnel under the L & N.W.R.

By the 1916, the Gospel Oak Brickworks has expanded and altered in building layout. There are areas of excavation with water both on site and to the west of the site. The embankment along the eastern boundary still remains, with buildings constructed immediately to the east.

By 1954, the majority of the buildings, pits and ponds associated with the brickworks have gone and the kiln is shown as disused. The embankment along the eastern boundary still remains and the buildings immediately to the east are named as Slag Wool Works. The south western corner of the site is now a timber yard.

By 1968, the site has been redeveloped and Kiln Place housing estate constructed. Grafton Road has been constructed and forms the western site boundary. Houses have been constructed on the land to the west of the road. The Slag Wool works has been redeveloped and named 'works' with a depot. The embankment which forms the eastern boundary appears to have been widened and possibly increased in height.
