Nilkanth Estates Ltd.  
25 Old Gloucester Street  
Basement Impact Assessment  
Parmarbrook

Document ref  
PB-1712-BIA00 – 25 Old Gloucester Street - Basement Impact Assessment

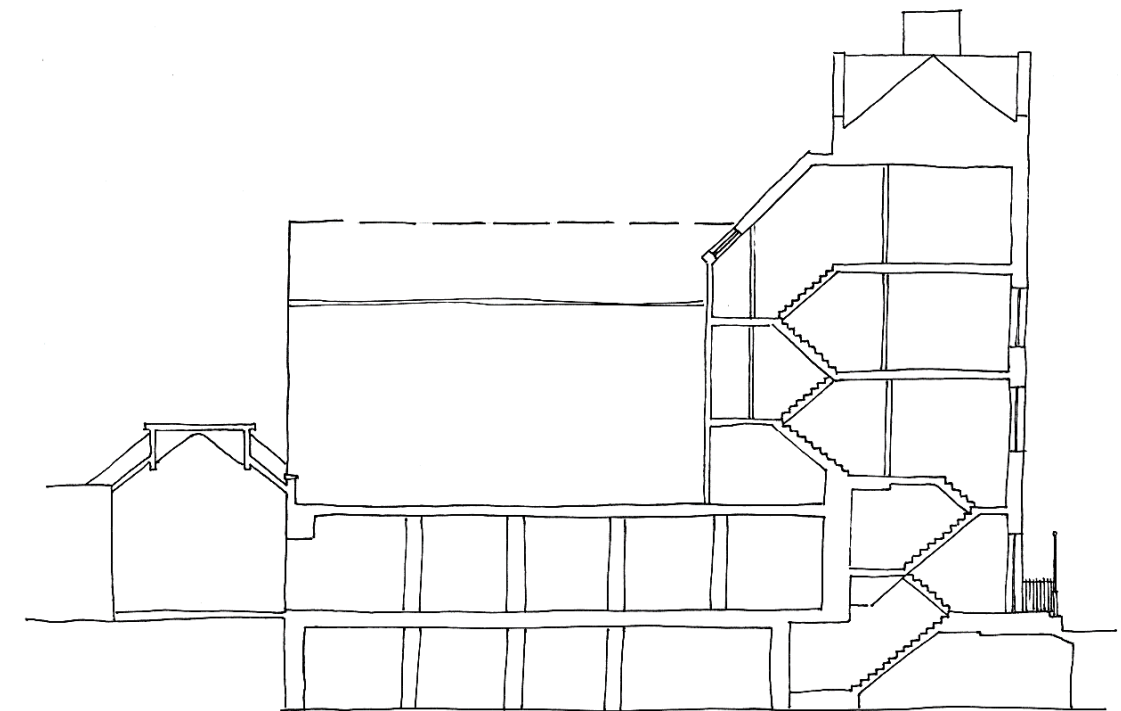
Existing Section X-X

It is proposed to redevelop the existing building at 25 Old Gloucester Street. The site to be redeveloped is mainly occupied by a Grade II listed school, built in 1877-78. A single storey extension has been constructed to the rear of the building. The building is generally three-storeys in height, with a five storey section at the front of the site. There is an existing single level basement below the main building.

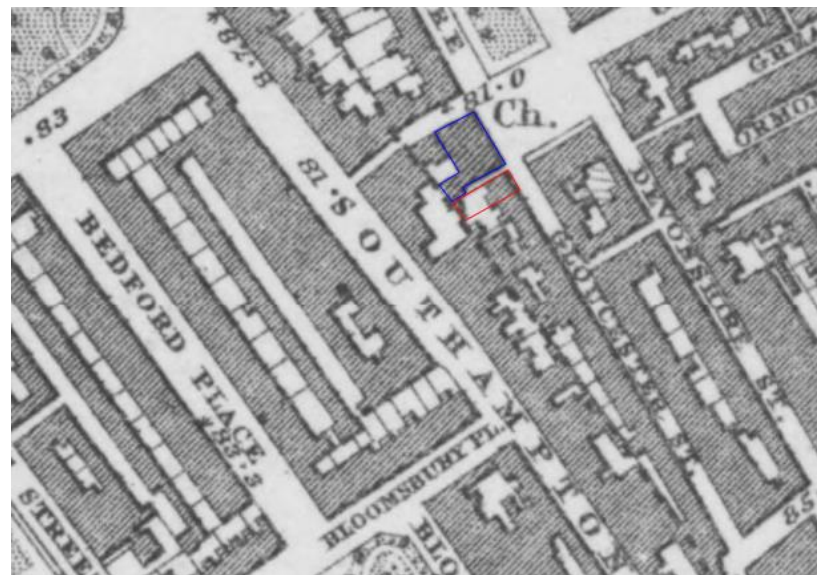
1863-73

The main building on the site was constructed around 1877-78, the use of the site has remained unchanged over the last 150 years. The plots surrounding the site have remained largely unchanged during this same period.
