# Flat N° 1a, 1 Holly Terrace, Highgate West Hill, Highgate London N6 6LX

## DESIGN AND ACCESS STATEMENT

Living Architects were instructed by the Client, Ms Bernadita Hudson to prepare drawings for submission to Camden Council. The drawings were to show the existing and proposed replacement windows to flat 1a on the Ground floor.

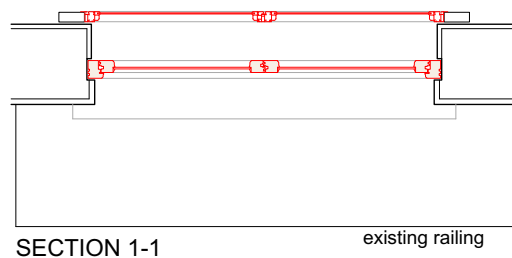
Extract taken from drawing WS01 showing one of the replacement French windows in Plan

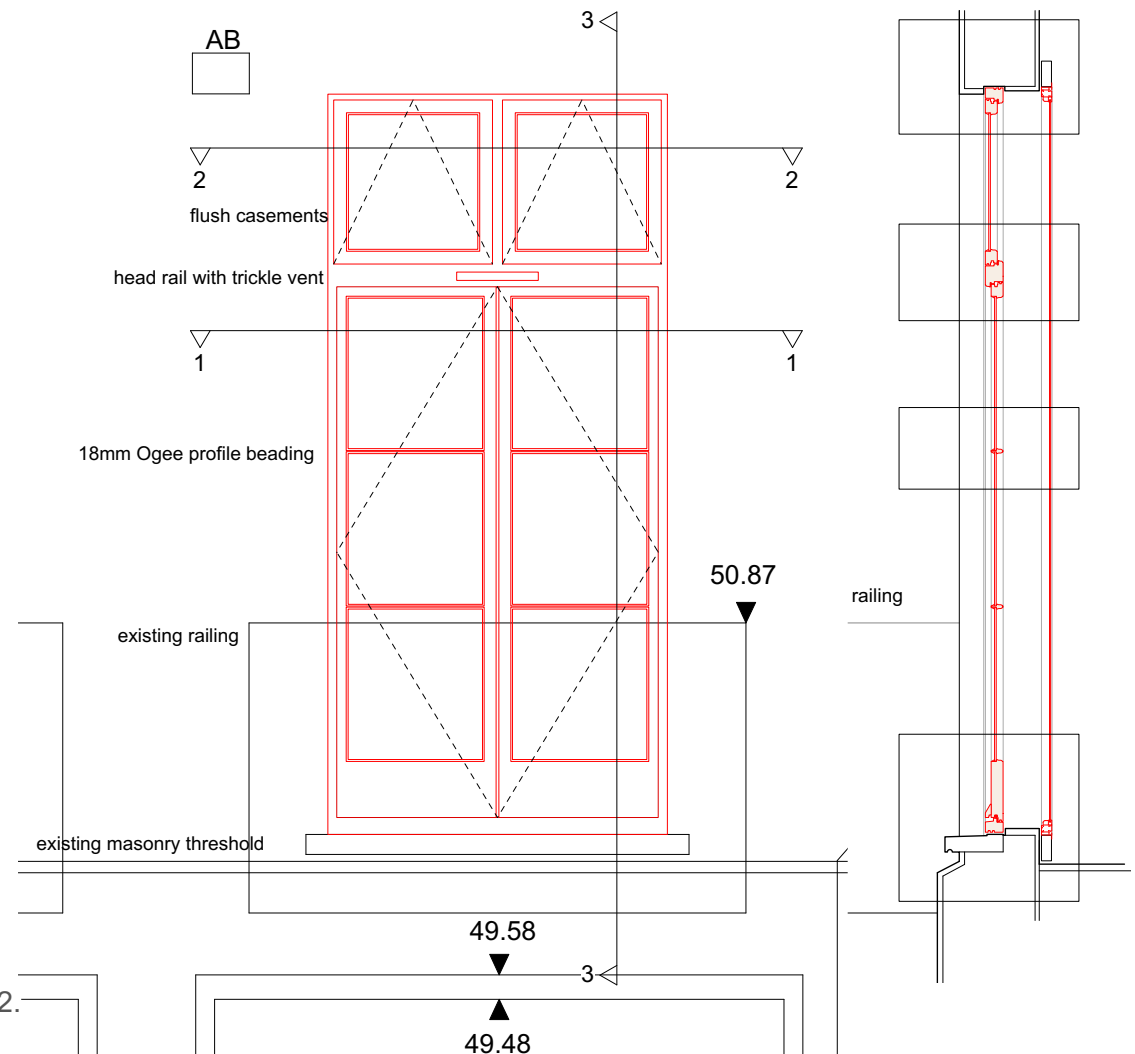
Extract taken from drawing WS01 showing one of the replacement French windows in Elevation & Section

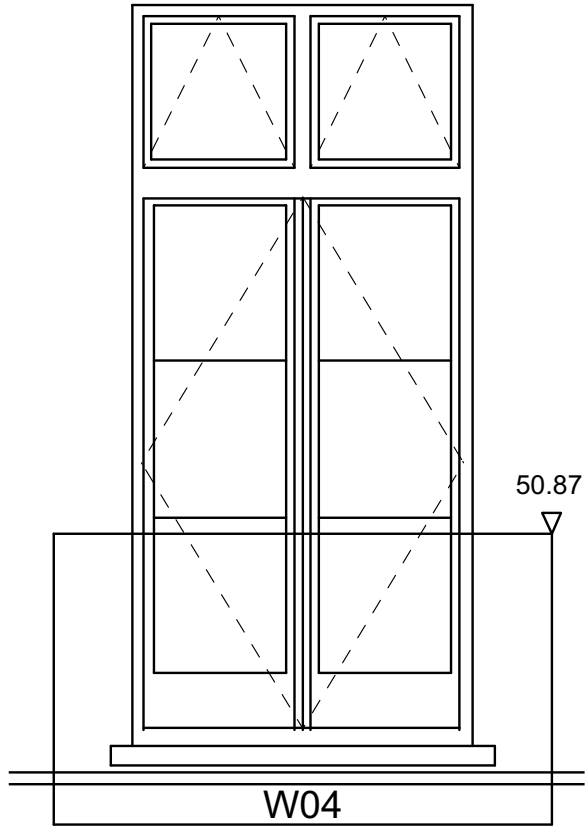
Extract taken from drawings X17 showing one of the existing French windows in Elevation

The fenestration is in a relatively poor state and in need of replacement. The proposed, white painted French windows and flush casement windows mimic the existing. New secondary glazing is also proposed.

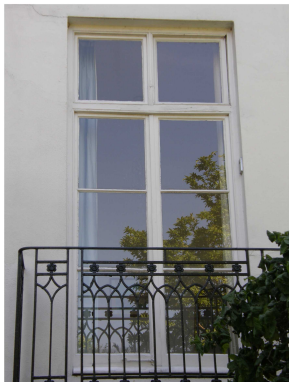
Photo of one of the existing French windows.

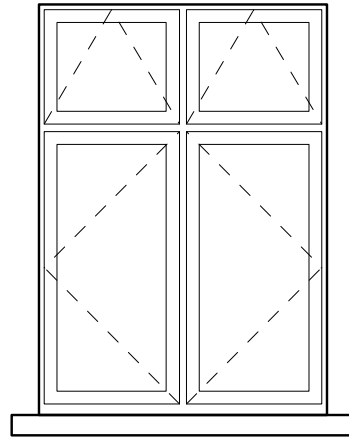
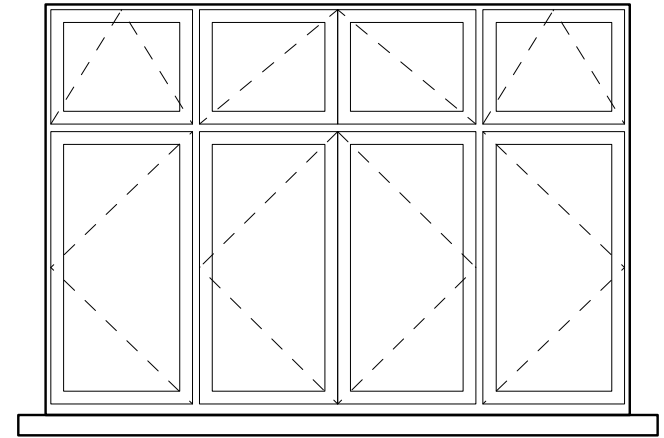
Extract taken from drawings X19 showing the existing bathroom and corridor windows at the rear in Elevation

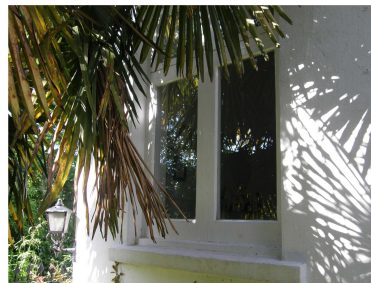
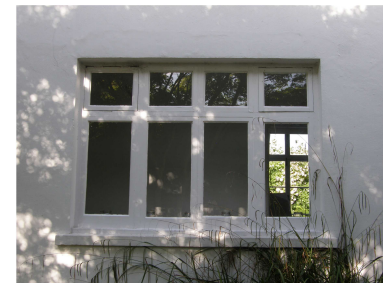
Photos of the existing bathroom and corridor windows at the rear.
