SITE INVESTIGATION REPORT

ST PANCRAS COMMUNITY CENTRE, 30 CAMDEN STREET, LONDON, NW1 0LG

Report ref: 10037/SC

Date: 26th June 2017 [Rev 2]

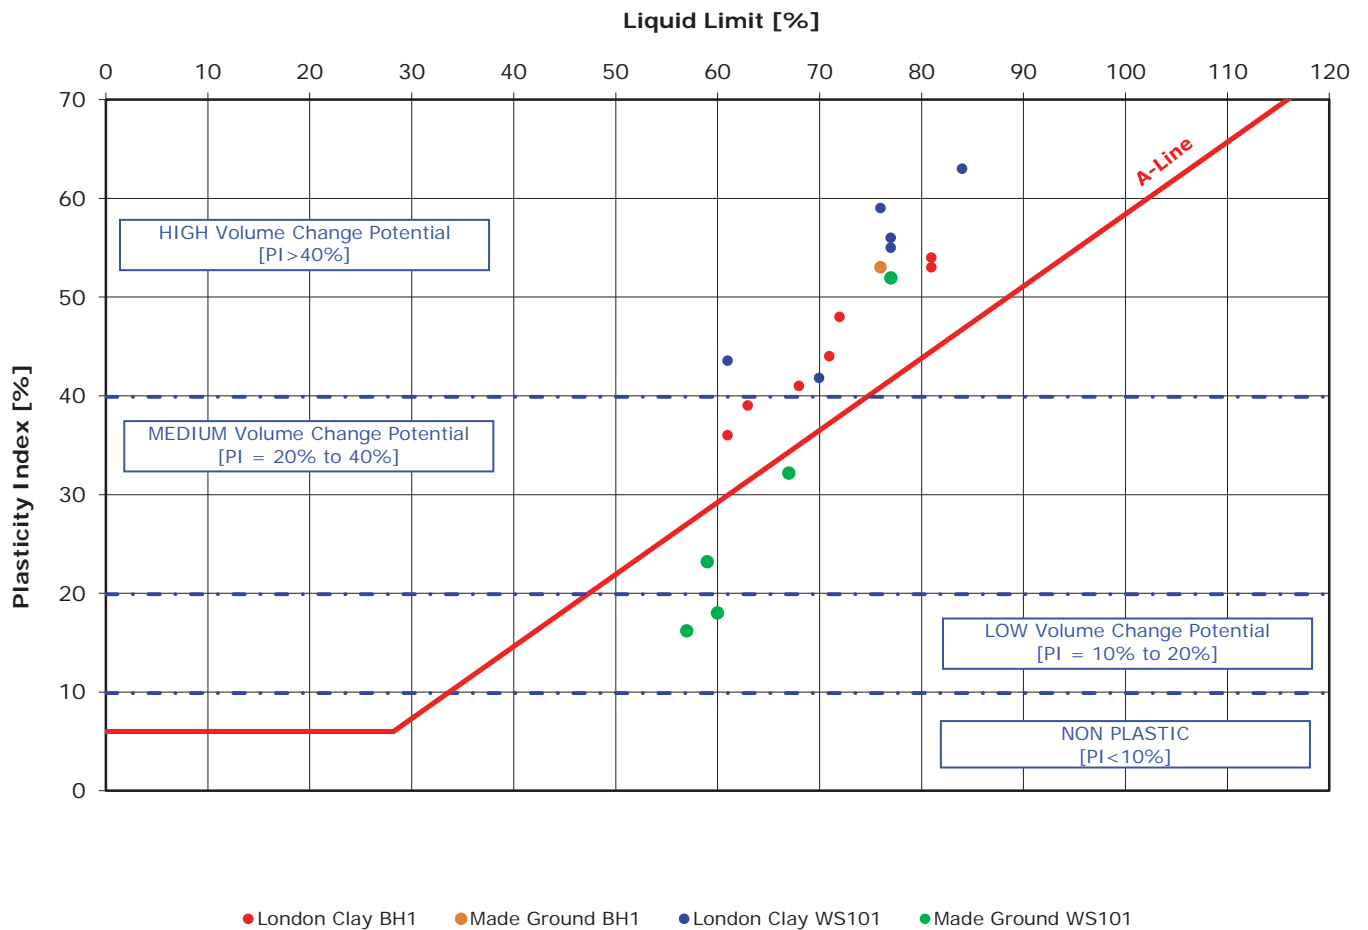
Plasticity Chart

Modified Plasticity Index, I'_p:

$$I'_p = \frac{I_p \times (\% \text{ passing } 425\text{mm})}{100\%} \quad [\text{where } I_p = \text{Plasticity Index}]$$

Classification in accordance with NHBC Standards, Part 4 'Foundations', Chapter 4.2 'Building near trees'

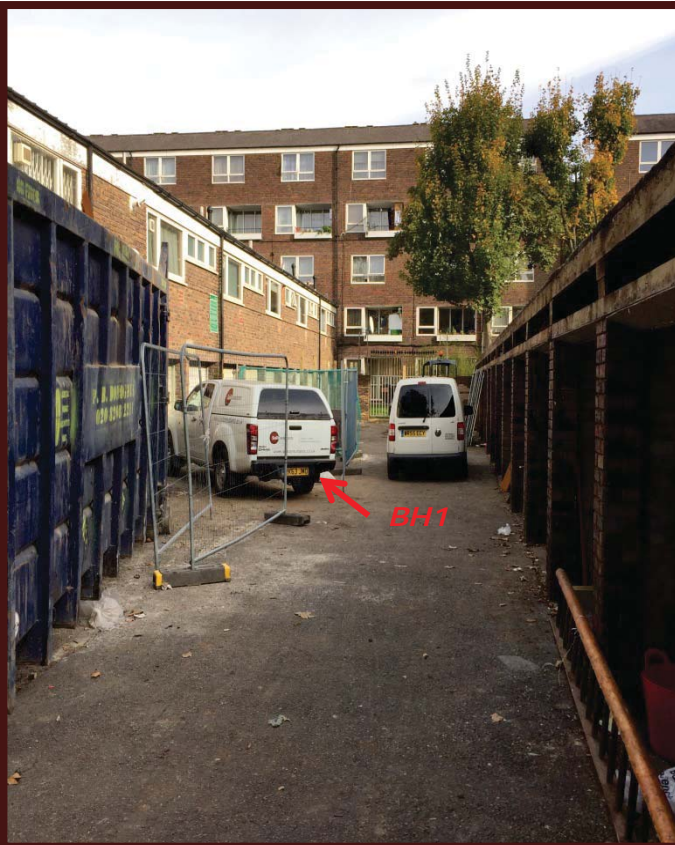
**Southern side of the community centre showing a
concreted courtyard and garages. A Mature
deciduous tree located to the end of the courtyard**

Due to the thickness and poor quality of the untreated made ground, floor slabs should be designed to be fully suspended with a void below to allow for potential swelling of clay soils which may be desiccated through tree root growth. However, we understand that the made ground may be treated and a piling mat constructed to facilitate piling operations. In this scenario, for nominally loaded floor slabs, it may be possible to cast the floor slab directly on the treated ground. This would not of course protect against any potential swelling and thus it would be necessary to excavate and replace any root infested and/or desiccated clay below the floor slab area prior to construction of the piling mat.
