23 Macklin Street
Design and Access Statement
December 2013

23 Macklin Street

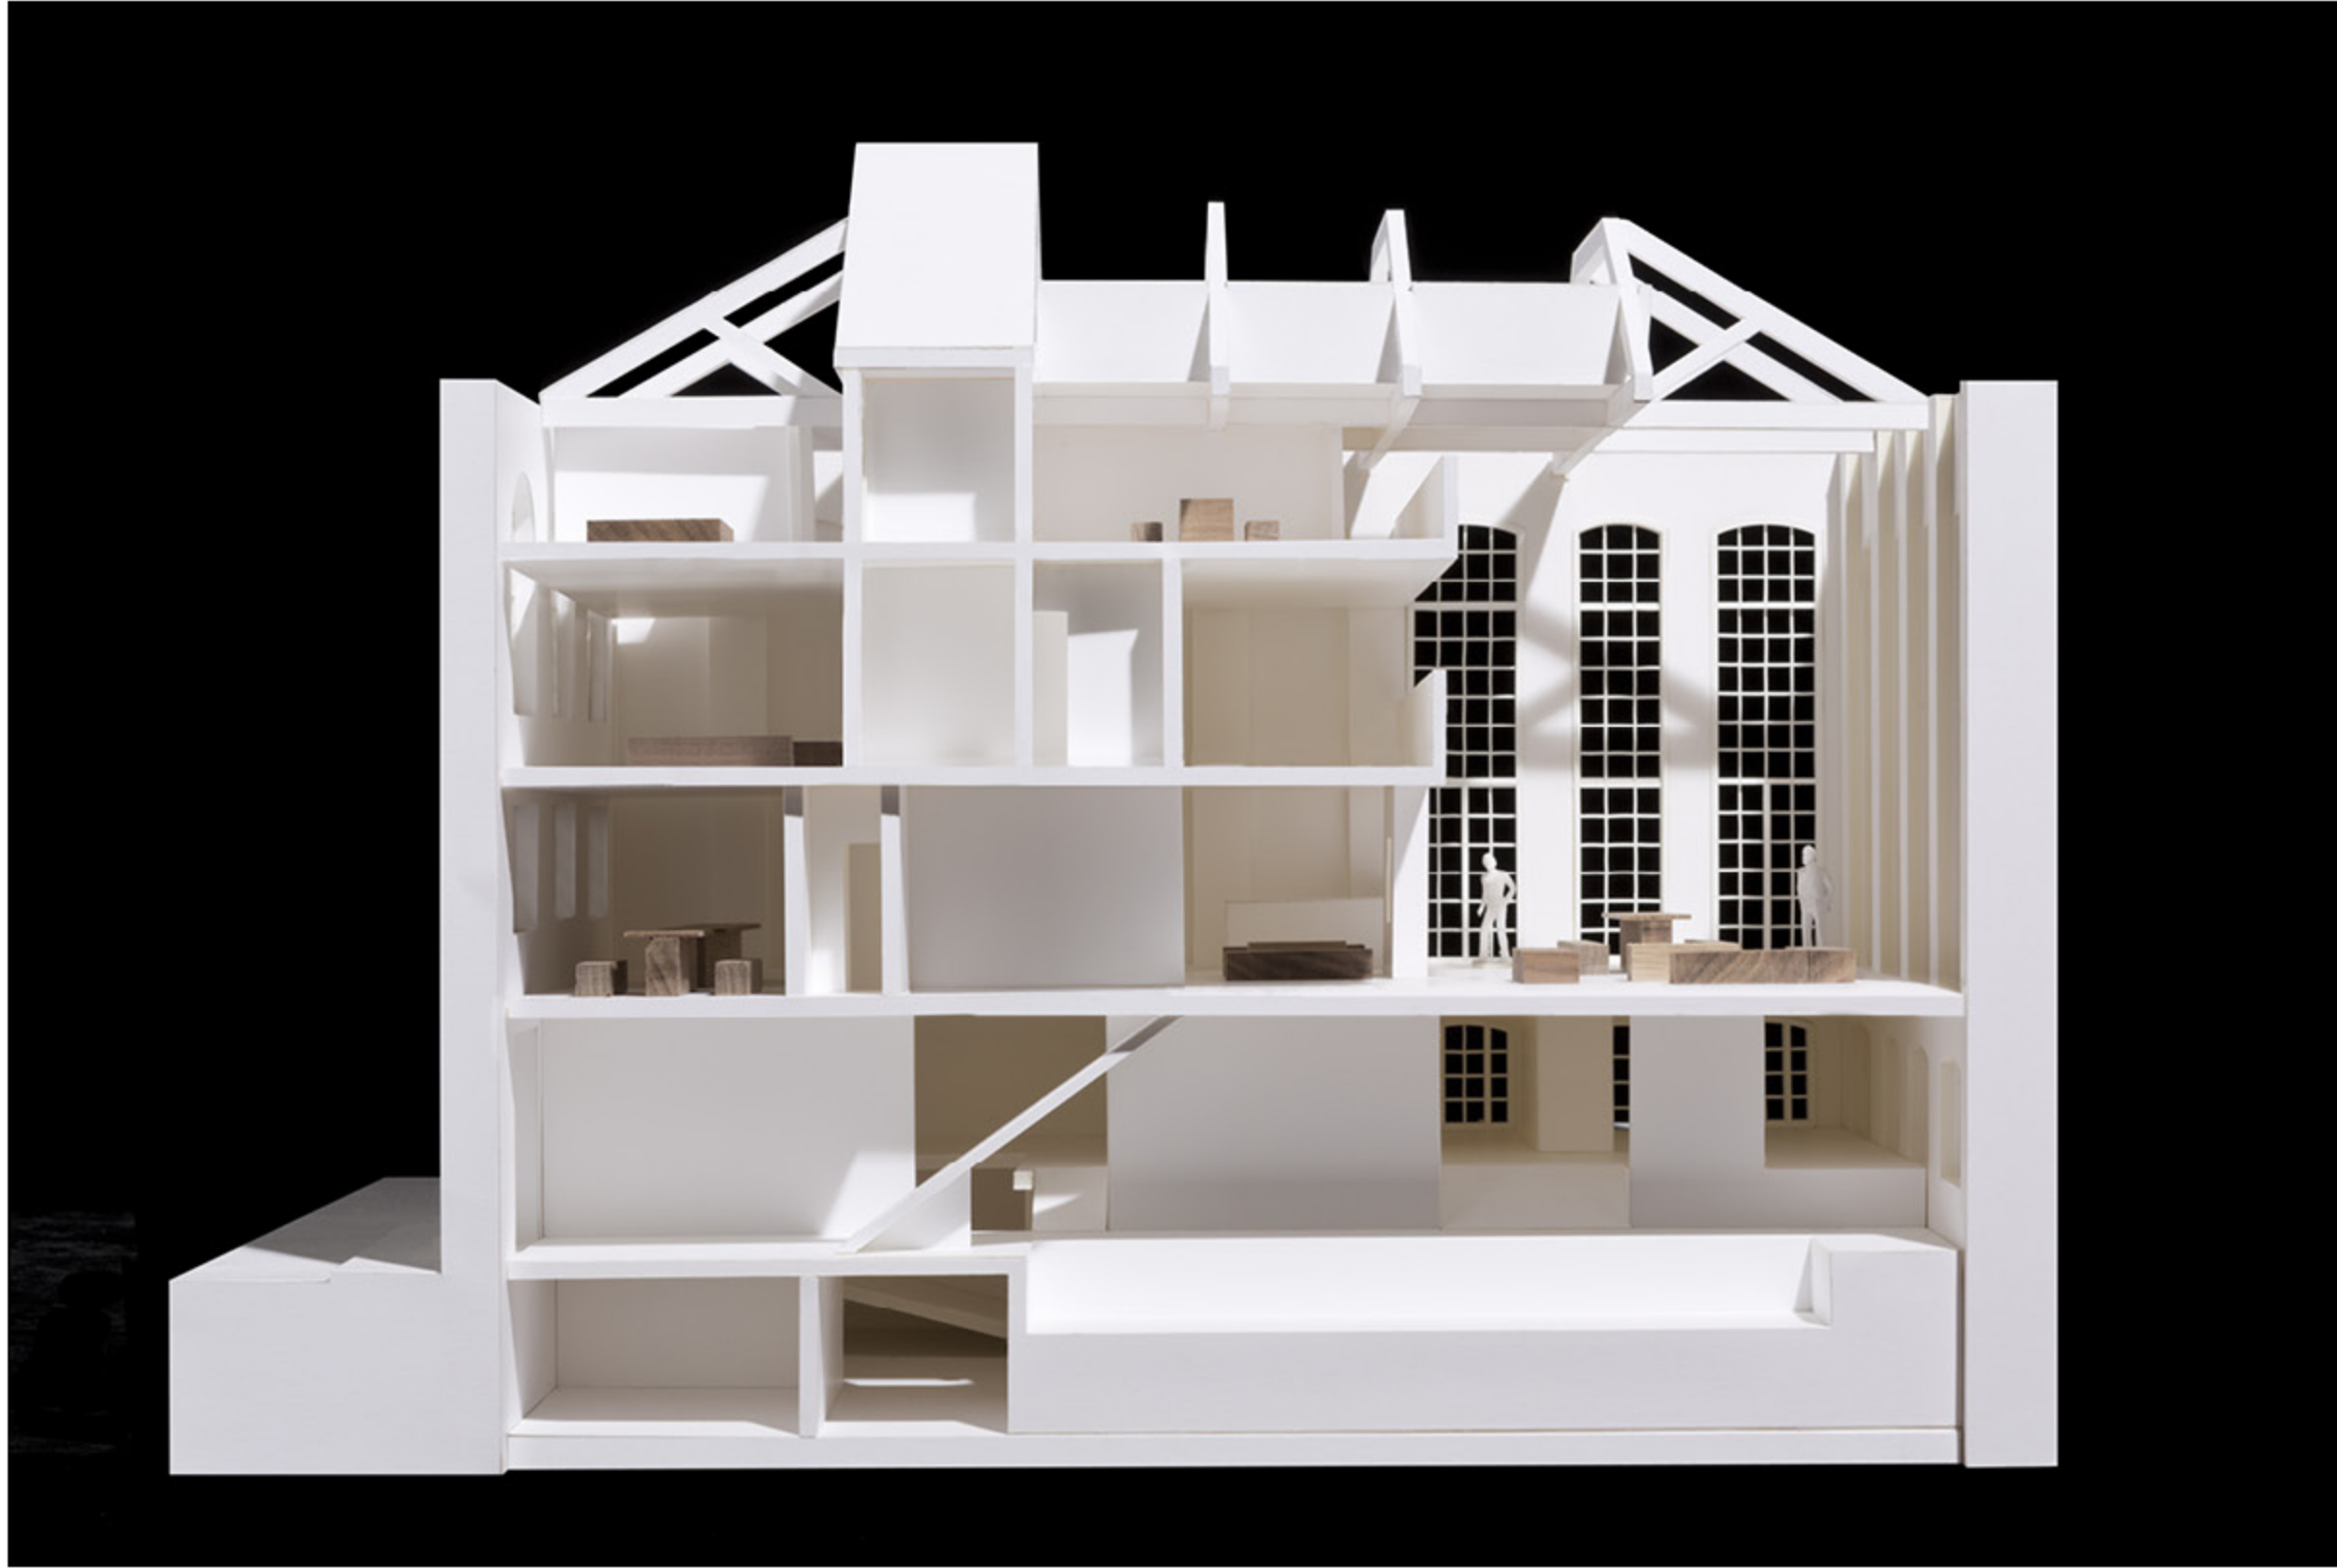
Architectural model of proposal, scale 1:50

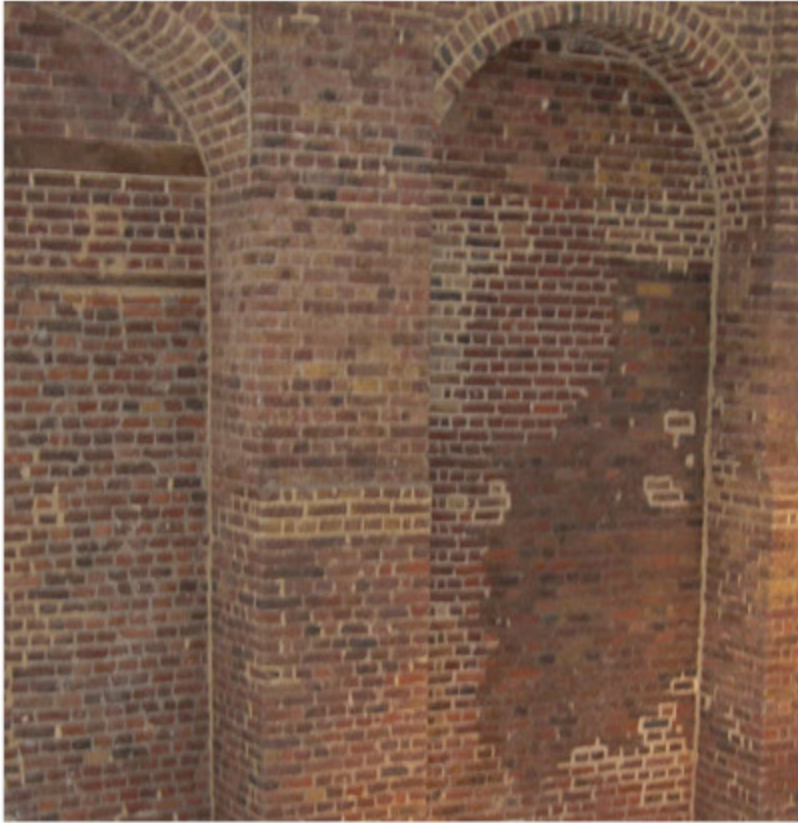
North Main Hall showing imperfections in the brickwork patterns, possibly due to past damage.

A map dated 1939-45 London County Council Bomb Damage Map shows there was damage to the northern neighbouring property on Stukeley Street but that 23 Maoklin street escaped any material harm. The orange on the map indicates 'general blast damage, minor in nature.' It is unlikely that there caused any serious damage to 23 Maoklin Street. However, there is a possibility that some minor damage could explain the change in brick pattern between the arches in the northern boundary wall.

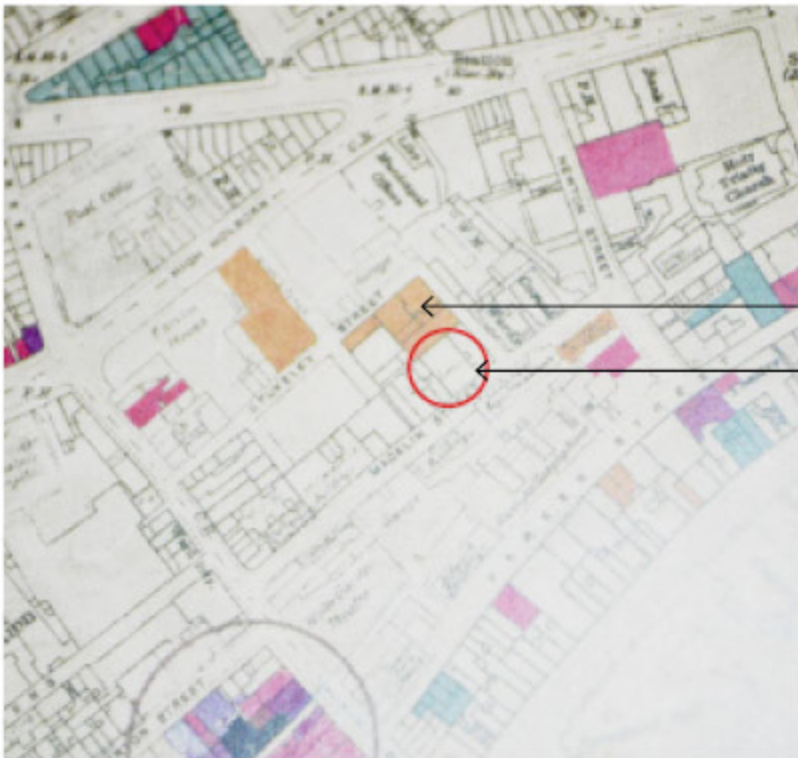
Colour Key:
General blast damage, minor in nature

1939-45 London County Council Bomb Damage Map highlighting bomb damage to 22 Stukeley Street.

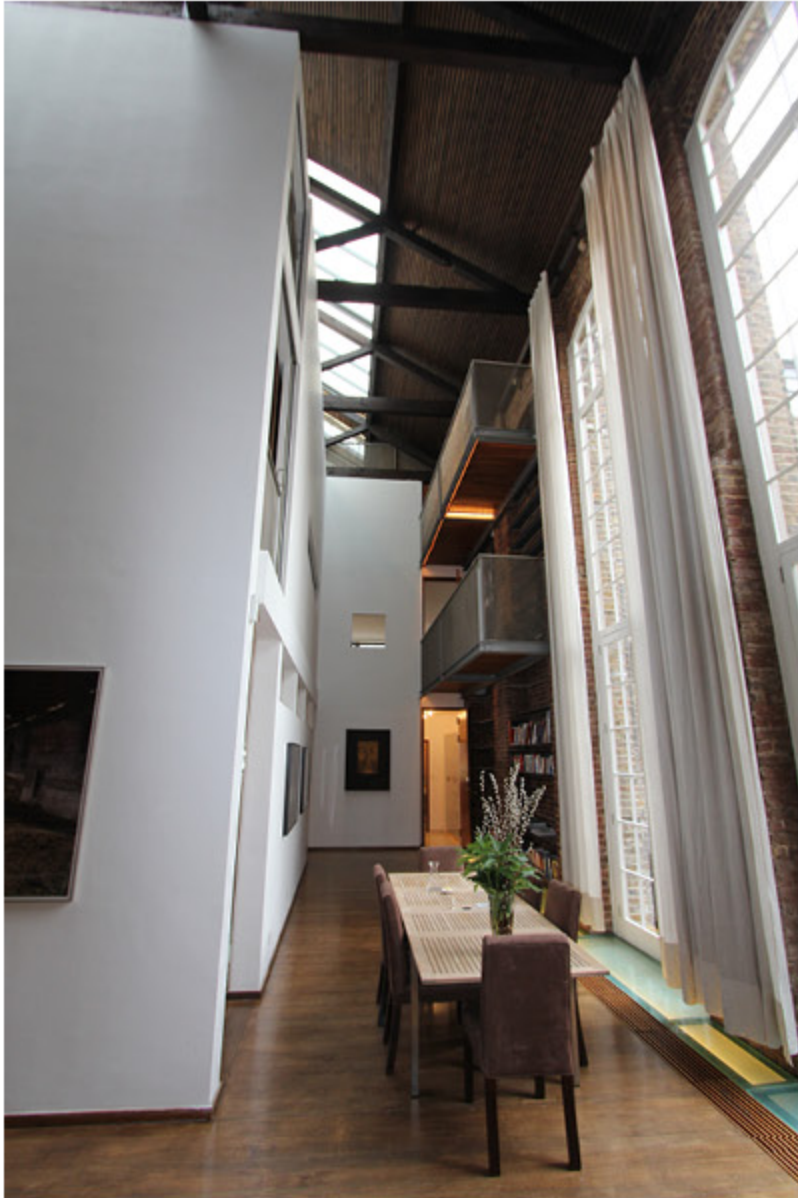
View looking south in the main hall into the side corridor between the historic fabric and 1990s insertion.

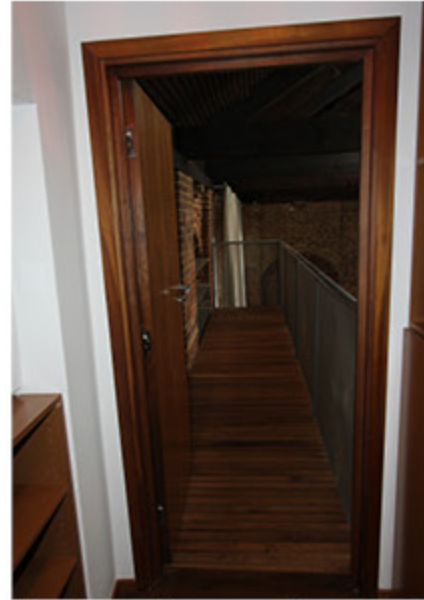
View to doorway between second floor office and library balcony with limited daylight.

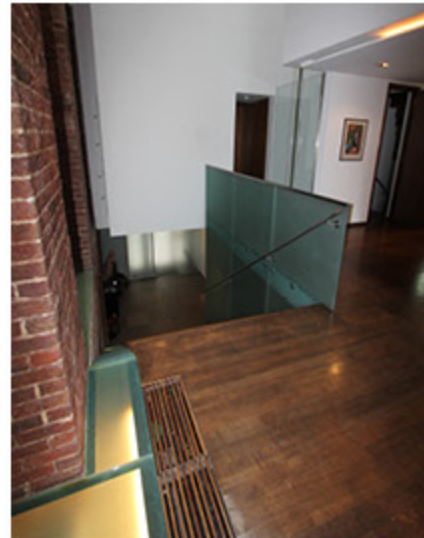
View from the first floor looking down the entry stair showing 1990s glazing features.

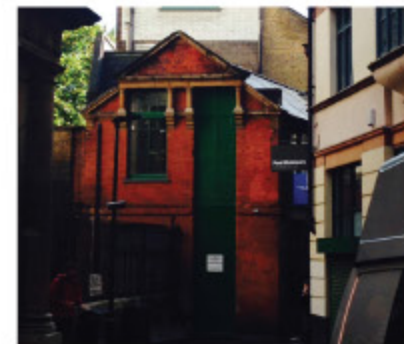
**Elms Lester Painting Rooms
Flitcroft Street, 1903-4**

Painting Rooms for theatrical scenery built in 1903-4 for Messrs W & J Elms Lester. An important and complete survival of a theatrical scene-painting workshop. The centre of the building is occupied by the painting frames, workspace is lit by the projecting lantern which has cast-iron framework to glazing. The first floor painting area, supported on a steel frame, gives access to four 50'x 30' painting frames which run along the outer side walls and both sides of the inner dividing screen wall. Each cast-iron frame can be raised or lowered by electric winches. The large entrance lobby to the front has a hoist and trap doors, which facilitated the exit of completed backdrops from the painting rooms, via the full-height doors in the facade.

- Elms Lester Painting Rooms: Large projecting lantern with cast iron framework to glazing.
- Mara's Scene Painting Shop: Large glazed roof light.
- Harker's Rooms: Gabled roof mostly glazed.

- The vertical workshop typology uses a system of frames and pulleys to enable a vertical painting process:
- Elms Lester: First floor painting area supported by steel framing enables access for painting frames (50" x 30").
 - Mara's Scene Painting Shop 5 & 7: Shop 5 uses the full height and width of building to stretch canvas and winch up and down.
 - Harker's Rooms: Open plan two storey gable end over three bays.

- Elms Lester: Large entrance lobby with hoists and trap doors facilitated the exit of completed backdrops from the painting rooms, via the full-height doors in the facade.
- Mara's Scene Painting Shop: Narrow unloading doors at the three storey scenery shop and a wide ground floor door at number 7.
- Harker's Rooms: Casement flanking double doors into the two-storey zone of the ground to first floor.

- Elms Lester: Painting frames (50" x 30") accessed from first floor and run along the outer side walls and both sides of the inner dividing system.
- Mara's Scene Painting Shop (5&7): Originally eight frames run in pairs. In No 5 the full height and width of the building could be used to stretch the canvas and winched up and down for the convenience of the artist working at 1st floor level. Four vertical frames surviving.
- Harker's Rooms: Large wooden paint frames with pulley and counterweights occupy side walls and the centre of the room.

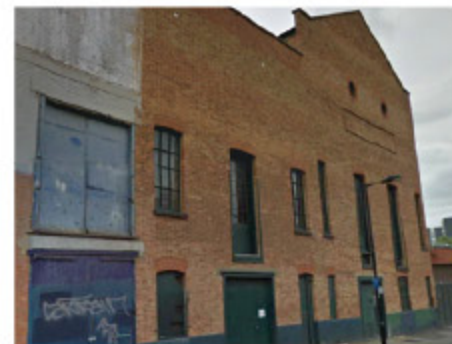
**Mara's Scene Painting Shop
Newport Street, 1913**

Built in 1913 to the designs of John A J Woodward of Kennington Oval, the LCC's District Surveyor for the area, by George Brittain Contractor to the Duchy of Cornwall Estate. It is the facility to design an entire theatrical set that makes this group of workshops unique. Nos. 5 & 7, the three storey part housed the painted scenery shop, and originally had eight frames run in pairs and first run by William Raphael. Narrow unloading doors and ground floor wide door is evident on No. 7. In No 5 the full height and width of the building could be used to stretch the canvas and winched up and down. Nos. 1 & 3 was a carpentry workshop for theatrical 'props' and scenery, first occupied by John Brinskill. No.1 (left hand side) is of 2 storeys. No 3 is of three storeys with hipped roof. 2 lower storeys have 4 cambered fixed casements leading door to 1st floor and wide door to ground floor.

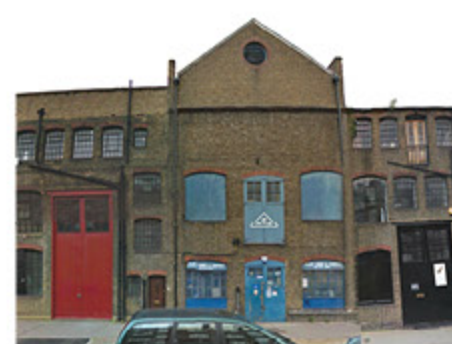
**Harker's Rooms
Queens Row, 1904**

Painting rooms for theatrical scenery. Built in 1904, and partly rebuilt in mid 20th Century for Joseph Harker. The building is constructed from English bond brick with a gabled roof (mostly glazed). Open plan. 2-storey gable end of 3 bays has red brick segmental arches over metal casements flanking double doors to ground and 1st floors; moulded red brick cornice beneath gable with louvred oculus. Rear elevation facing Horsley Street rebuilt in mid 20th Century. INTERIOR: large room, lit by glazed roof, is occupied by large wooden paint frames with pulleys and counterweights; these occupy the side walls and the centre of the room. Large double doors to ground and 1st floors of rear wall. An important and rare survival of a theatrical scene-painting workshop, named after Joseph Harker (1855-1927) who was one of the most important theatrical scene painters of his day, having made this reputation through his designs for Henry Irving's productions at the Lyceum.
