4.1.3 Macklin Street Set Painting Studio

4.1.6 Historic Internal Arrangement

4.2.1 Internal Arrangement

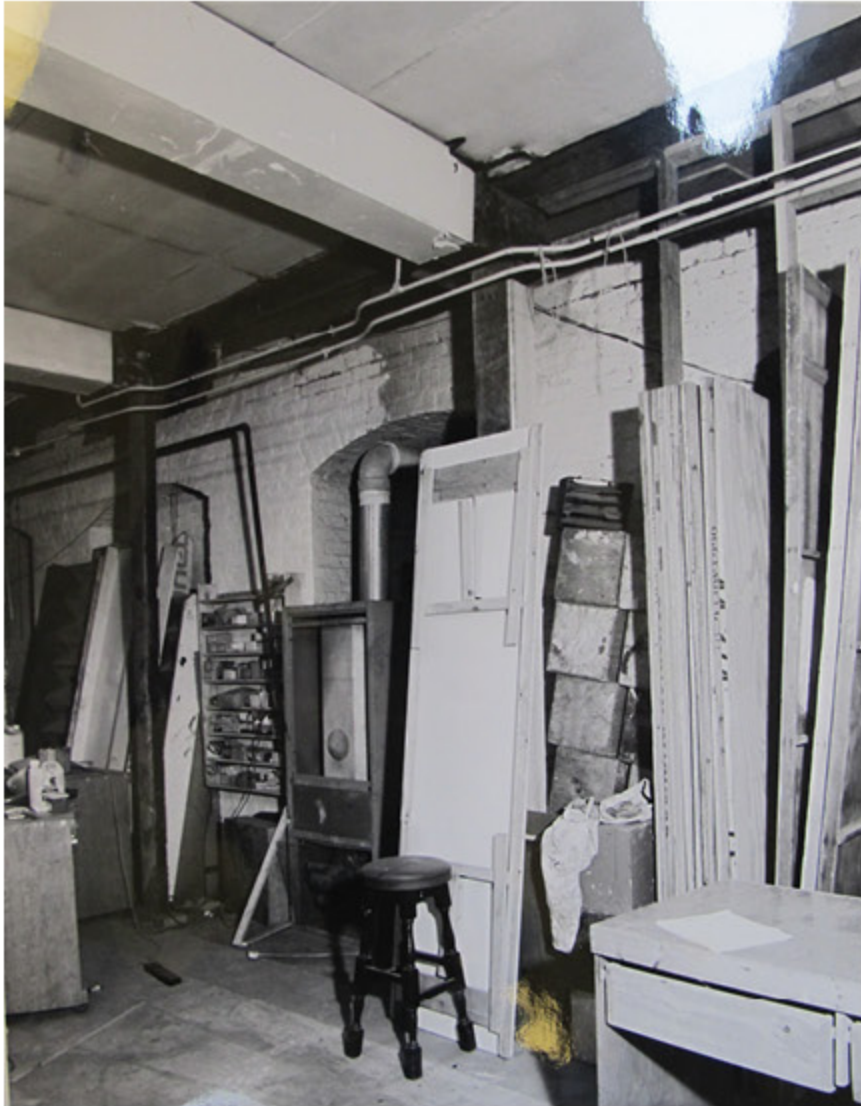
View of the Ground Floor of 28 Macklin Street (circa-1980) showing the exposed timber beams and columns (English Heritage Archive)

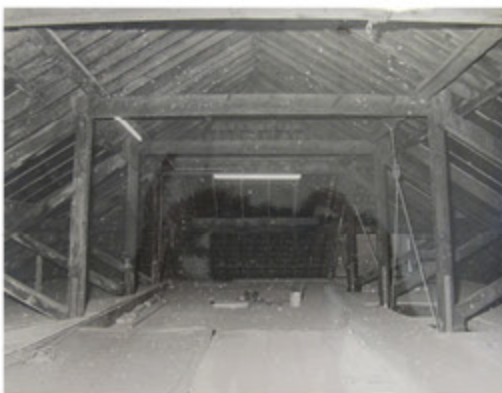
Photograph (circa-1980) looking north in the roof cavity at the level of the fourth floor (English Heritage Archive)

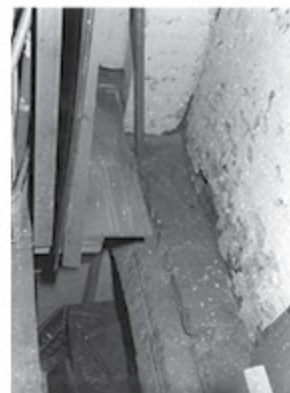
Photograph (28 Macklin St, date unknown) showing the gap between the brick side wall and the floor slab ground floor showing that the paintframe did pass to the basement level. It also shows that at ground floor the gap did not go right into the brick arch (Theatres Trust)

A photo from the Theatres Trust Archive (refer to Section 4.1.3) shows evidence of the timber columns on this floor set in from the brick walls allowing the canvases to pass freely down around the edges. The canvases would have been set within a timber frame structure working to create ample tension on the canvas for painting as well as allowing the painting space to become part of a moving mechanism, moved at the painters request.

The historic photographs of the interior give evidence of the gap used for the movement of the paintframes. The photos also provide evidence that there was an internal wall and floor on the ground floor level historically.

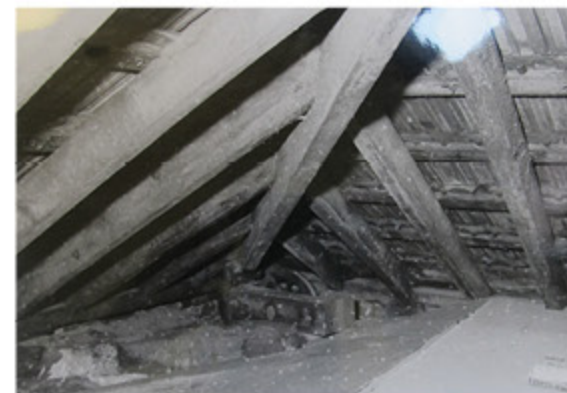
Photograph (28 Macklin St, circa-1980) showing a pulley in the corner in the ceiling interface between the fourth floor and roof cavity (English Heritage Archive)

The frames dropped down into a pit on the basement. This allowed enough space for the full height of the canvas to be dropped down to a level allowing the painter to reach the top. There is still evidence of the pulleys in the top corners of the building today.

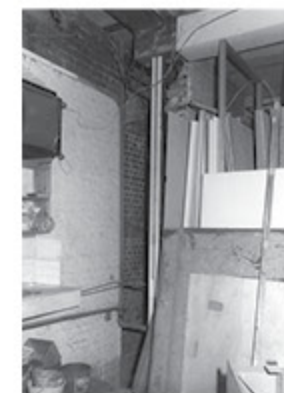
Photograph (28 Macklin St, date unknown) showing the scenery well (from ground floor) and that there were inner walls and floors at one end. (Theatres Trust)

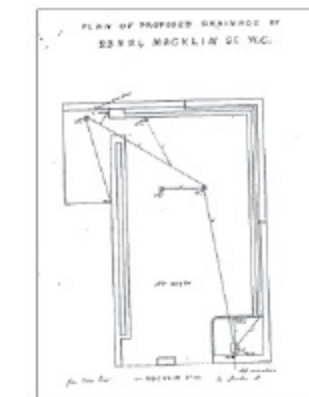
1903 Proposed Drainage Plan—showing location of painting slots (Camden Local Studies Archive)

The historic photograph and section shown on this page illustrate the open nature of the space at 23 Macklin Street. The section illustrates the simple, open nature of the historic building and the scenery wells for the paint frames prior to its conversion for residential use. The 1903 proposed drainage plan shows the location of the slots on the north, east and west perimeter.

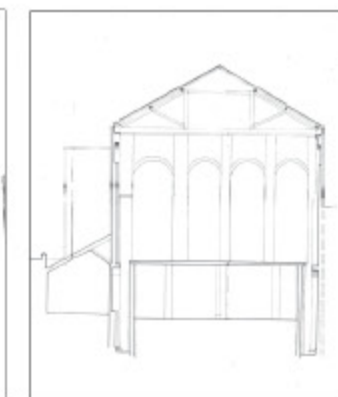
Survey Drawings, Grimley and Son, 1978 (Camden Planning)

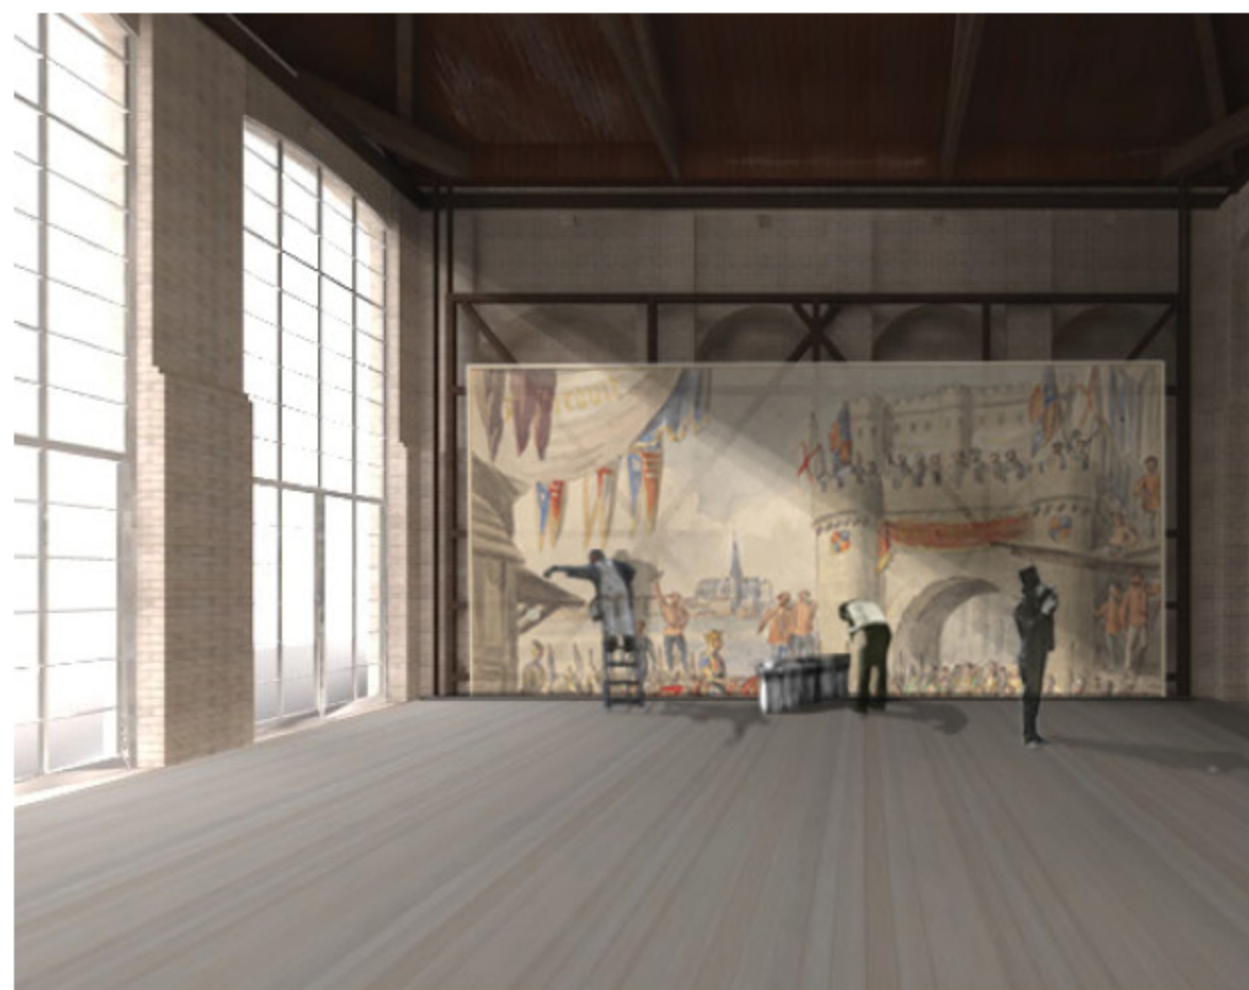
Reconstruction of Historic Condition illustrating the process of painting a canvas on a movable frame structure

The computer generated reconstruction image to the left illustrates what the building may have looked like on a typical working day in the 1850s, with canvasses being worked on.

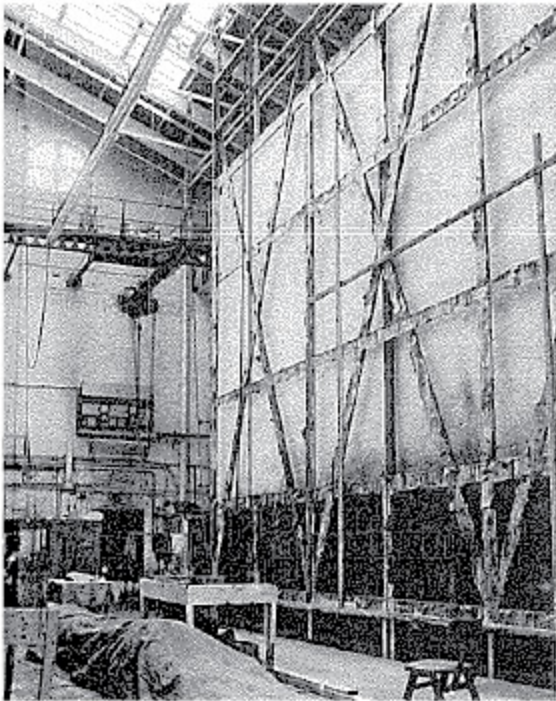
Covent Garden: Scene painting room
(Source: Richard Leacroft: *The Development of the English Playhouse*, 1978)

He speaks of the "vast proportions" of the room at Covent Garden: "90 feet long by 30 feet wide and about 55 feet high & possess four separate stretching frames – the largest, 42 feet by 70 feet. This enormous stretcher is worked up & down by means of a very powerful windlass and multiplying gear, and hung by iron chains. The physical strain is covering so large a surface, and in walking backwards and forwards from one end of the room to the other to judge of the effect is exceedingly severe."

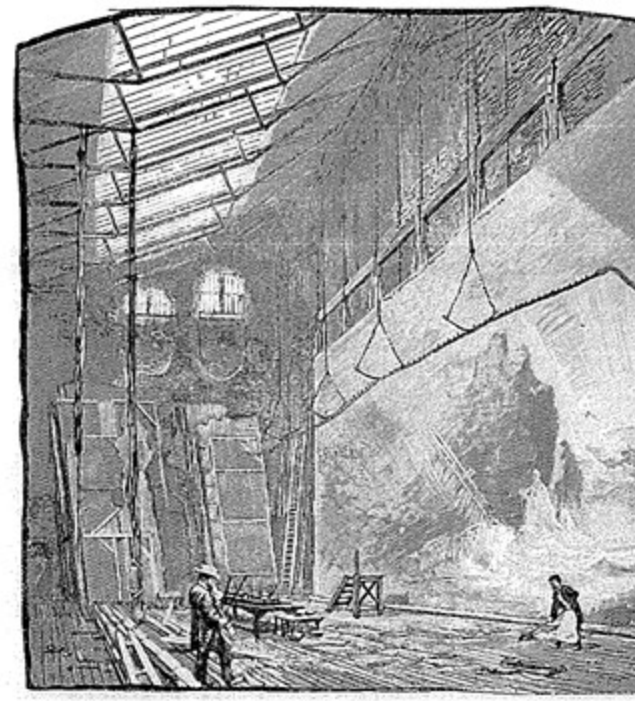
Victorian Scene Painting
(Source: Iain Mackintosh, *Architecture, Actor and Audience*, 1970)

The Victorian Scene Painting image shown here is described in Richard Southern's book, *The Victorian Theatre. A Pictorial Survey*, of 1970, to contain "a gigantic paint frame, rising and falling through a slit in a specially designed floor by means of a winch and counterweights." Southern also explains that on the Continent theatre scenery was often painted on the floor, but that this was unfeasible in London where such large footprints were unaffordable. Thus the 'vertical method' of painting was generally used.

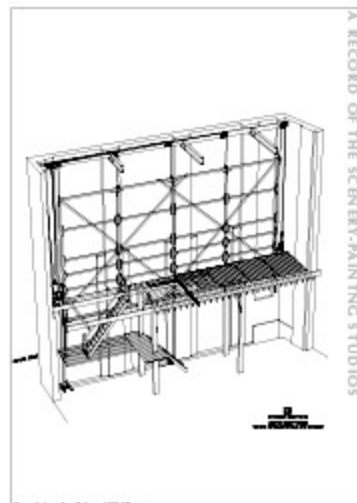
Photograph and axonometric diagram of Paint Frame system at Mara's Scene Painting Shop,
at 1-7 Newport Street Lambeth, London built in 1913

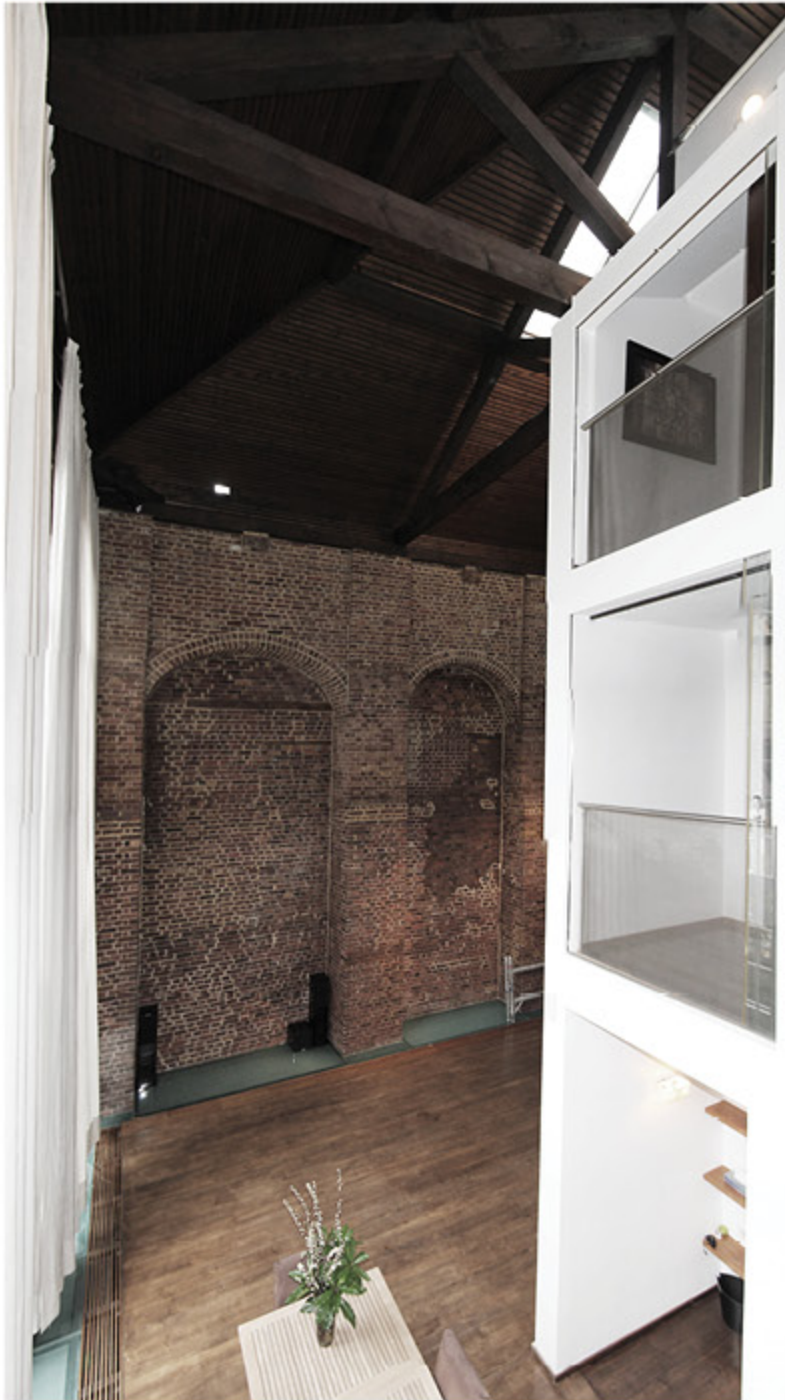
Panoramic photograph of Main hall historic fabric with 1990's volume insertion

The Main Hall is currently defined by the 1990s volume of bedrooms inserted within the historic fabric. The insertion operates exclusively to the historic fabric making no effort to communicate visually or environmentally, which in turn creates an awkward and uncomfortable spatial environment.

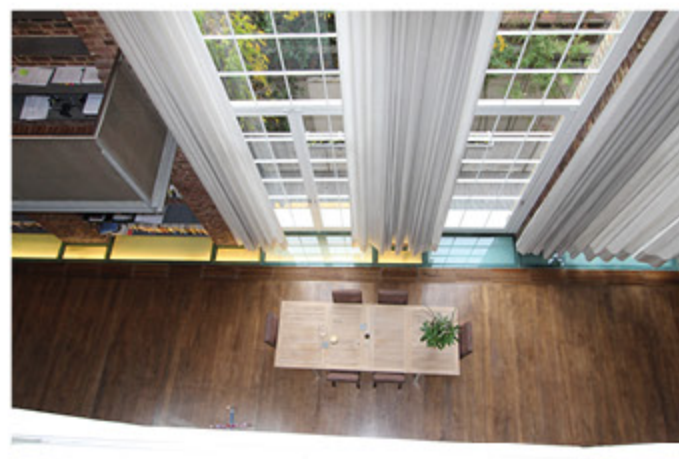
View down to the Eastern side between the external doors in the main hall and the white box insertion. Illustrating the proportionally tall and long corridor spaces leftover around the modern insertion.

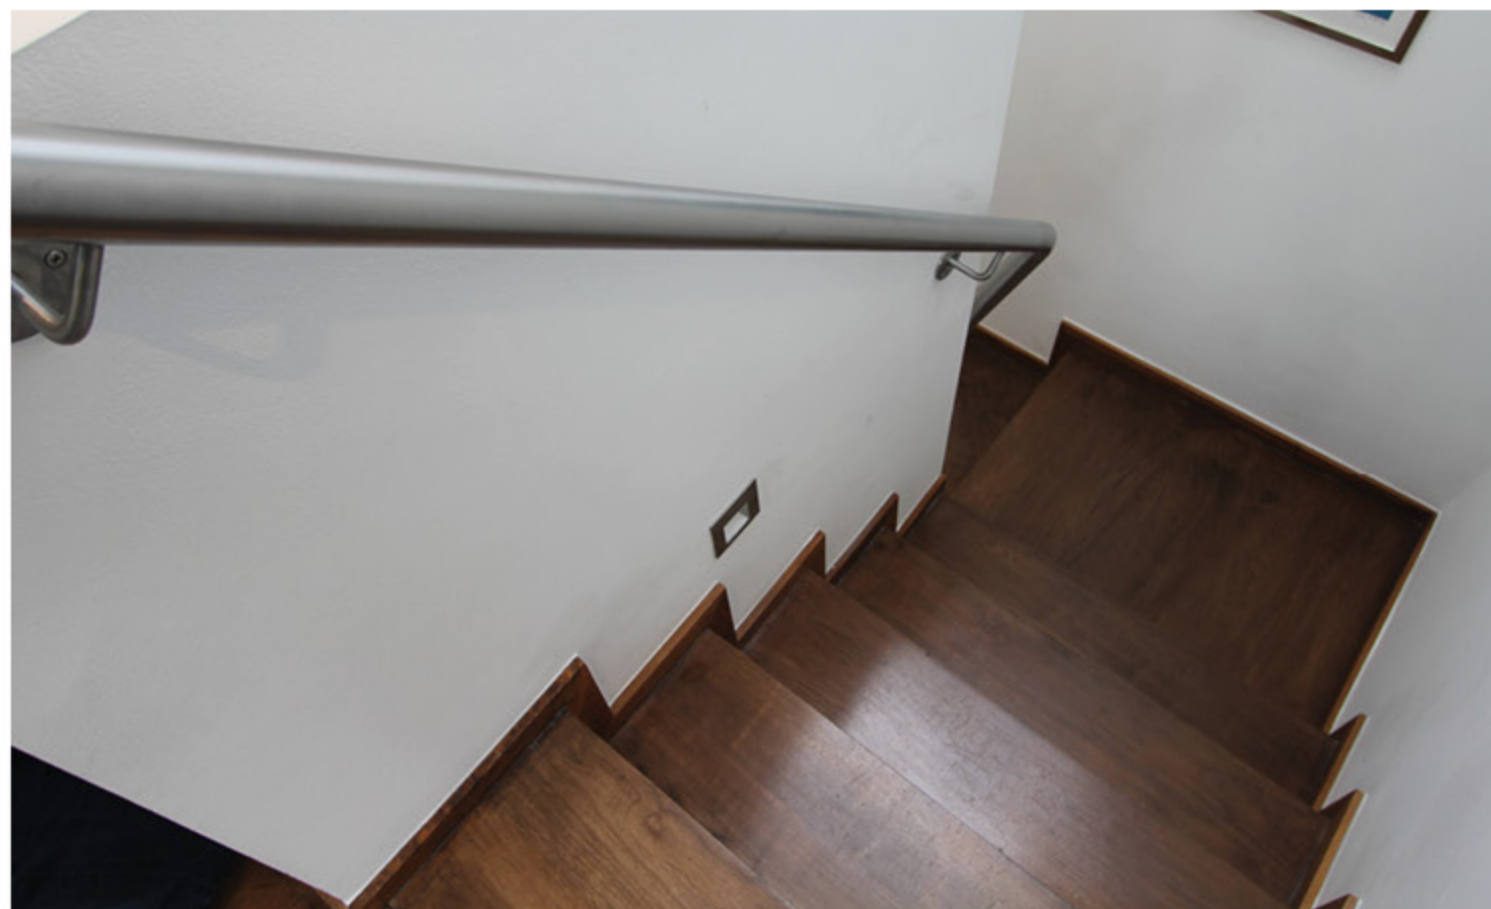
Tight and continuous fire stair from Basement to Fourth Floor.

There is only one stair for circulation from basement floor to fourth floor (apart from the front entrance stair to the first floor, and the separate staff flat). Given the scale of the house the tightness of the stair is heightened by the fact that this stair is a continuous fire stair relentlessly winding and making the circulation between the upper floors a tiresome task. There is an existing elevator servicing from ground to fourth floor.

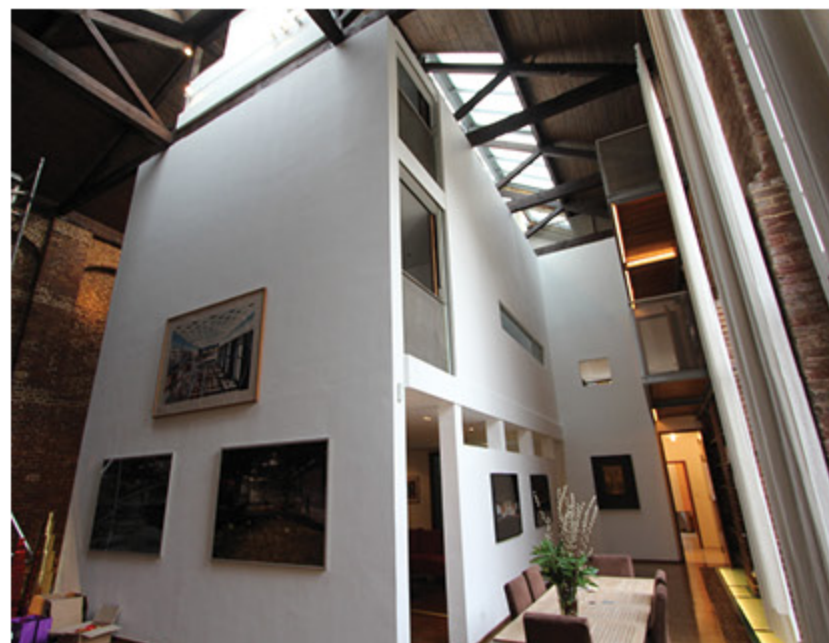
View from the NorthEast corner of the house looking into the Main Hall with the white box creating double internalised rooms without access to direct sunlight or ventilation.

For such a large house there is surprisingly no open large volume. Each space feels internalised as either a very tall corridor that one would expect to find in a commercial building or a double internalised space without access to direct sunlight or ventilation.

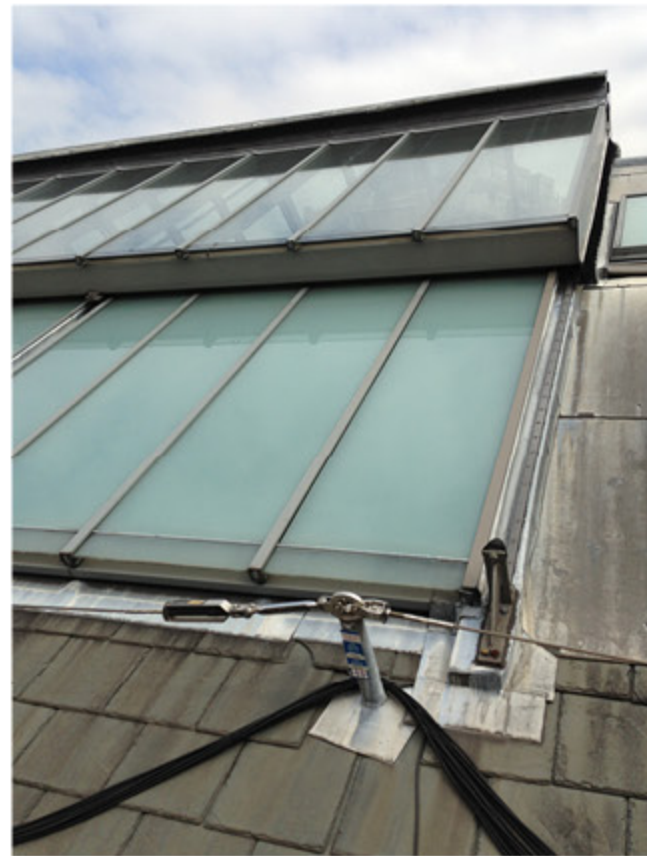
Existing operable roof light. View at roof level looking north north east from the western side of the roof

The roof (finished with slate tiles) provides the main source of light to the house from the large skylight centred on the roof apex. There are also three other minor skylights located on the falls of the roof at the north and south ends. The skylight opens mechanically and is the main source of fresh air and ventilation to the house, however this is restricted in times of inclement weather.

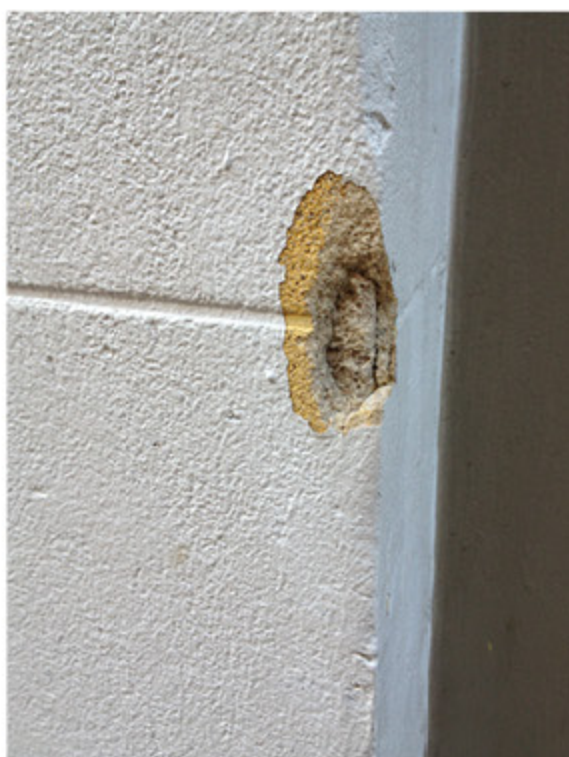
Detailed photograph of facade render (applied in the 1990s) exposing the 15mm thick cement slurry, a fine scratch coat and a more coarse top coat.

A specialist report prepared for the 1998 Planning application by T.J Shepherd describes that the existing facade is rendered with 15mm thick cement slurry, a fine scratch coat and a more coarse top coat. The fine scratch coat applied by a very shallow scoring into the cement render is patterned as faux-stonework. It has been observed that this scoring does not continue around sides of the building. The render condition of the 1990's conversion is in very poor condition.

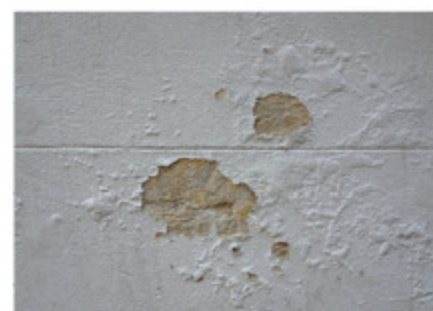
Photograph of the facade with faux-stonework pattern applied as a shallow scoring into the fine scratch coat.
