Work to Drain in Floor of Light Well

88 Albert Street, NW1 7NR

Proposed works to light well wall

Drawing 00418-12

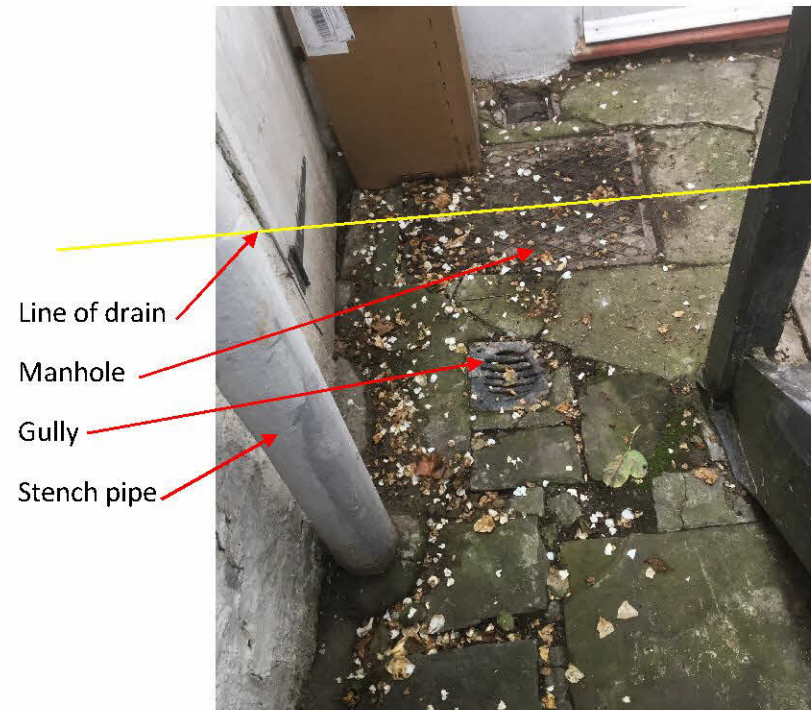
Figure 1 Floor of lightwell

1. Allow for CCTV survey of existing drain to identify the location of any defects.
2. Assuming that defects are found, excavate to expose the drain, carefully lifting the flags for later reinstatement.
3. Remove the stench pipe adjacent to the wall of the vaults. Seal off within the manhole. (It is considered to be unnecessary provided that there are suitable vent pipes inside the building.)
4. Carry out necessary repairs to drainage and backfill with pea shingle.
5. Reinstall the paving flags.
