### 1930: Lutyens remodelling

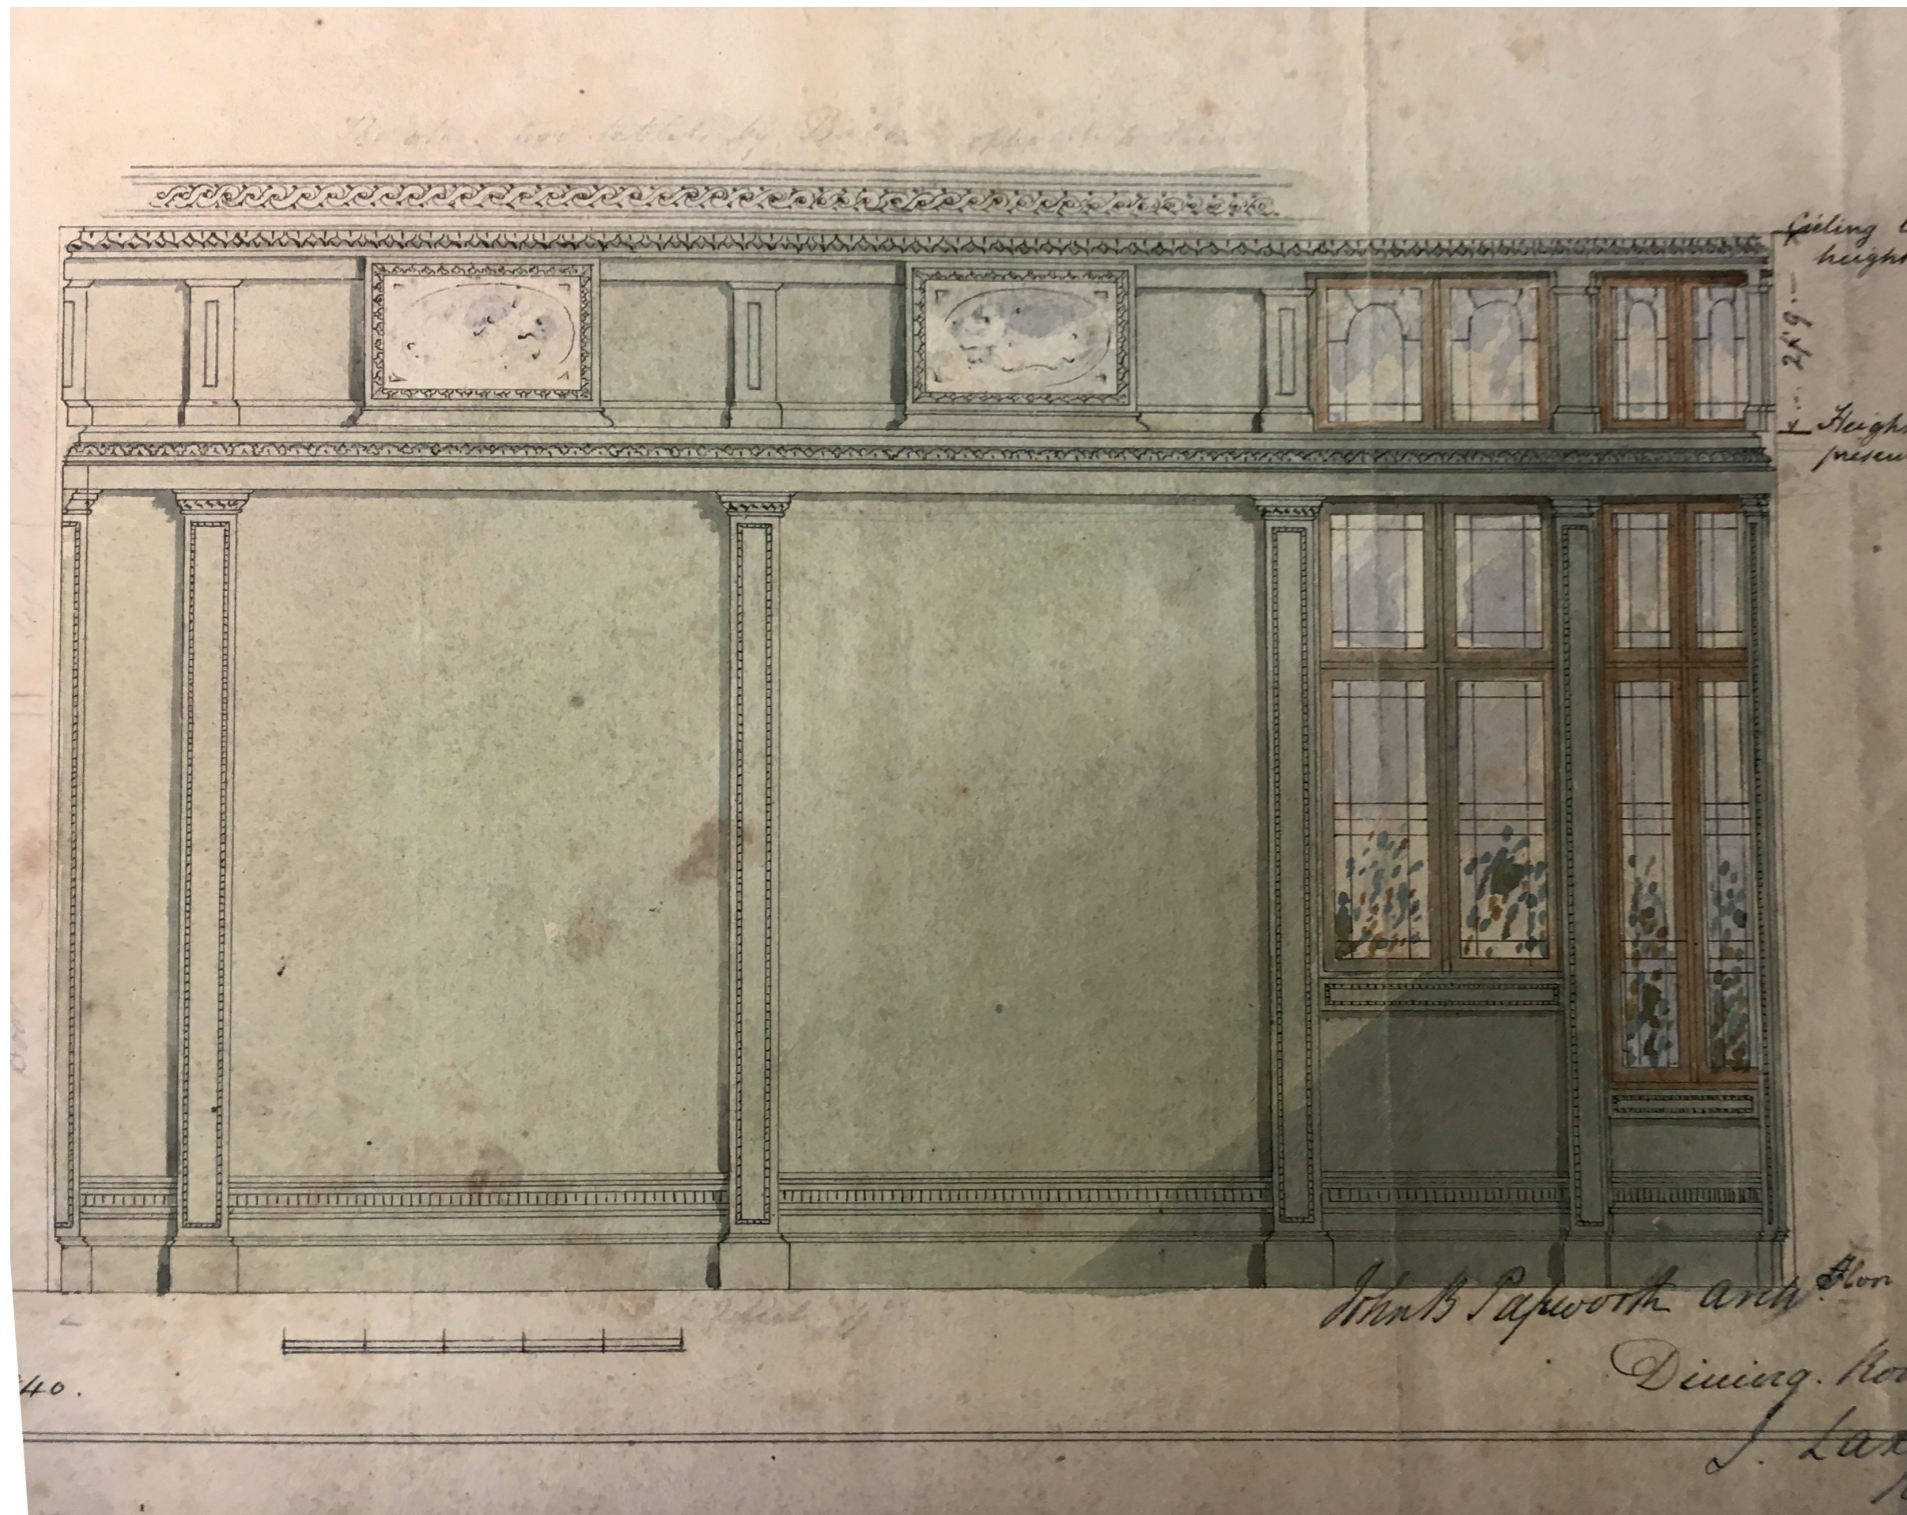
Figure 3.7 Papworth's design for the decorative detailing to the dining room interior.

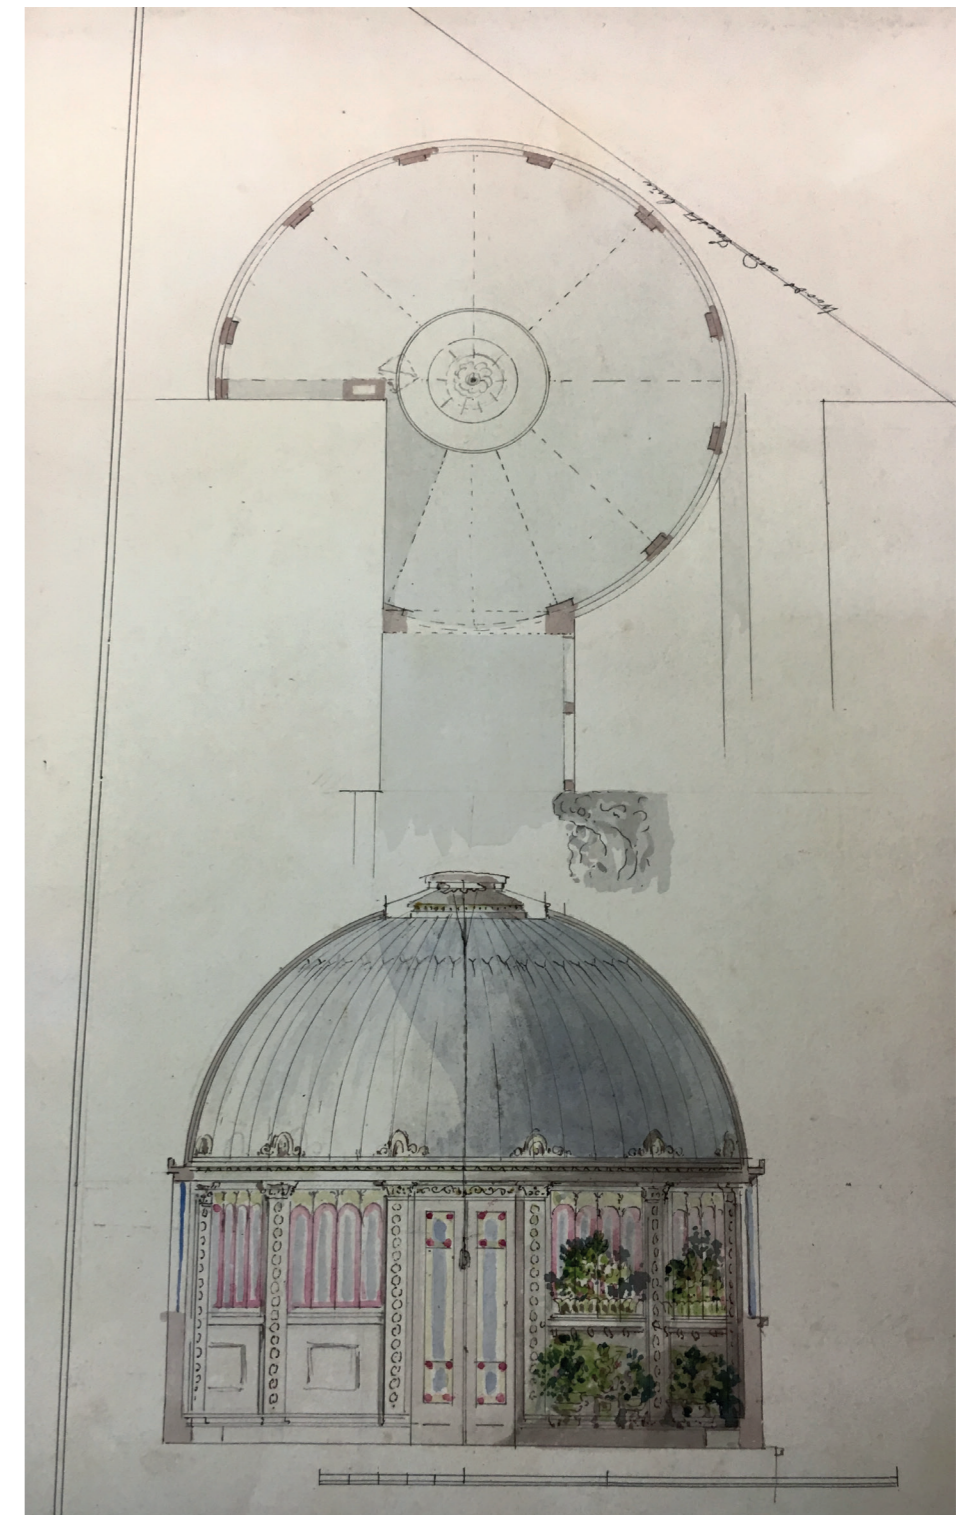
Figure 3.8 Papworth's design for a free-standing conservatory or garden room within the rear courtyard to Gloucester Lodge.

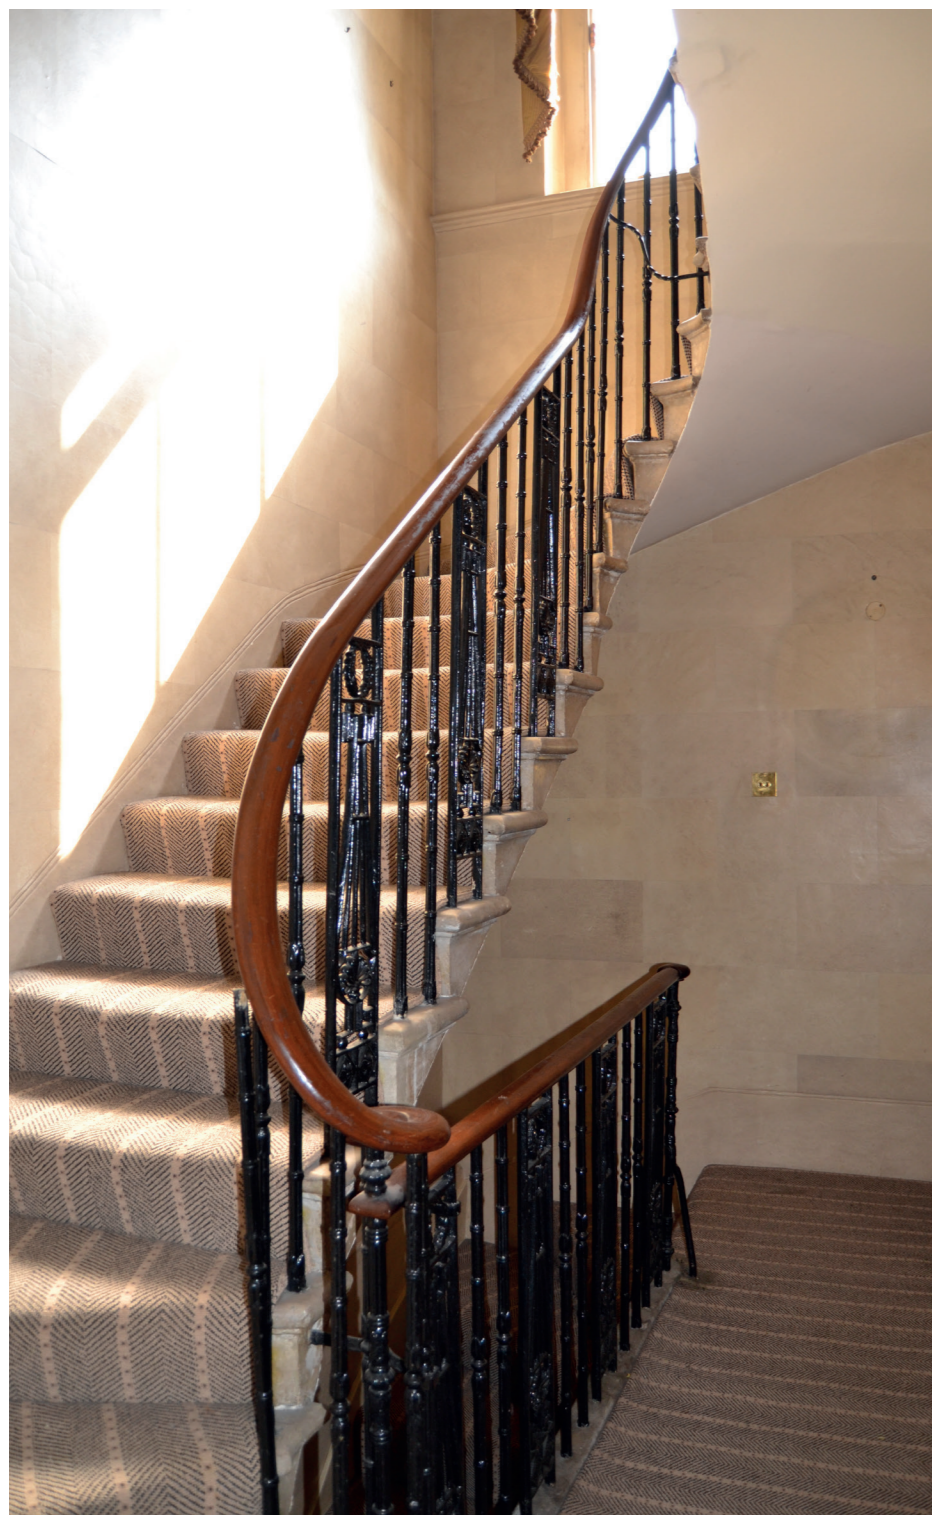
**Figure 3.9** Cantilever stone staircase within Gloucester Lodge, thought to date from the Papworth subdivision of the villa.
