// GLOUCESTER LODGE

4.0 ASSESSMENT OF SIGNIFICANCE

## 5.0 ASSESSMENT OF THE PROPOSALS

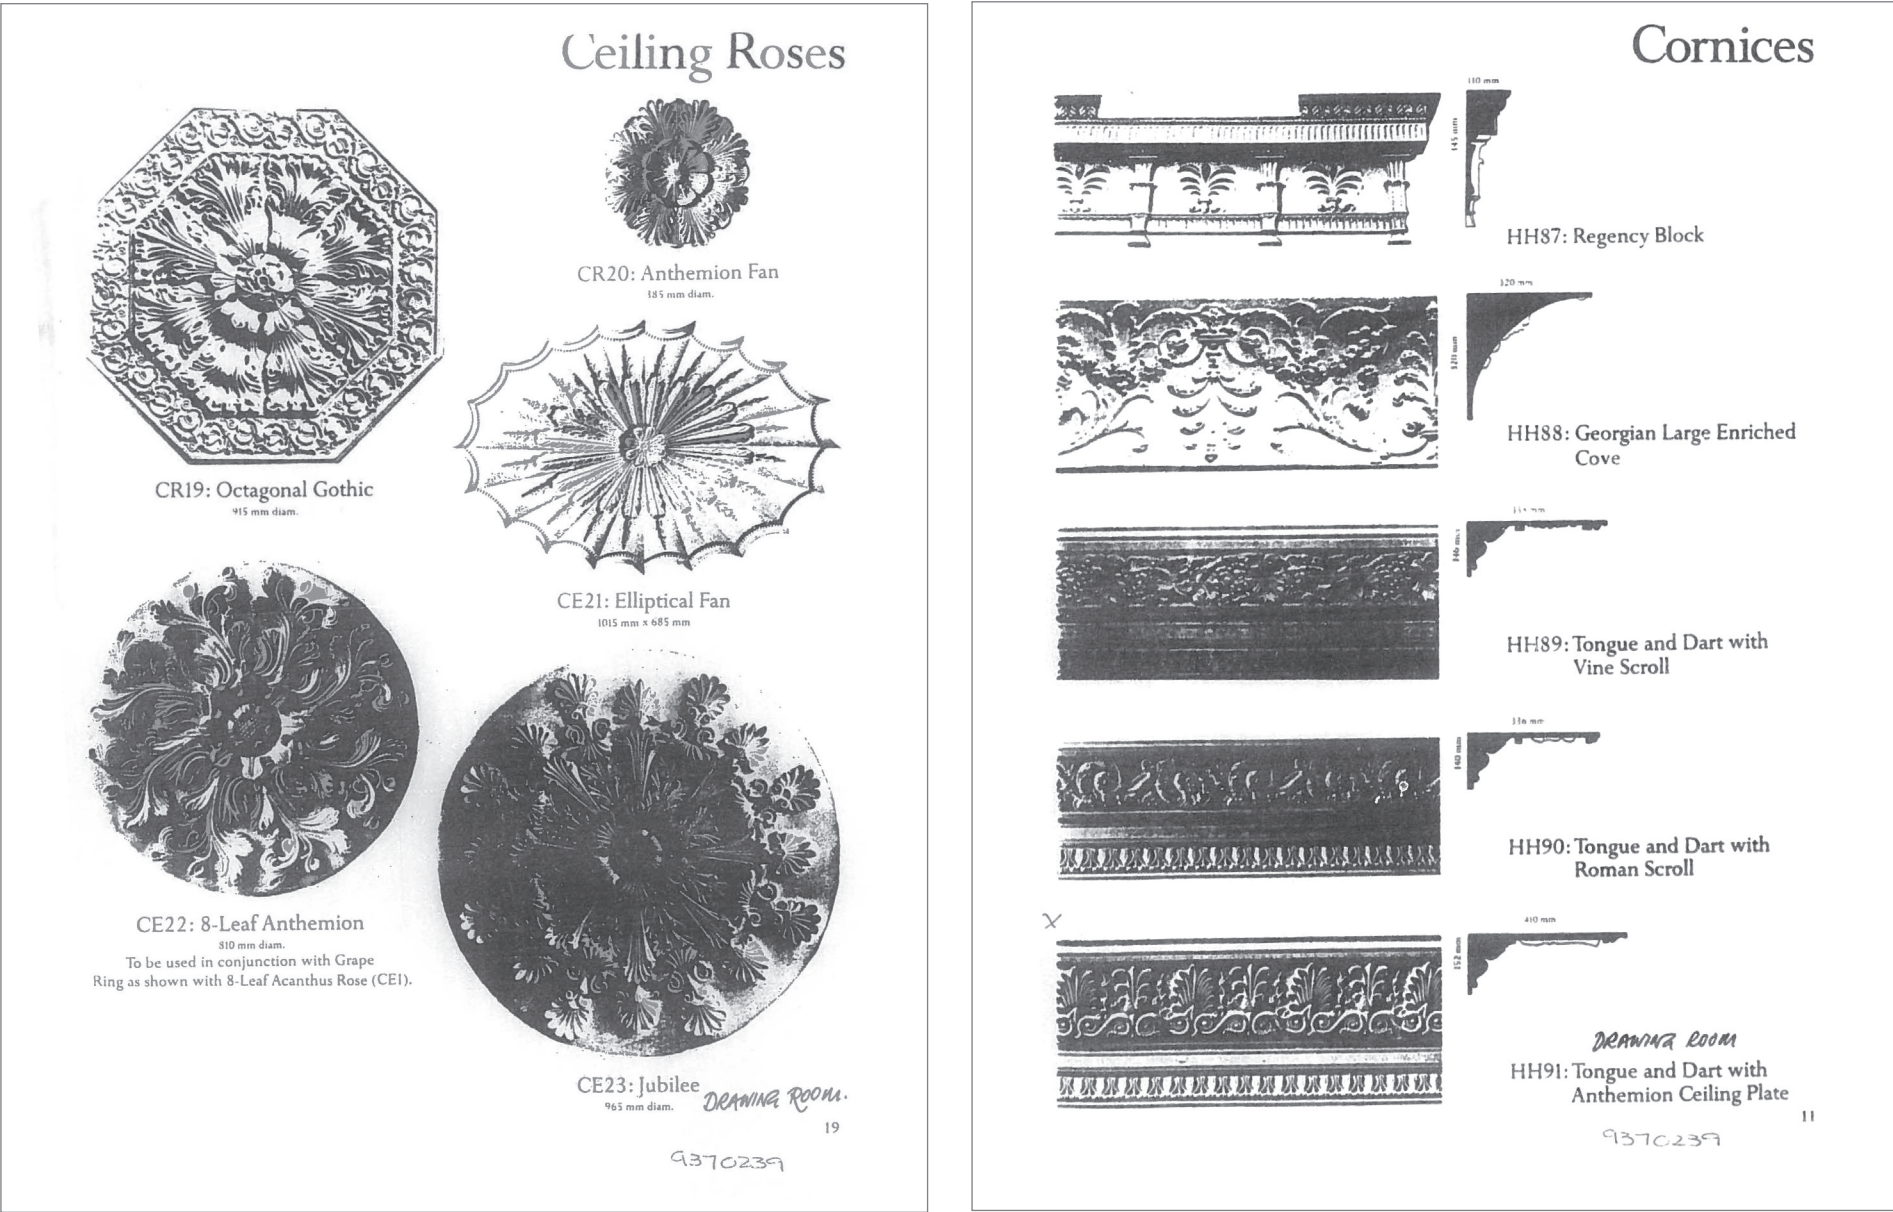
Figure 3.22 Proposed ceiling roses, cornices and skirting from the Donald Insall programme of works.

- 3.32 Considerable classical detailing in the form of cornices, skirtings and mouldings was added by Donald Insall Associates throughout the primary rooms of the house (**Figure 3.22**). Little work appears to have been carried out to the second floor at this time.
