Arboricultural Assessment & Method Statement
35a King Henrey's Road, Primrose Hill, London

17 July 2017
17170-AA-CA

Report purpose, validation statement and tree protection plan

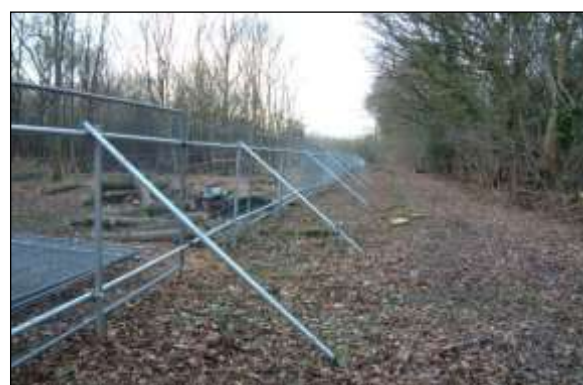
Fencing image 2: Heras fencing wired to scaffold braced posts is a robust and effective interpretation of the BS specification.

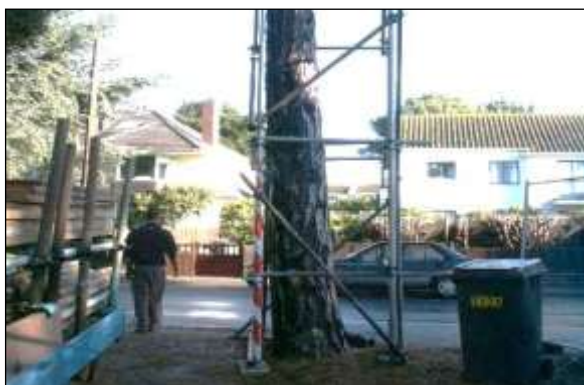
Fencing image 3: A scaffold-braced framework surrounding the trunk reduces the risk of accidental impact.

Where individual trunks or branches are vulnerable to impact damage, a framework of scaffold or wood can be constructed to provide protection (Fencing images 3 and 4).

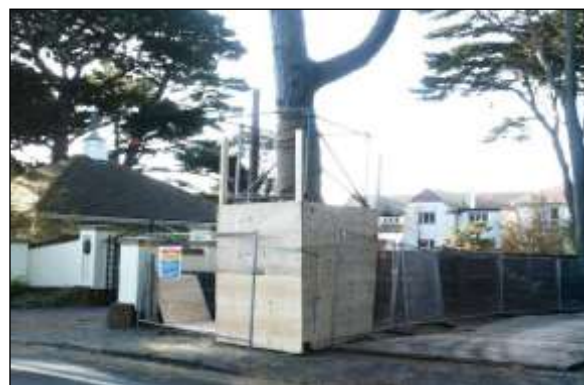
Fencing image 4: Board secured to scaffold framework adds another layer of protection for vulnerable trunks and branches

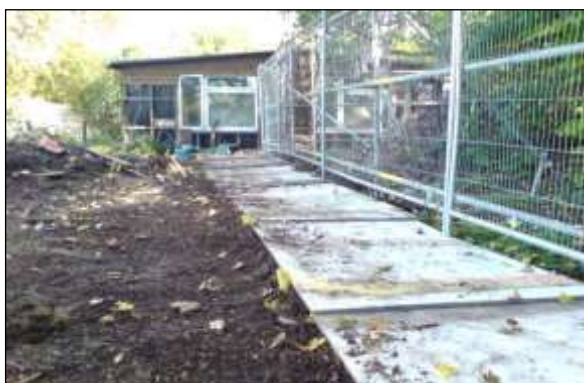
Ground protection image 1: Heavy-duty plywood set onto a compressible woodchip layer and pinned into position is suitable to spread the loading from pedestrian access.

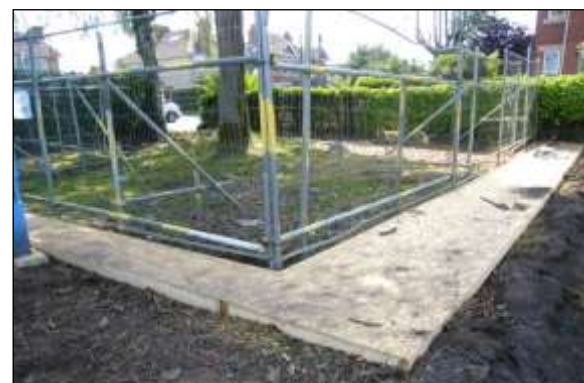
Ground protection image 2: Plywood fixed to a wood frame is another effective method of protecting soil from pedestrian compaction.

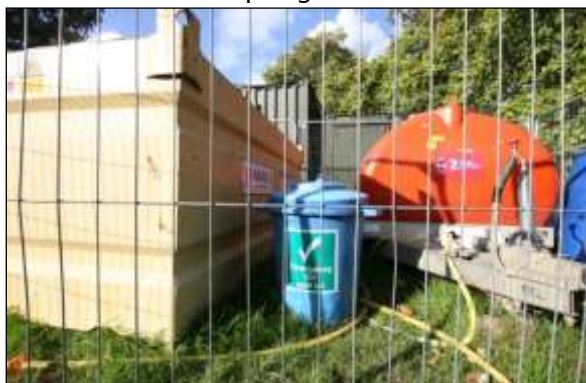
Pollution image 1: Where fuel or other chemicals are stored on site, it is now standard practice to have emergency spillage kits available to restrict the environmental impact of accidents.

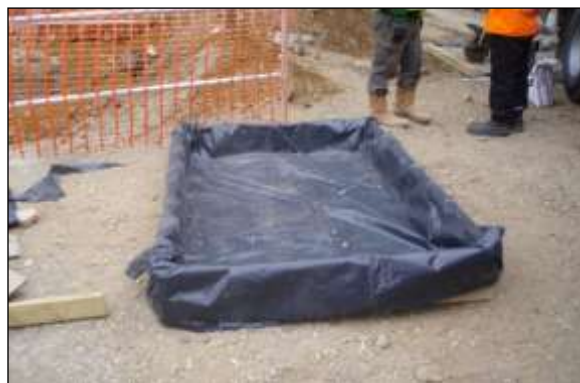
Pollution image 2: Soil bunding or a supporting framework covered in heavy-duty plastic sheeting is essential where there is a risk of spillages contaminating RPAs. This specifically applies to cement mixing areas and vehicle washing facilities.

contain any spillages. Where the contours of the site create a risk of polluted water or toxic liquids running into RPAs, a precautionary measure of bunding or a frame, sealed with heavy-duty plastic sheeting sufficient to prevent contamination (Pollution image 2), must be used to contain accidental spillages.

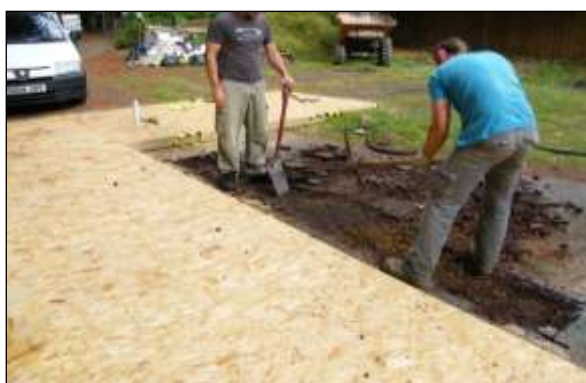
Excavation image 1: Careful hand-digging using conventional

tools is acceptable for exposing roots in RPAs.

The following guidance applies to tree T6, which is shown on the tree protection plan. Precautionary areas are RPAs outside the fencing, i.e. they are areas where construction activity can take place, but it must be carried out with care to avoid damaging the sensitive rooting environment. BS 5837 (7.2) makes provision for excavating in RPAs, explaining that all excavation must be carried out carefully using hand-held tools and preferably by compressed air soil displacement, taking care not to damage the bark and wood of any roots (Excavation images 1–4).

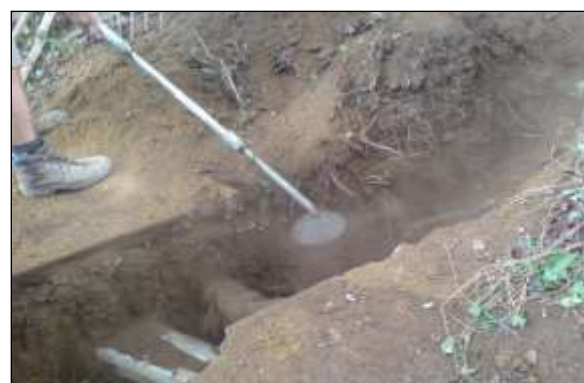
Excavation image 2: Air spades are very effective at exposing

roots and services with minimal damage.

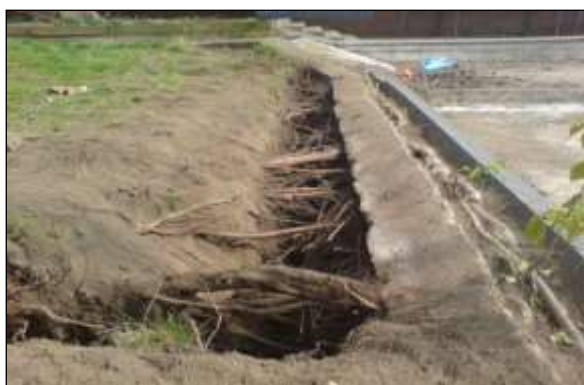
Excavation image 3: Air spades are particularly useful where roots are very dense.

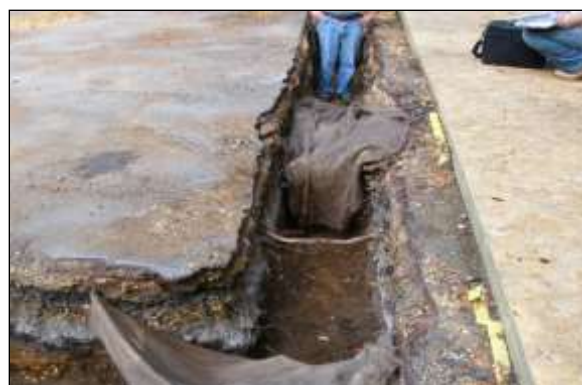
Excavation image 4: Exposed roots must be protected from light, drying out and extremes of temperature by covering with hessian sacking and boards until they can be covered back with soil.

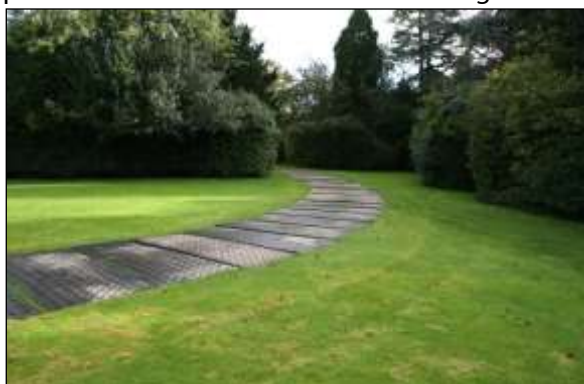
Hard surfacing/structure removal image 1: Ground protection must be used where repeated foot or vehicle traffic could cause compaction in sensitive RPAs. It can be as simple as plywood for pedestrians, but must be more robust for vehicles.

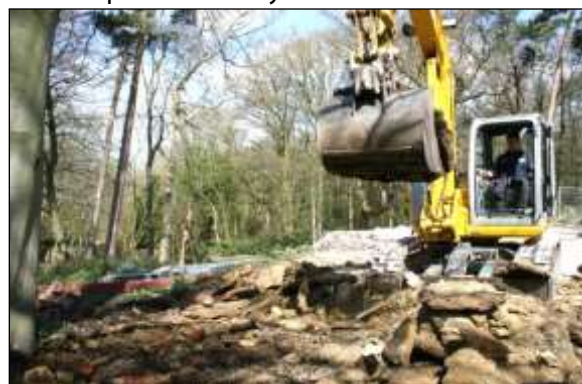
Hard surfacing/structure removal image 2: Machines with a long reach can be used to lift out heavy surfacing and structures as long as the machine sits outside the RPA and the exposed surface is protected before there is any further access.

2. Machines with a long reach may be used if they can work from outside RPAs or from protected areas within RPAs (Image 2 above), but they must not encroach onto unprotected soil in RPAs.

3. Debris to be removed from RPAs manually must be moved across existing hard surfacing or temporary ground protection in a way that prevents compaction of soil. Alternatively, it can be lifted out by machines, provided this does not disturb RPAs (Image 2 above).

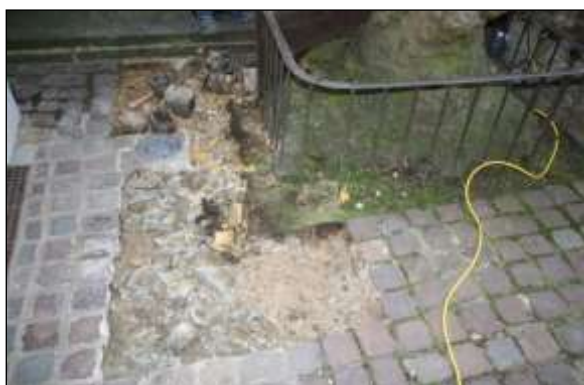
Hard surfacing/structure removal image 3: Careful lifting of cemented-in sets round this tree allowed them to be re-laid on a permeable sand base, improving the water input into the soil around the trunk.

1. Appropriate tools for manually removing debris may include a pneumatic breaker, crow bar, sledgehammer, pick, mattock, shovel, spade, trowel, fork and wheelbarrow (Images 3 and 4 below). Secateurs and a handsaw must also be available to deal with any exposed roots that have to be cut.

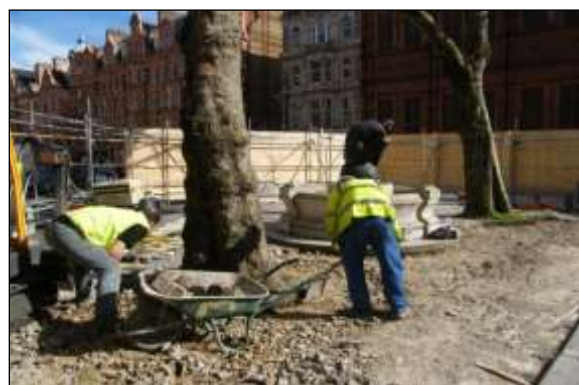
Hard surfacing/structure removal image 4: These trees had impermeable surfacing right up to their trunks, which had to be removed by hand before installing new structures.
