13-15, JOHNS MEWS, LONDON,  
WC1N 2PA

**Chelmer Site Investigations**

# Addendum Factual Report

# Laboratory Report

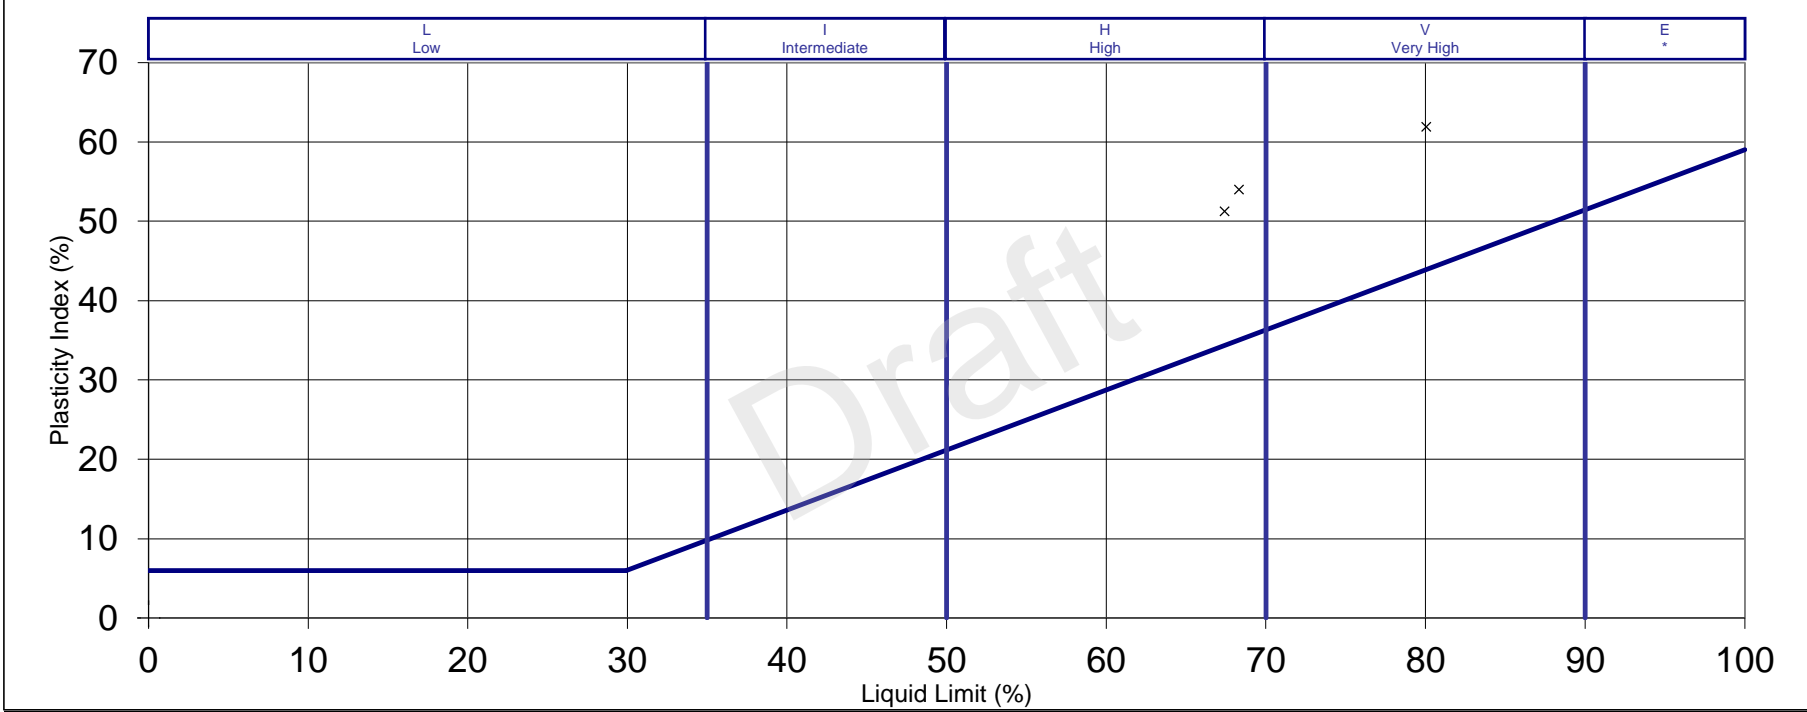
SILT (M-SOIL), M, plots below A-Line  
CLAY, C, plots above A-Line }M and C may be combined as FINE SOIL, F.
