Multiplex Construction Europe Ltd  
Centre Point Project Office  
103 New Oxford Street  
London  
WC1A 1DD

**CENTREPOINT – HERITAGE MOSAICS**

**1. PILOTI COLUMN MOSAICS – TYPE 1**

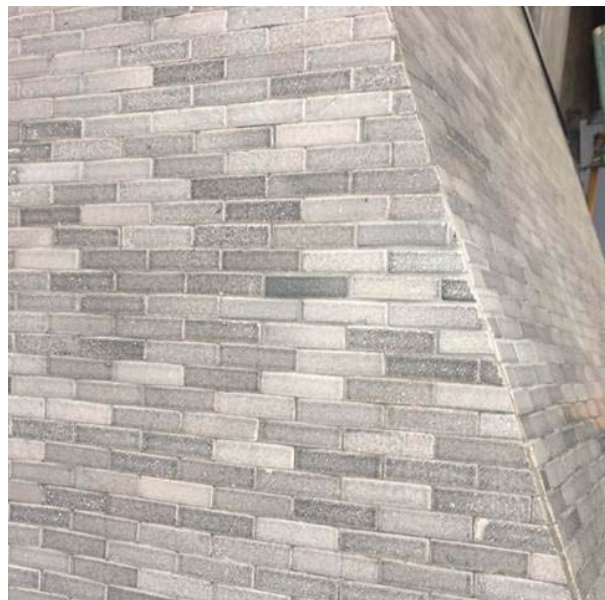
*Photo 1. Type 1 - Repair sample*

With respect to the type 1 mosaic sampling at the above project, after a year of sampling different background colours and glazing we have provided a range of 8no. Tesserae samples A1&A3, B1-3 & C1-3 which accurately represent the spectrum found on the original mosaic columns.

The guidelines for the repair areas will be to remove and replace each defective Tessera piece on a 'like for like' basis, matching the colour of the existing units against the range of sample Tesserae provided. The large full scale replacement areas will be removed and replaced with the entire range of new Tesserae to the consistency and ratio of the sample patch provided.

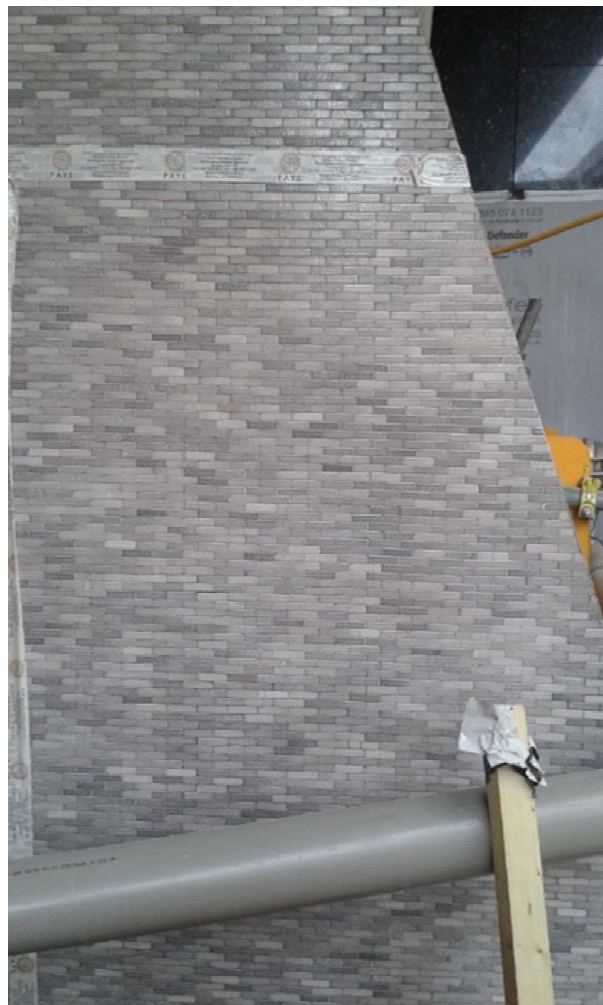
*Photo 2. Type 1 - Repair sample*

We would not recommend any further removal of Tessera samples from the range A1, A3, B1-3 & C1-3 provided, the range has been carefully selected to accurately represent the distinction in colour and glaze found on the original tiles. Any further changes made would have a detrimental effect on the appearance of the finished works.

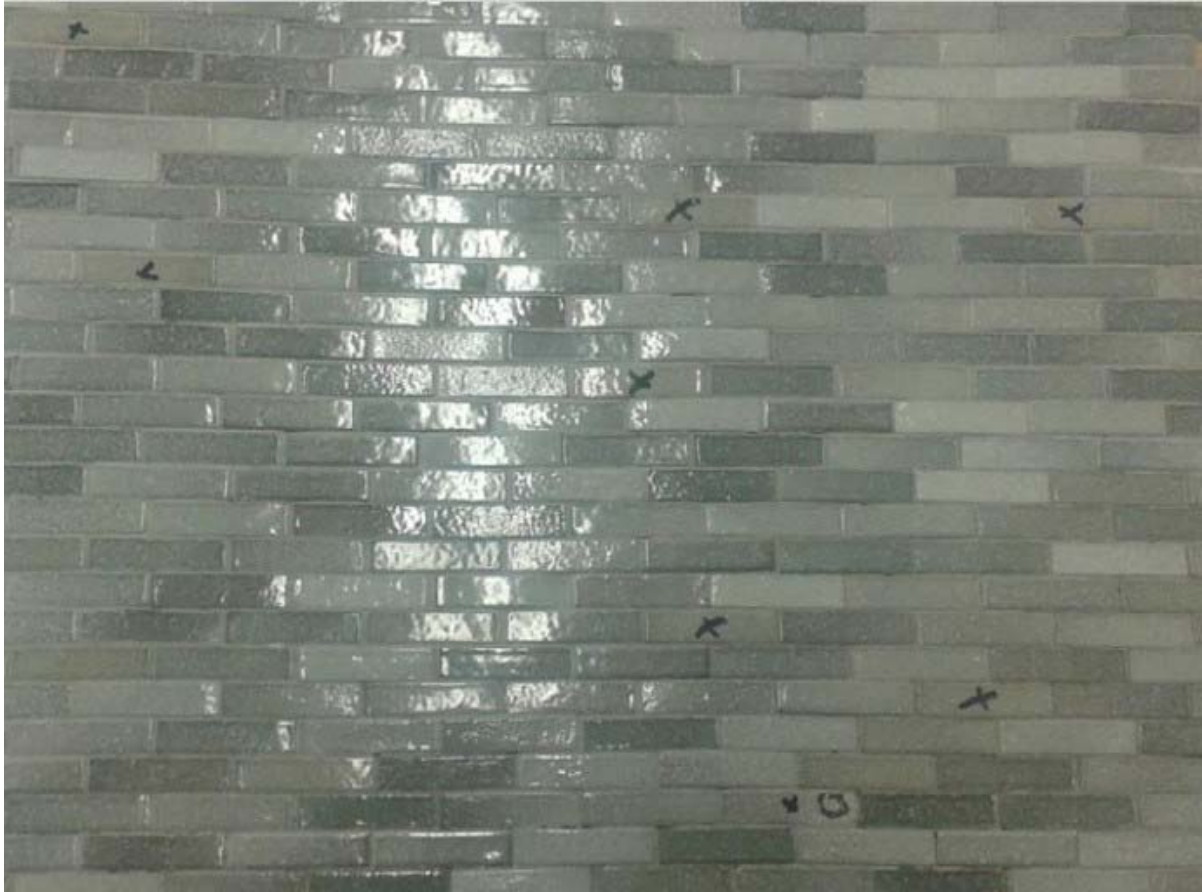
**MOSAIC PICTURE:**

Approved patch sample (A2 tiles were rejected (x))

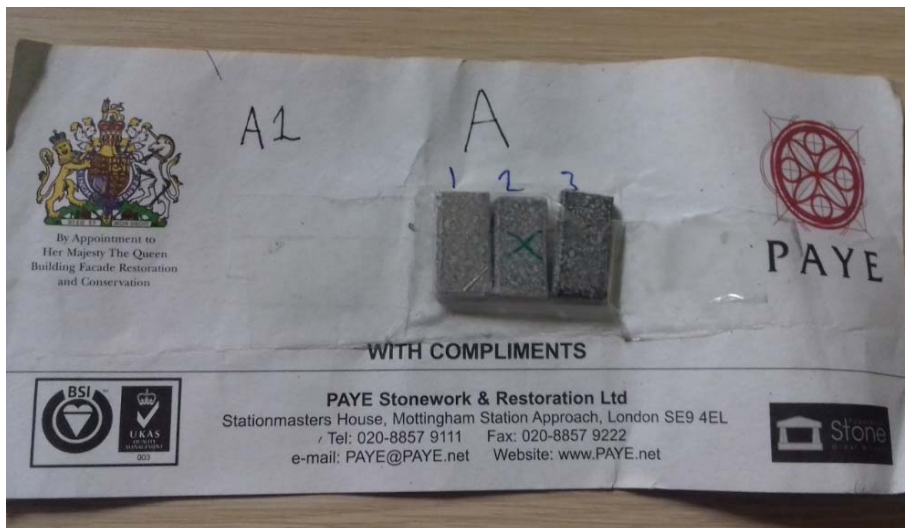
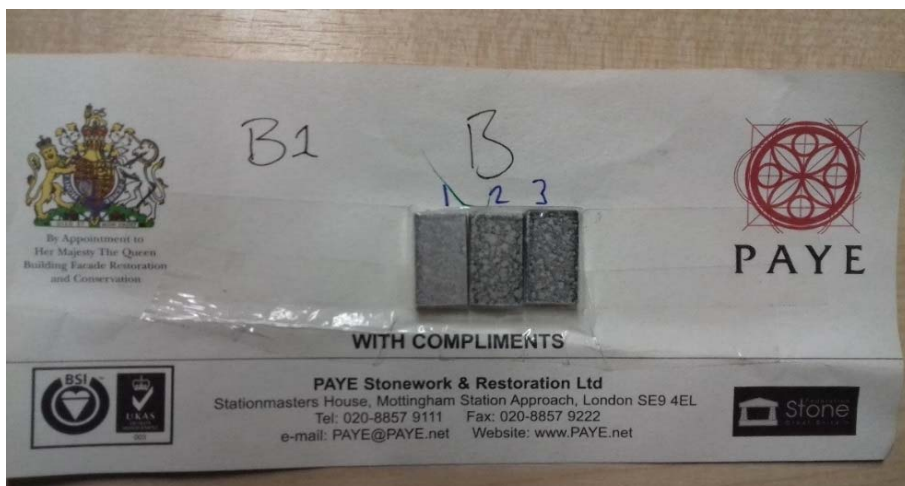
**MOSAIC CLASSIFICATION PICTURE:**

**Original Mosaic Tile Classification:** A1,A2, A3, B1, B2, B3, C1, C2 & C3.

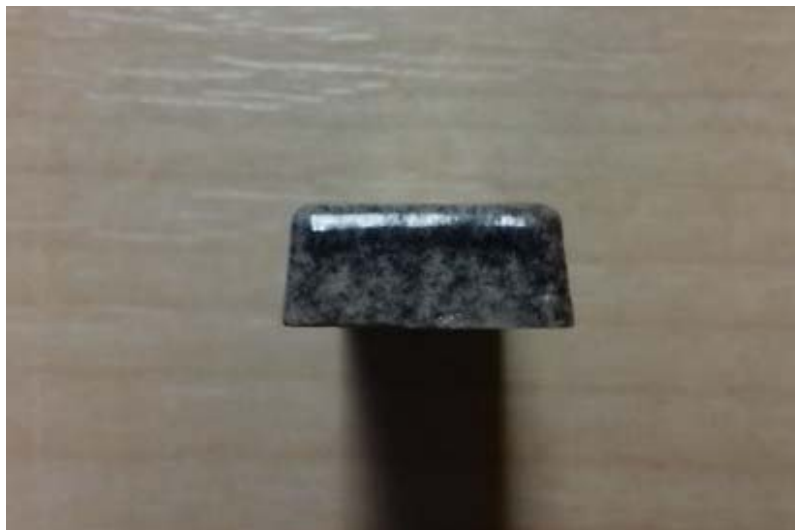
- **FRONT FACE:** 49 x 5 x 12mm
- **BACK FACE:** 50 x 5 x 12mm

- 1) Section through the tile (Width way).

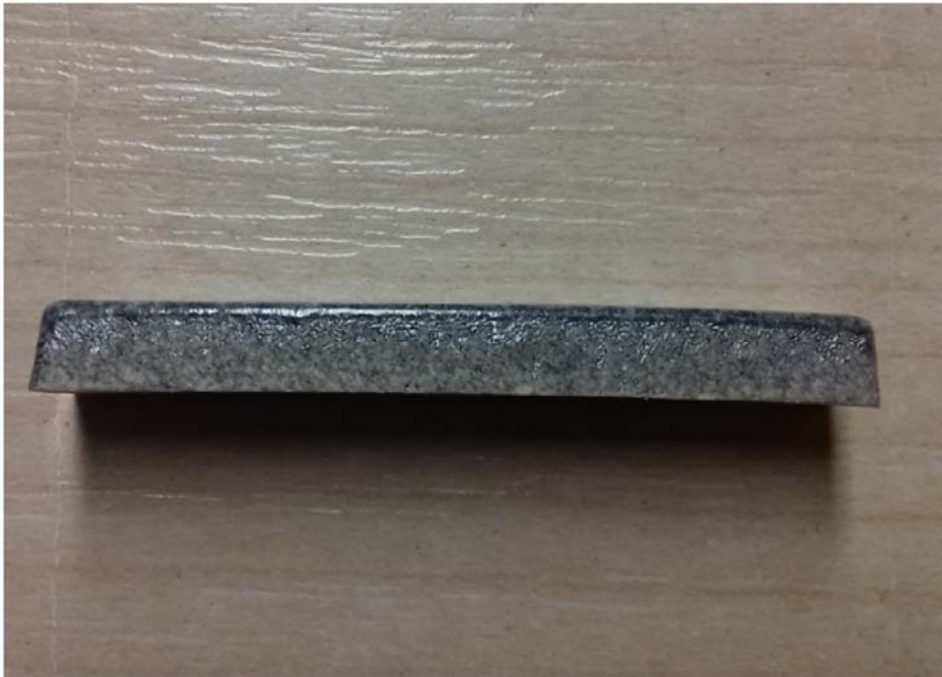
2) Section through the tile (Length way)

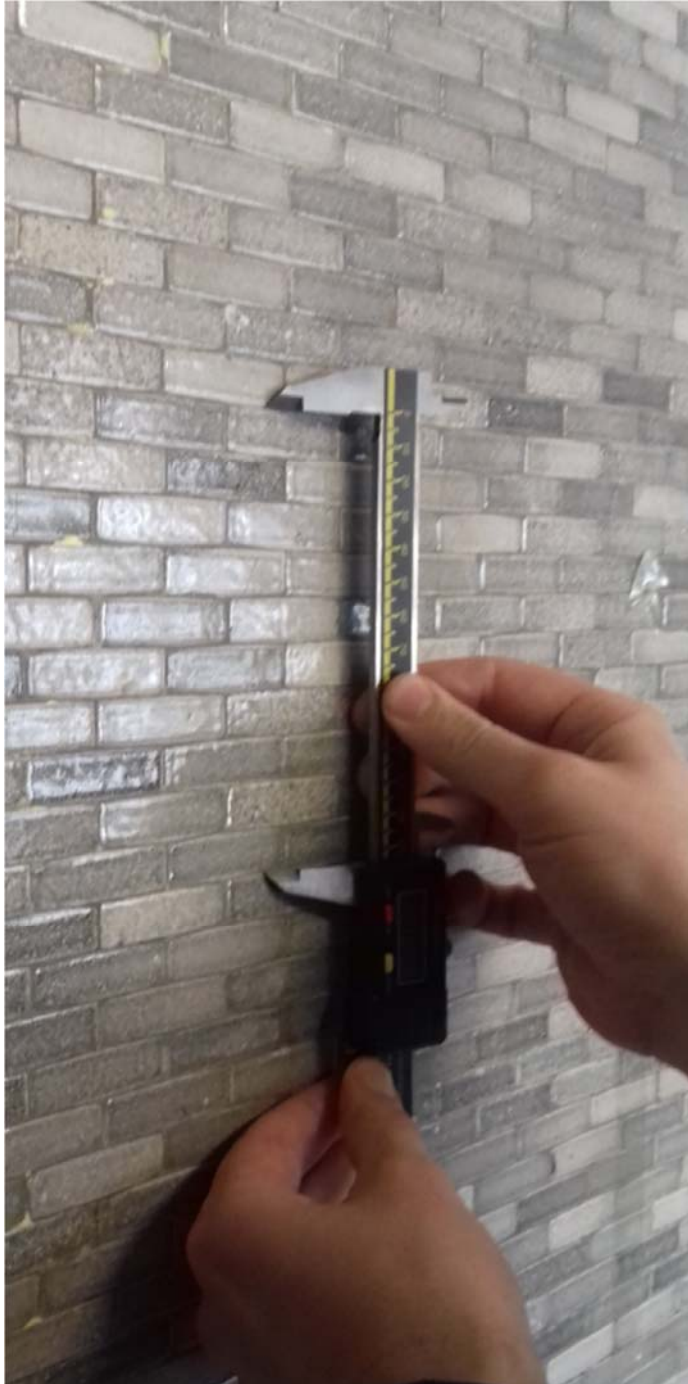
- Average Vertical measure over 10no. Existing mosaic tiles – **133mm.**

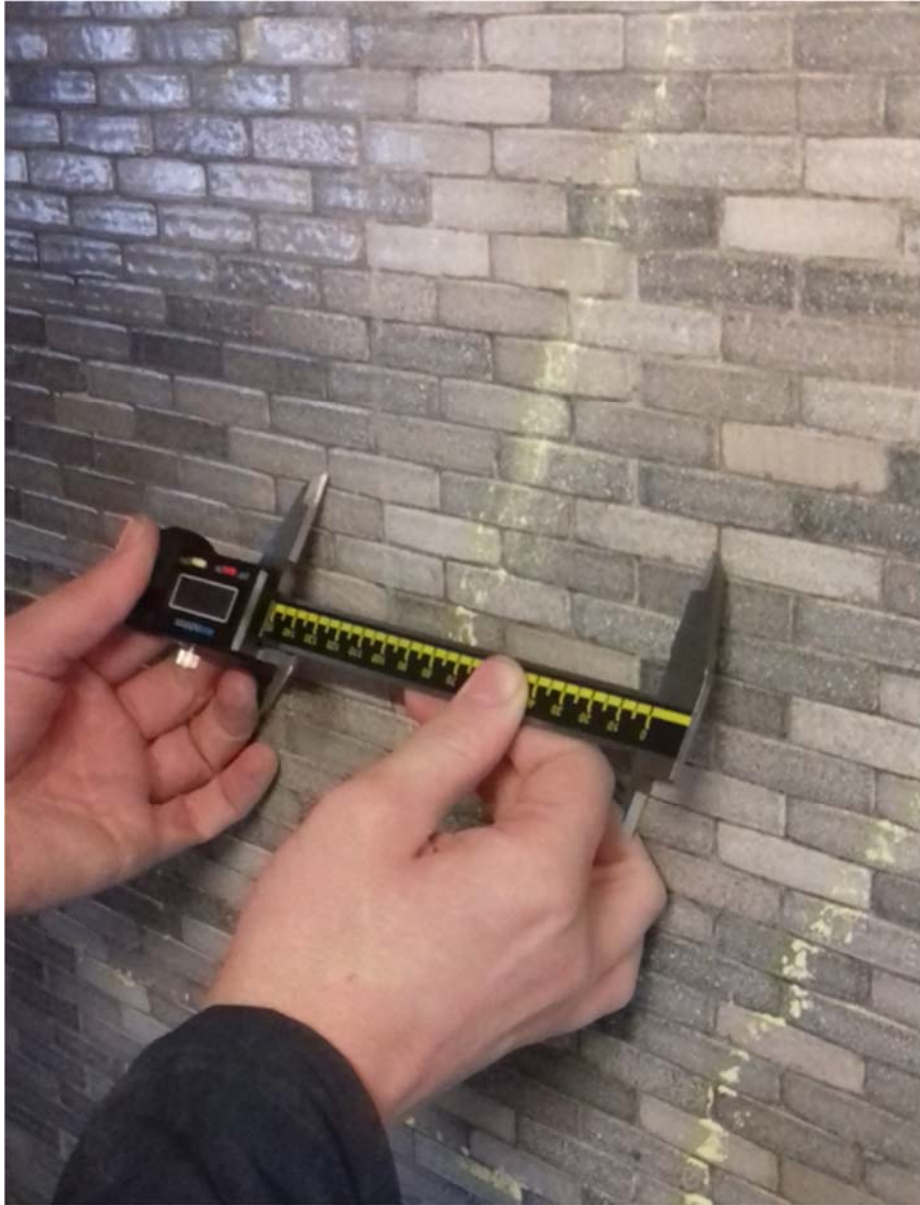
- Average Horizontal measure over 3no. Existing mosaic tiles – **149mm.**
