The Zabudowicz Collection, 176 Prince of Wales Road, London NW5 3PT

APPLICATION FOR FULL PLANNING PERMISSION & LISTED BUILDING CONSENT

DESIGN & ACCESS STATEMENT ADDENDUM II

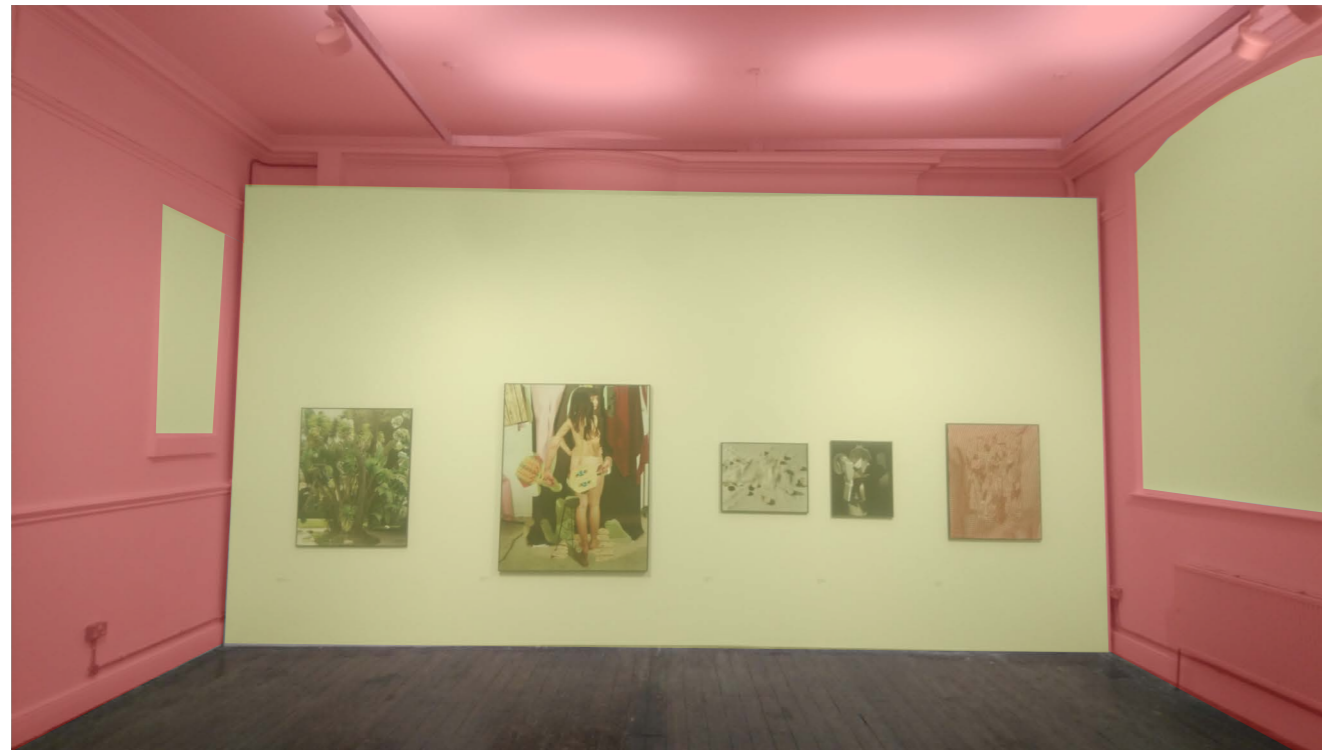
Middle gallery: Additions blocking historic fabric

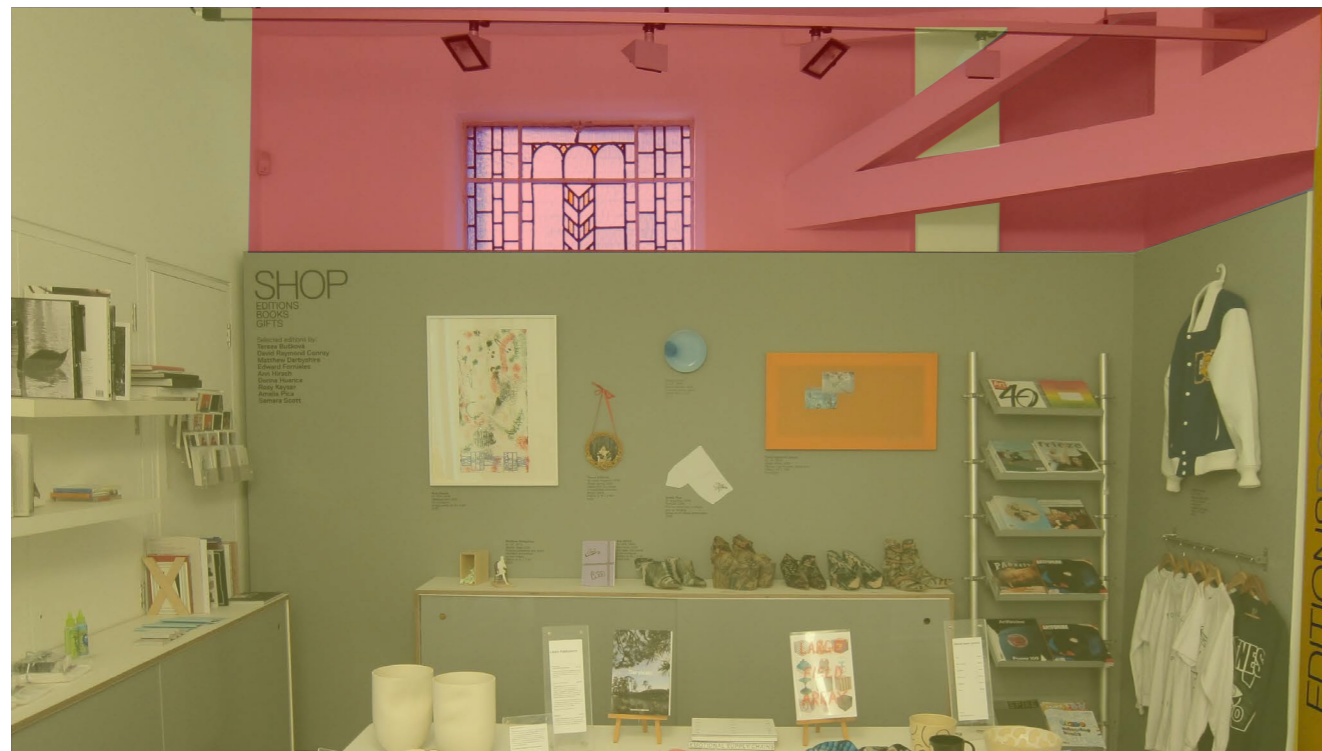
Reception Bookshop: Additions blocking historic fabric

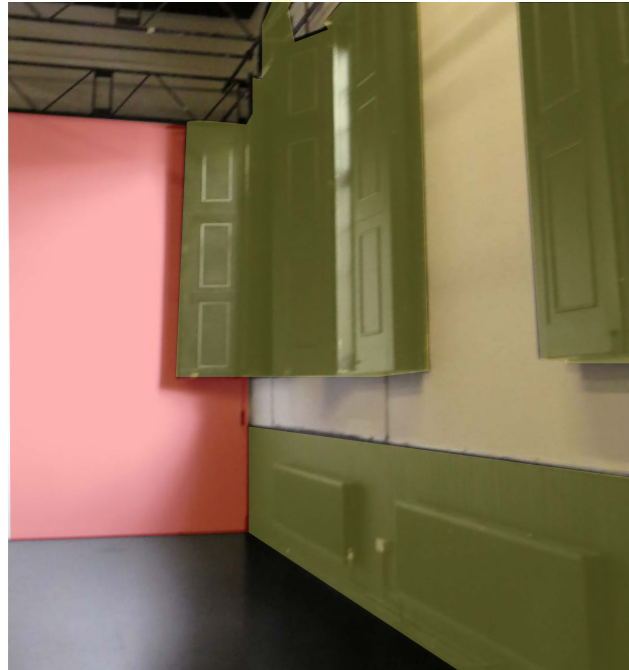
Fig. 3

The gallery's details include the west wall's windows and wooden shutters (Fig. 3). The wood panelling along the perimeter of the floor is exposed in the west wall (Fig.4). The east wall shows original wooden panelling covered by plasterboard (Fig. 5).

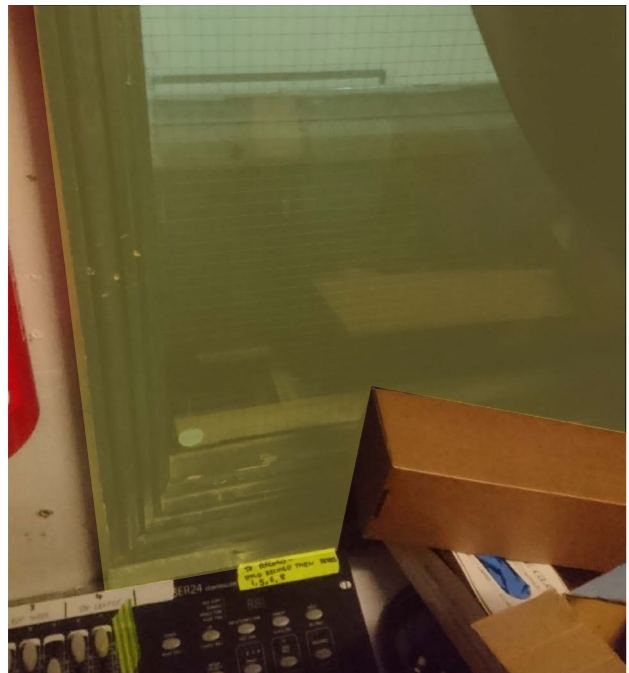
Fig. 6

In the AV room's server room, there are additional panelling (Fig. 6) and stucco detailing (Fig. 7 & 8).

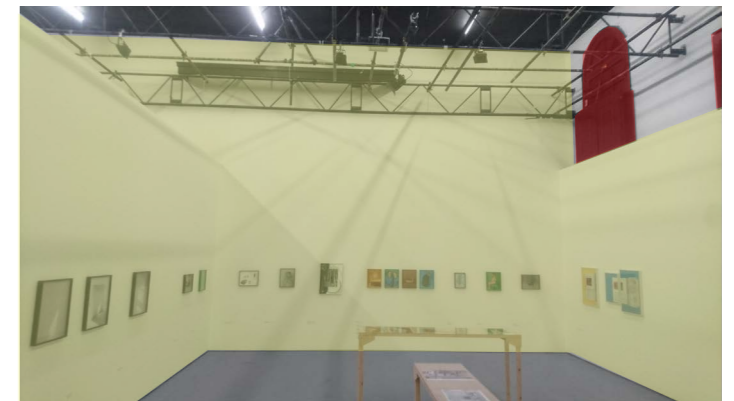
Fig. 1

The rear gallery currently uses plasterboard walls to hang its exhibits (Fig. 1). At first floor level, the south wall has windows which overlook from the AV room into the gallery space (Fig. 2).

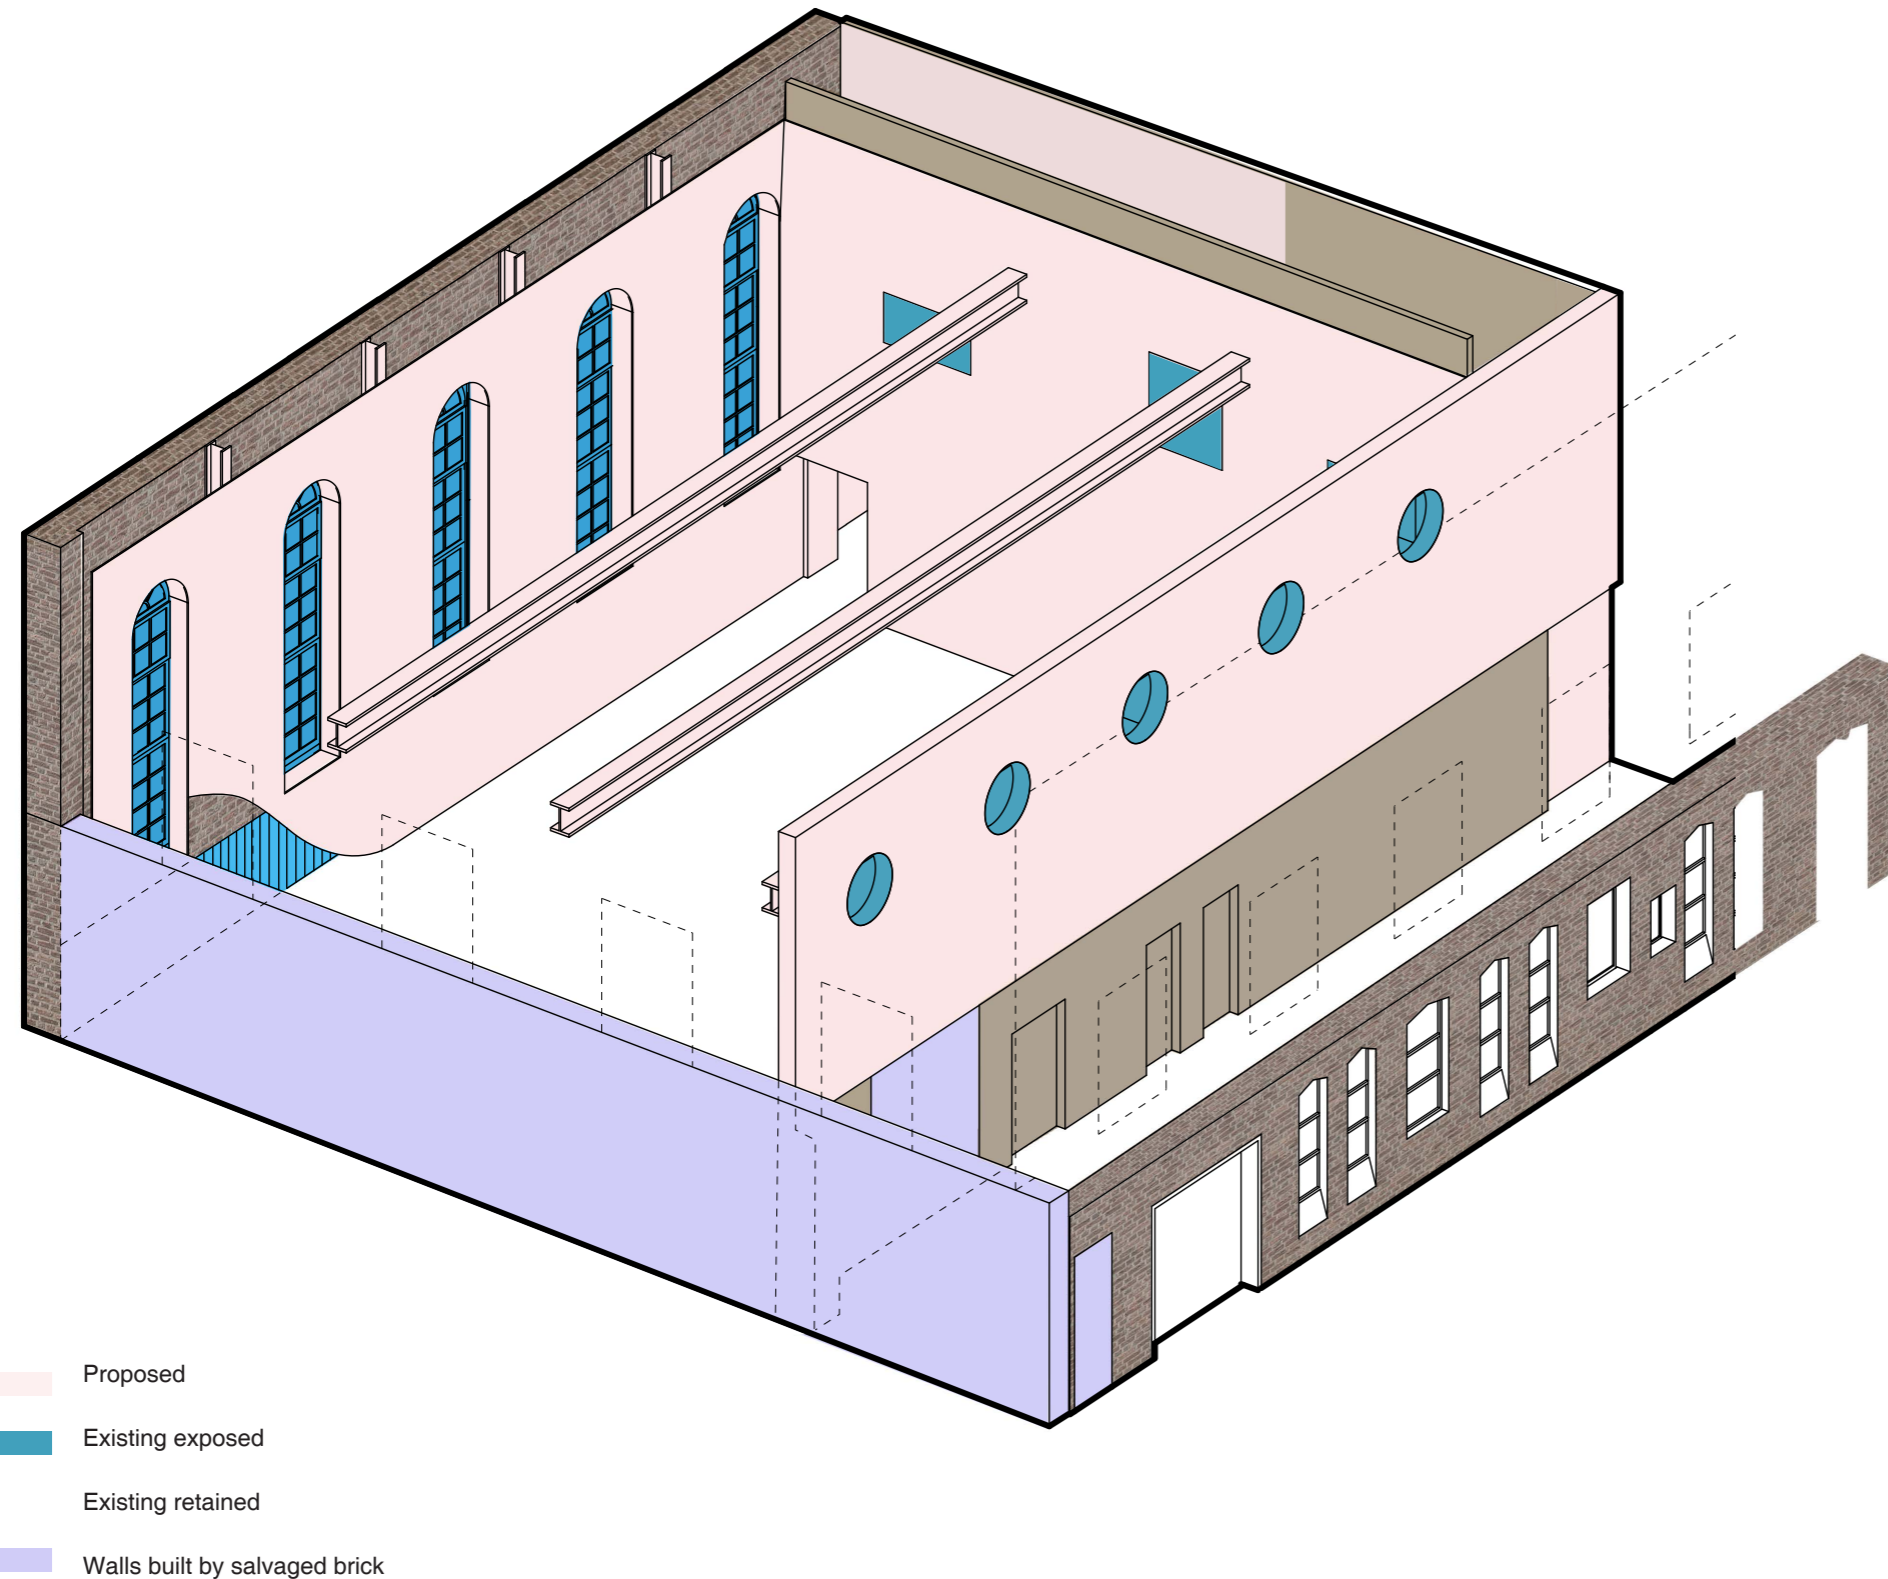
1.2 REAR GALLERY INTERVENTION

Following the revisions to maintain the south and west wall, the proposed extension does the following interventions:

1. Remove the radiators and lighting track and replace them by fan coil units and purposed-built gallery lighting. The current lighting track is a legacy of the Drama School use.

2. Maintain the south wall and stucco and wood details found in the AV room's server room. Extend this to the new walls built as part of the same interior.

3. The west wall on ground floor is kept in order to preserve wood panelling detailing and niche openings. Openings done to the wall are closed with salvaged brickwork. The wall on first floor level is rebuilt with roundette openings located, coordinated with the beams, and lowered in order to maintain their visibility from the ground floor.

4. Maintain all original details at ground floor level in all walls of the rear gallery, including the wood panelling and window frames. The walls are covered by plasterboard mounted on met sec that sheaths the panelling. The gallery use requires walls that do not have dividing elements in order to give flexibility when hanging art pieces. This flexibility is maintained but evenly rationalised across all walls whilst showing the main window features: tall west windows, roundette windows and south wall square windows.

5. Columns are located in between the plasterboard lining and the retained walls, therefore not showing visibly the means by which the extension is supported.

Cumulatively, the room maintains its current shape with improvements in ventilation, lighting and hanging space. All window detailings are revealed and timber panelling on the wall are sheathed by the plasterboard used for exhibition purposes, which can be removed at a later date.

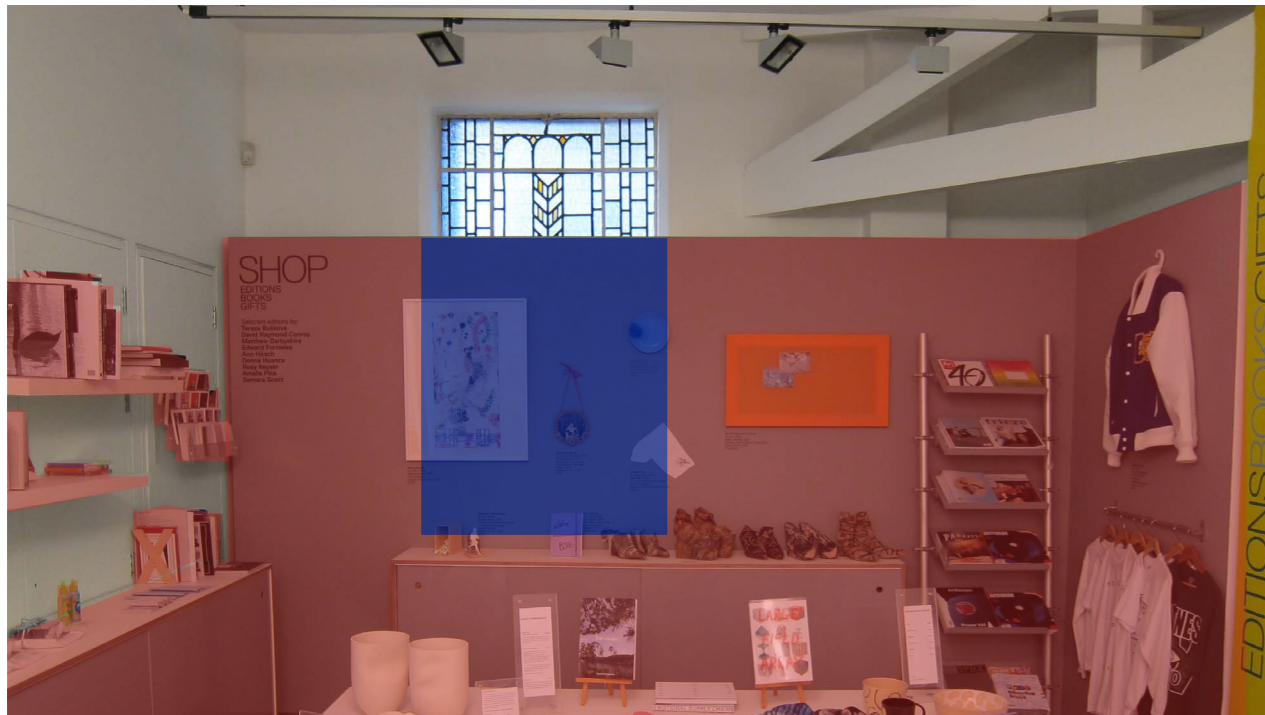
Fig. 1

Currently, the book shop clutters one end of the reception space and blocks a stained glass window with a wall used to hang merchandise (Fig. 1). Shelves block the use of the cupboard where meters are kept (Fig. 2). The proposal is to relocate the shop to where the cafe currently sits.

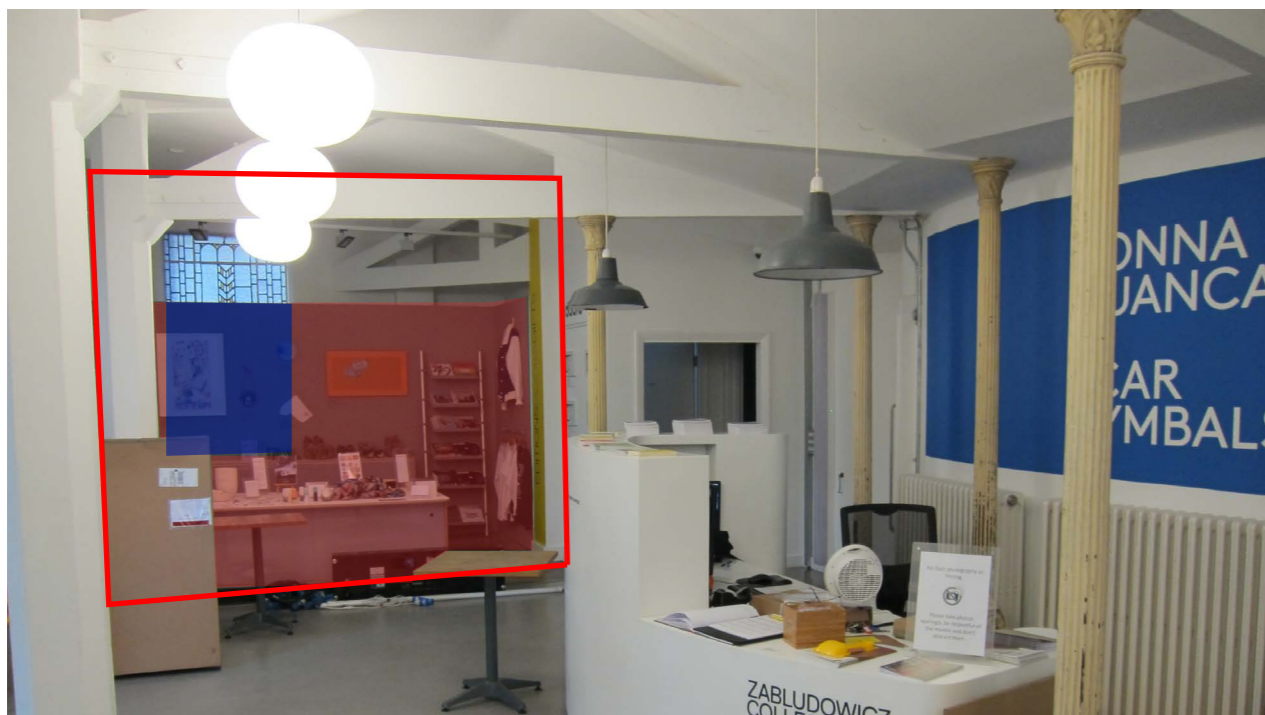
Fig. 3

The former shop is to be repurposed as an office, restoring the view to the stained glass window and, by means of a glass partition, maintaining the perception of the reception hall as a unified space (Fig. 3).

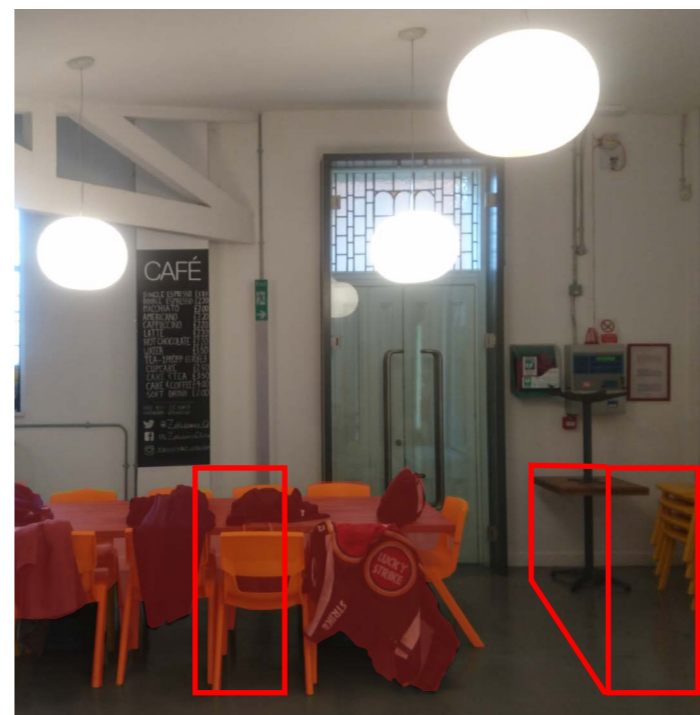
Fig. 4

The relocation of the cafe allows for the stained glass / emergency exit to be cleared as tables aligned perpendicular to the wall give a more orderly arrangement to the room. (Fig. 4)

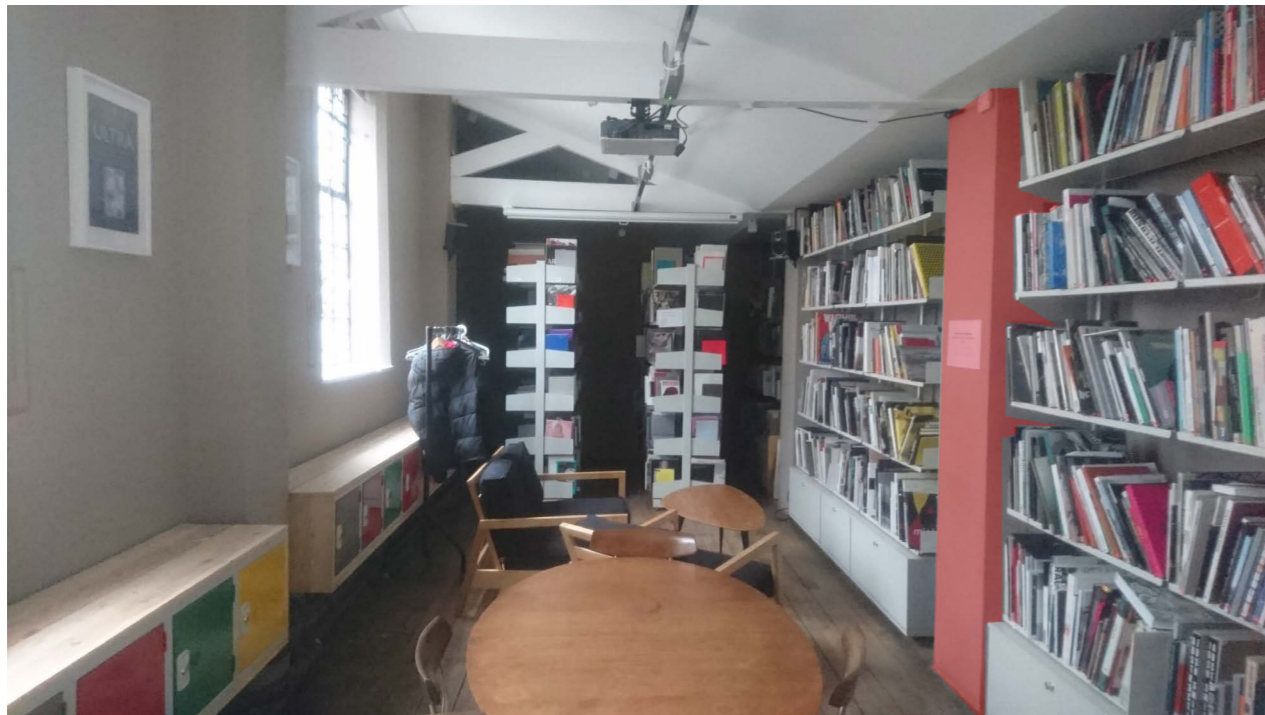
Fig. 1

The columns along the east wall are square and solid, with no details (Fig. 1). The east wall is solid too, giving no indication of gallery partitioning to the main front gallery space (Fig. 2). The current library layout blocks view to a stained glass window (Fig. 4). By turning the room into an office, the shelves are removed, giving access to the stained glass window. The change of use between library and office is compatible with the current electric cabling and power and data points, meaning that no interventions are required.

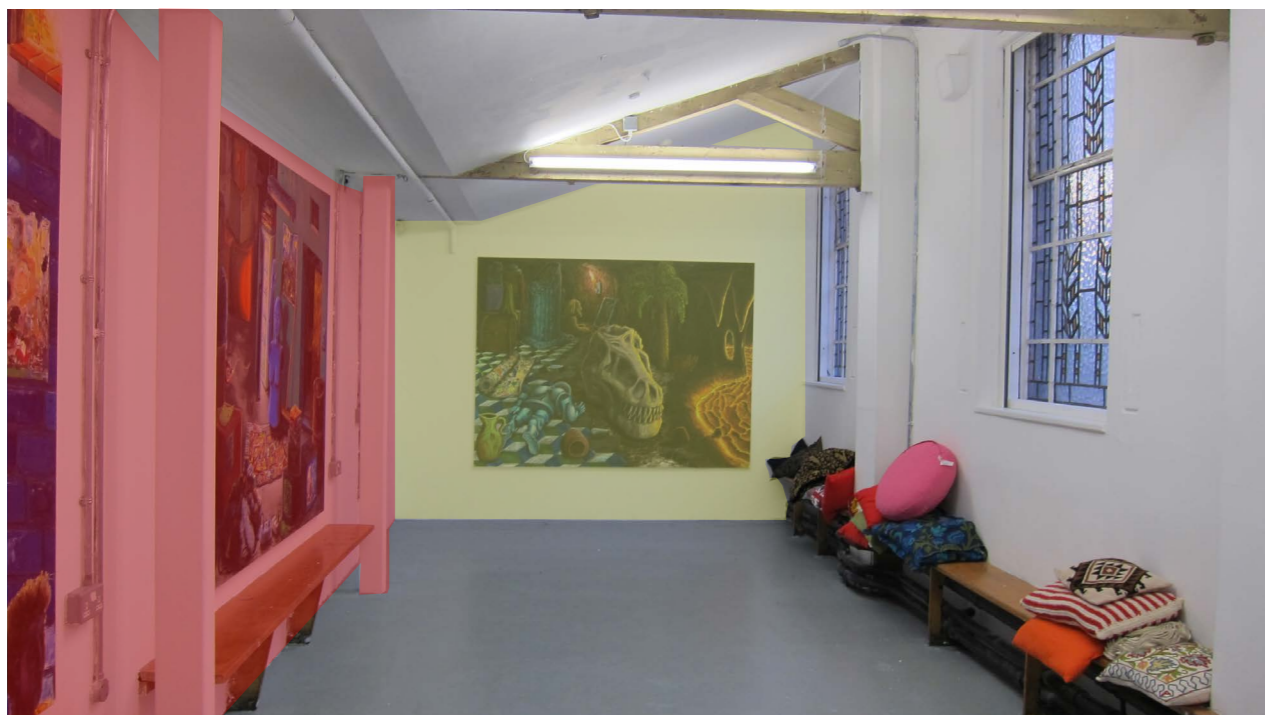
Fig. 3

The gallery space, to be turned into a cafe, has the same condition of its west wall being solid, giving no indication of gallery partitioning to the main gallery space (Fig. 3). The columns are metal and of rectangular profile. The far wall is removed as it is a gallery partition, giving more space for the cafe.
