DESK STUDY, GROUND INVESTIGATION & BASEMENT IMPACT ASSESSMENT REPORT

**35 TEMPLEWOOD AVENUE
LONDON
NW3 7UY**

Report Title: Geotechnical Desk Study, Ground Investigation & Basement Impact Assessment for 35 Templewood Avenue, London, NW3 7UY

Job No: P1019J1129

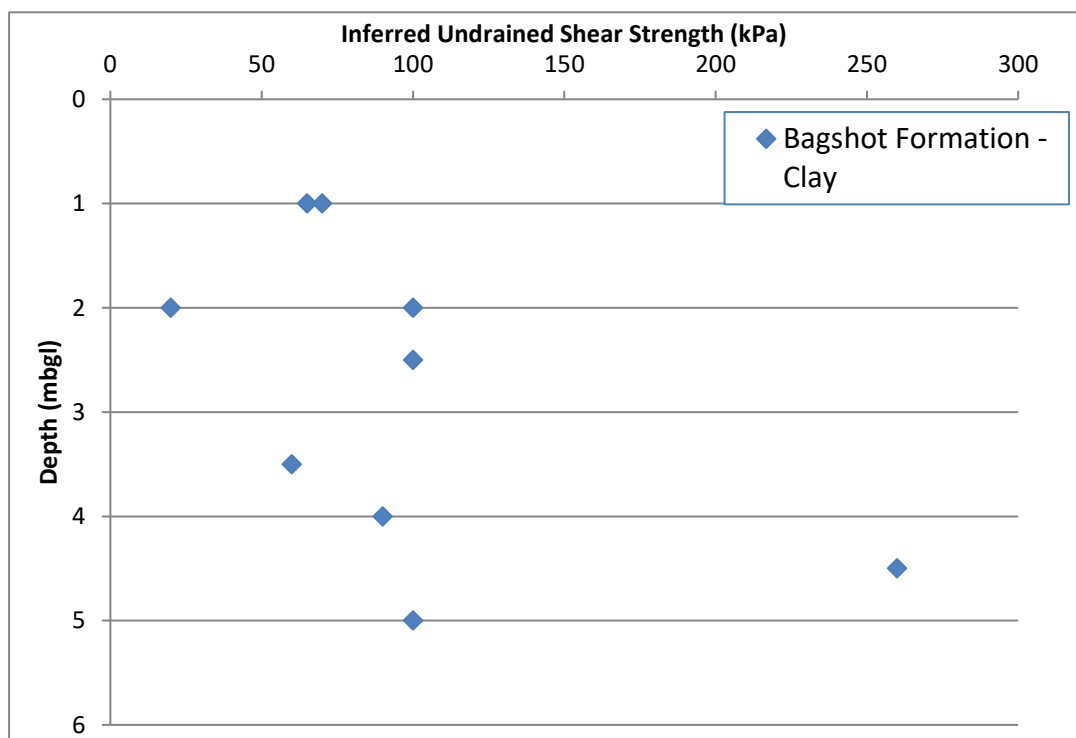
Figure 14.1: Inferred Undrained Shear Strength vs Depth

14.3.4 An SPT 'N' value of 22 was reported for the layer of Bagshot Formation - Sand at 3.50mbgl. This is slightly higher than the values recorded in the clay at around the same depth.
