SITE INVESTIGATION REPORT

PROPOSED REDEVELOPMENT:

GARAGES TO THE SOUTH OF 27A WEST END LANE, LONDON, NW6 4QL

Report ref: **10120/MR/CB**

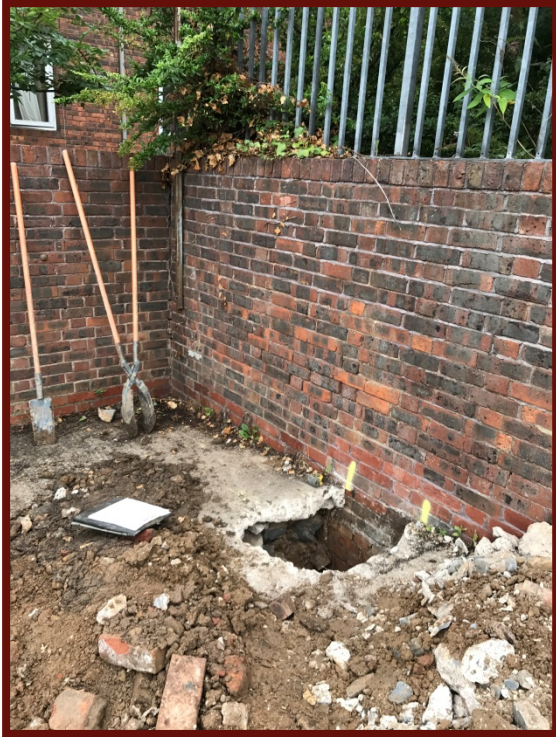
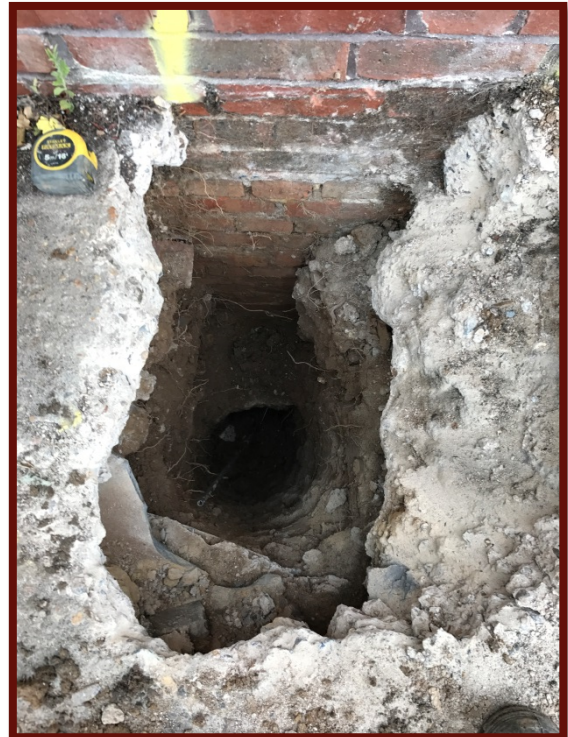
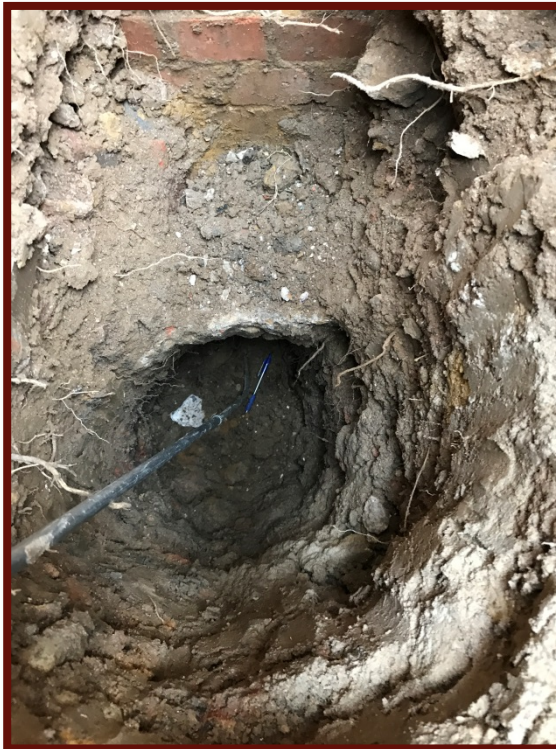
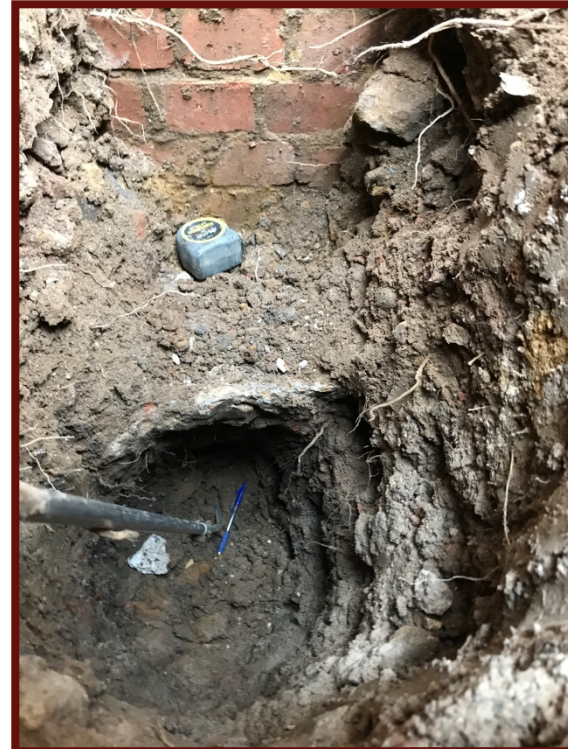
Site & Location	Garages to the south of 27A West End Lane, London NW6 4QJ	Trial Pit No: TP 1 [2 of 2]
Client:	StreetPlot Ltd	Report No: 10120/MR
Engineer:	Pringuer-James Consulting Engineers Ltd

PHOTOGRAPHS

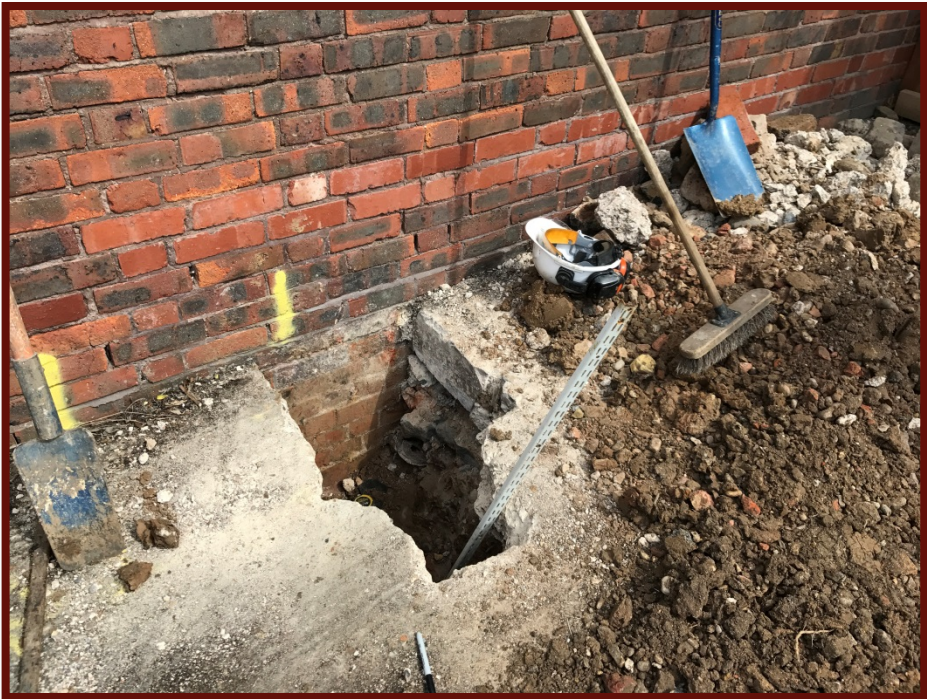
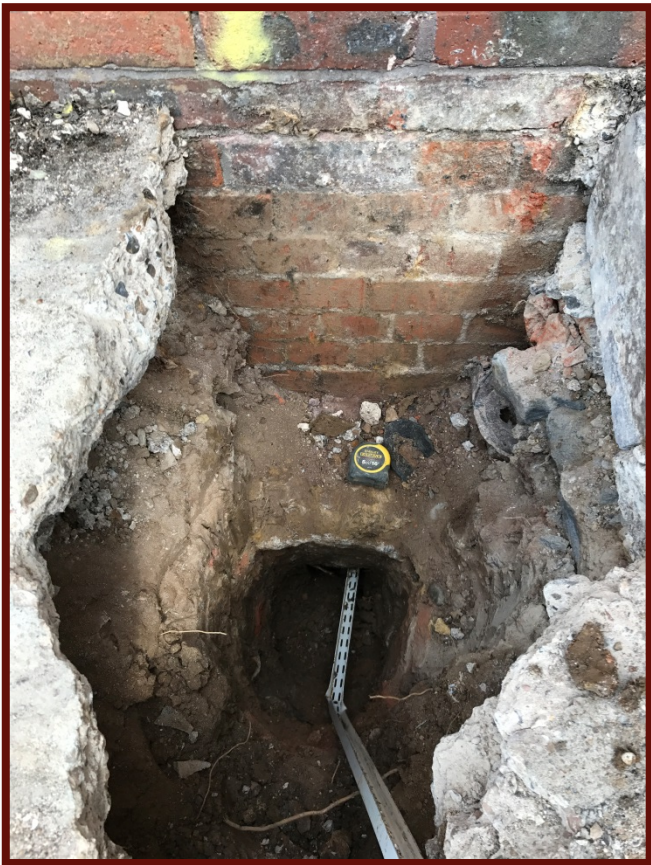
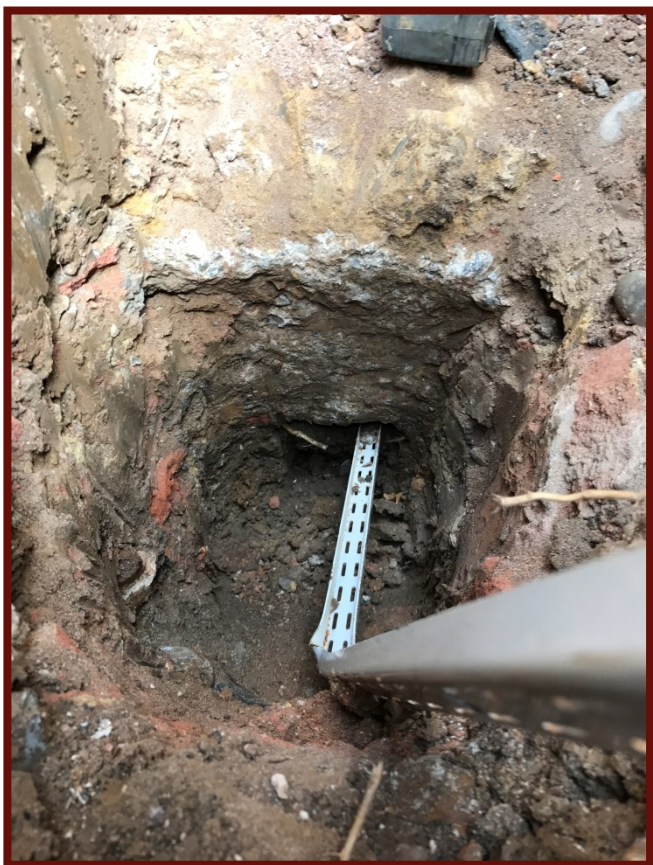
Site & Location	Garages to the south of 27A West End Lane, London NW6 4QJ	Trial Pit No: TP 2 [2 of 2]
Client:	StreetPlot Ltd	Report No:
Engineer:	Pringuer-James Consulting Engineers Ltd	10120/MR

PHOTOGRAPHS
