94 Albert Street, Camden Town, Camden, London NW1.
Heritage Statement for the terraced house. 18 08 2017.

This report describes the building to form part of a Heritage Statement with a view to altering a basement room, adding a front staircase and adding a damp proof membrane system. The report is a desk top study using photographs supplied by Mr Michael Wiseman.

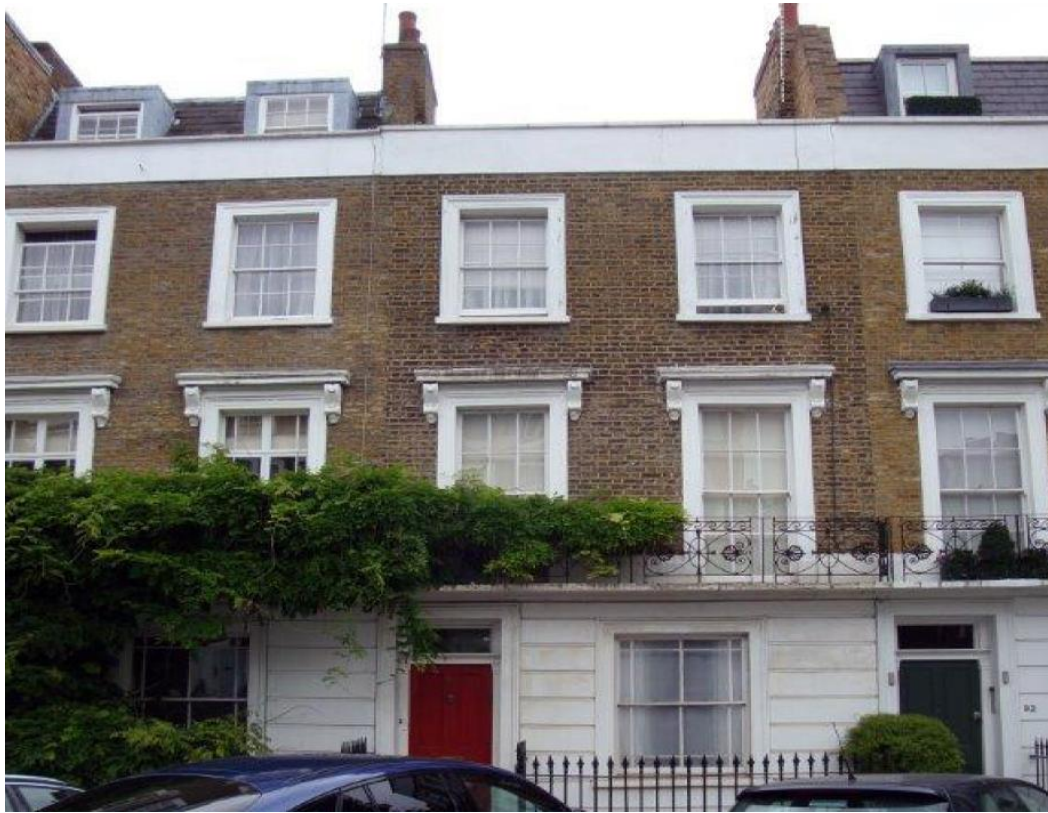
Eastern Elevation

The eastern elevation of 94 Albert Street.

The eastern elevation contains the main street entrance from Albert Street. The ground floor storey is of channelled (rusticated) stucco while the two upper storeys are of 65x110x225mm standard London Stock bricks in Flemish bond which appear darker than the neighbouring properties. The ground floor has a four panel Victorian style front door with a plain rectangular light above. The ground floor window is a margin glazed sash typical of the period c.1845.

The upper storeys have pairs of horned 6/6 sash windows decreasing in height by storey such that the panes also decrease in height from rectangular to square. All have wide plain architraves and the first floor windows have small hoods (cornices) supported on console brackets. The first floor has a balconette with ornate iron balustrades. The Listing describes the whole balcony as cast iron. There is a plain stuccoed parapet. Unlike its neighbours the property has no added attic rooms.

There is a bridge with an old shoe scraper to the front door over the light-well which is protected by original railings. Access to the lower rooms is at the back of the property.

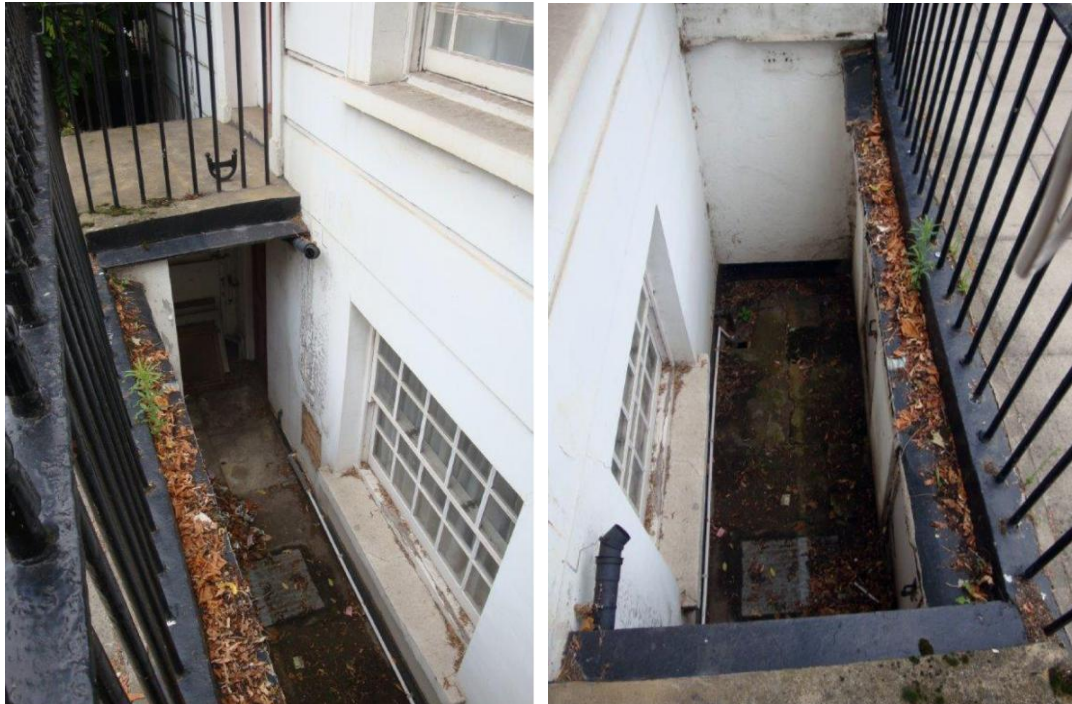
Looking N then S into the lightwell.

Looking down into the light-well, the original kitchen window can be seen as a horned 10/10 sash window set in a plain opening. A drainpipe appears to vent in to the area which may account for the damage to the wall and the damp evident inside.

The rooms suffer from damp and it is necessary for the long term wellbeing of the building that they be protected. The introduction of a small kitchen, new utility room, shower and WC will increase the humidity inside the rooms. Eternally the drainage is of poor quality and vents into the area at the front of the house.

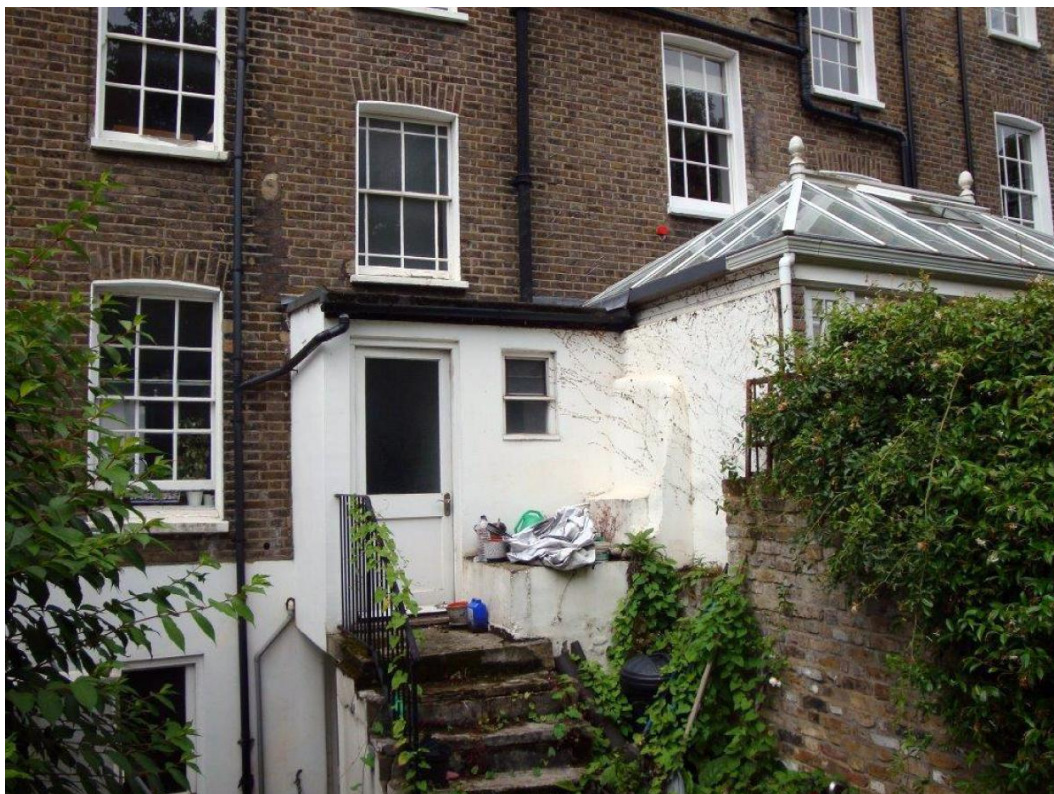
Western Elevation

The western elevation is the back of the building.

The rear of the building is also faced with London Stock bricks and the windows each have rough gauged segmental brick lintels. The lower ground floor wall has been hard rendered. There is an added lobby with stone steps down to street level with a half glazed LC20th door which is one of a suite of four on the lower ground floor. Above is a margin glazed window which must be for the staircase given its offset position. The other windows are 6/6 unhorned sashes of the same size.

2. On the rear wall it is proposed to close off the door under the rear outshot and insert a window. At the same time it is proposed to replace the current central back door with French windows.

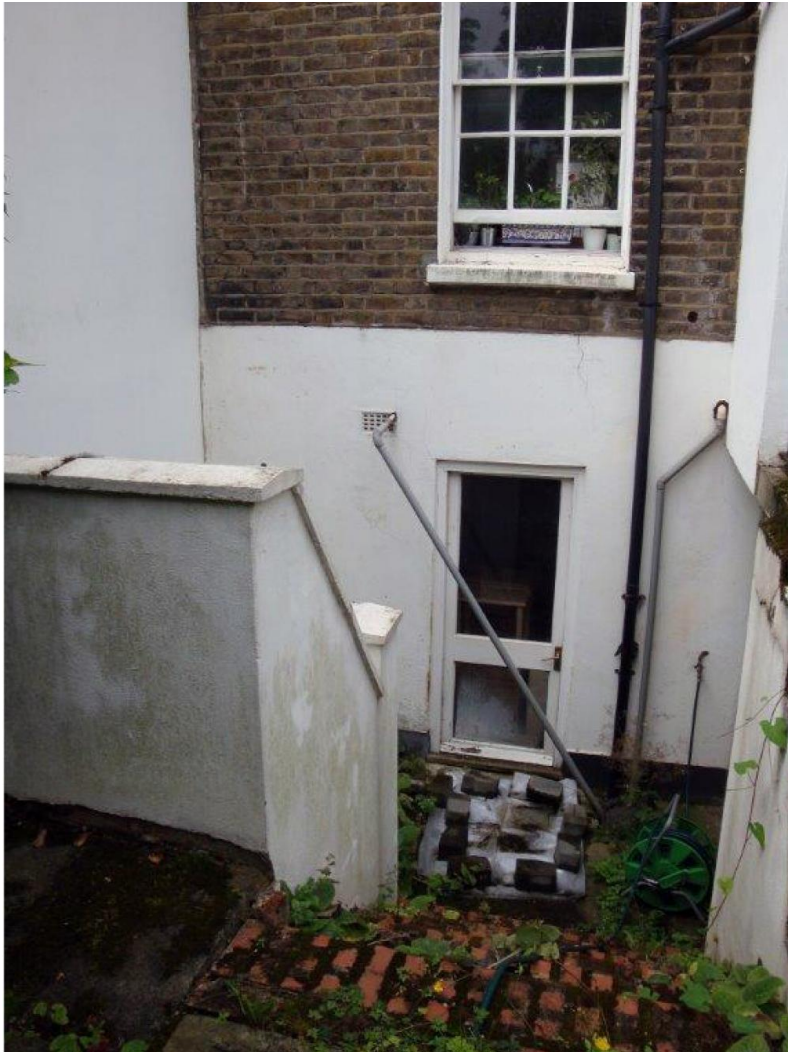
The stairs down to the back door.

A modern brick staircase descends to the back door where there is an ugly array of drainage pipes. The historic mapping indicates that there were structures either side of the stairs attached to the back of the house and these are mostly clearly seen on the 1871 edition of the Ordnance Survey. These were still in place as late as 1970. This would account for the brickwork having been rendered over. The neighbouring property has retained this unit and built a conservatory on top of it.

1. It is proposed to add a rear extension to the flat-roofed outshot that already exists at the back of the property to provide a utility area. As part of this it is proposed to move the short stairs that lead down from the upper back door and to relocate the stairs that lead downwards from the garden to the sunken courtyard. Neither set of stairs is of historic interest and appear LC20th in construction.

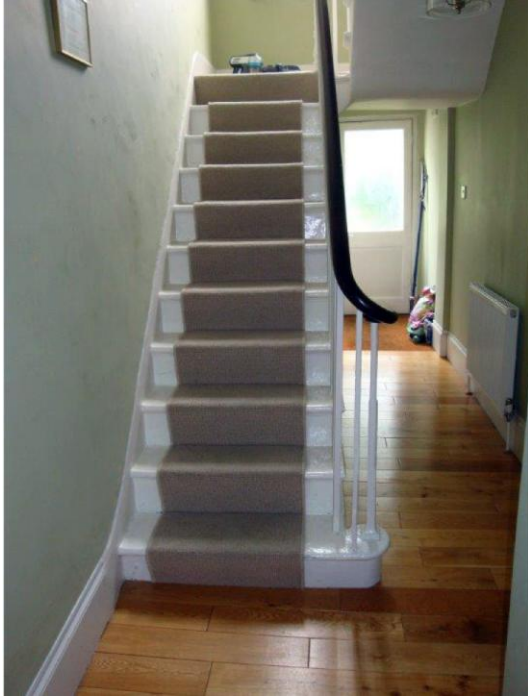
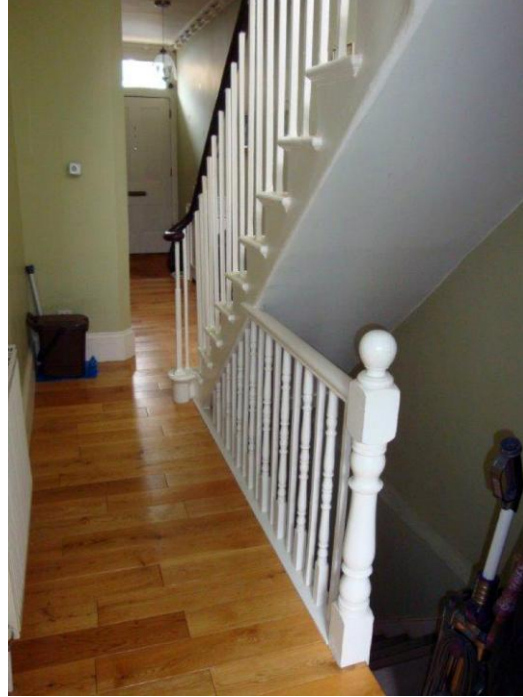
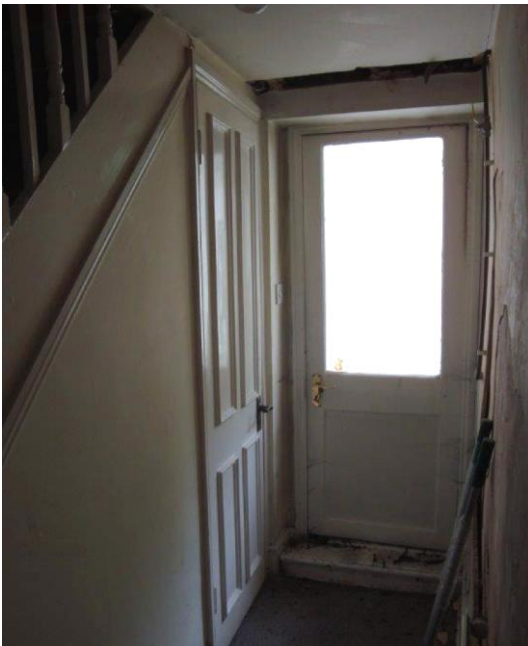
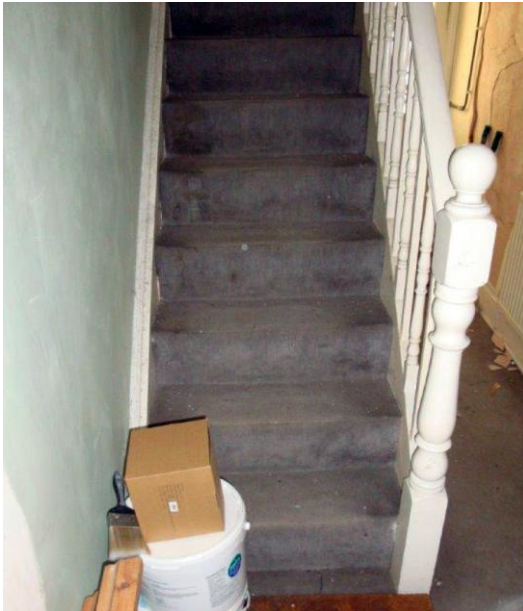
The staircase on the ground floor looking E then W.

The staircase on the lower ground floor.

The staircase is an original feature with typical Victorian elements combining different eras of past architectural styles. The open string has two balusters per tread, one stick and one machine turned. The newel posts are turned from square and there is a curtail step on the ground floor. The understairs cupboard has a C20th Victorian style four panel door with applied mouldings. There is a modillion cornice by the front door and deep toroidal skirtings.

8. It is proposed to install a small shower WC partly under the staircase. This would involve removing the understairs door which appears LC20th and a section of walling beneath the staircase. Again this is likely to be MC20th and of no historic value. The works should not otherwise affect the Victorian staircase.

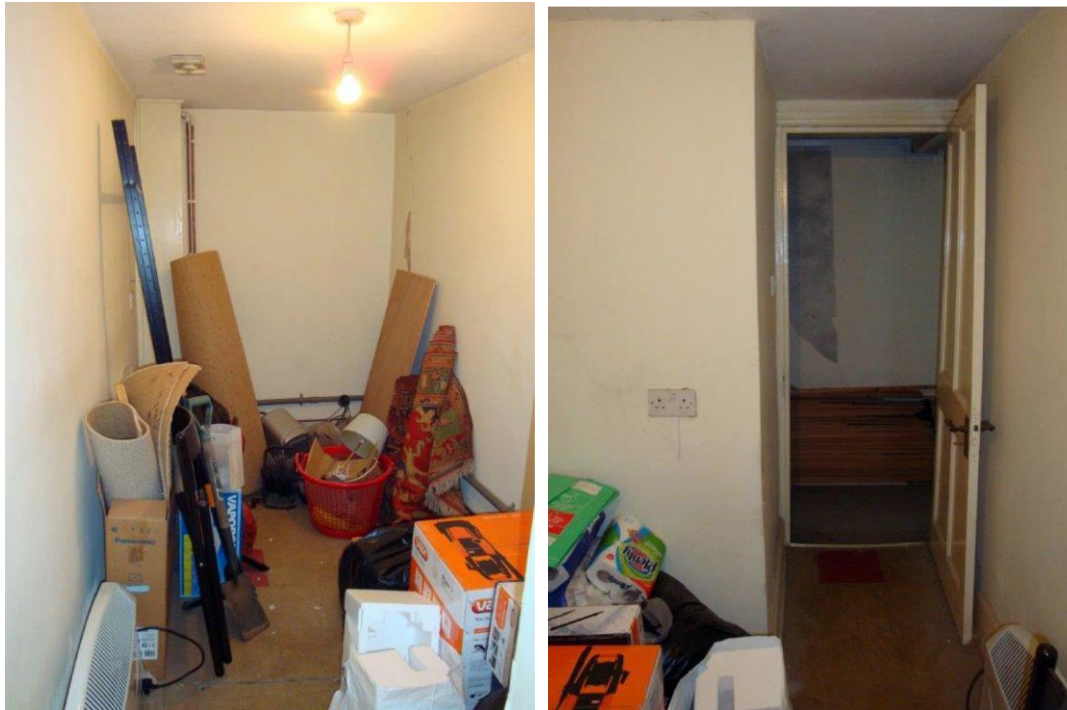
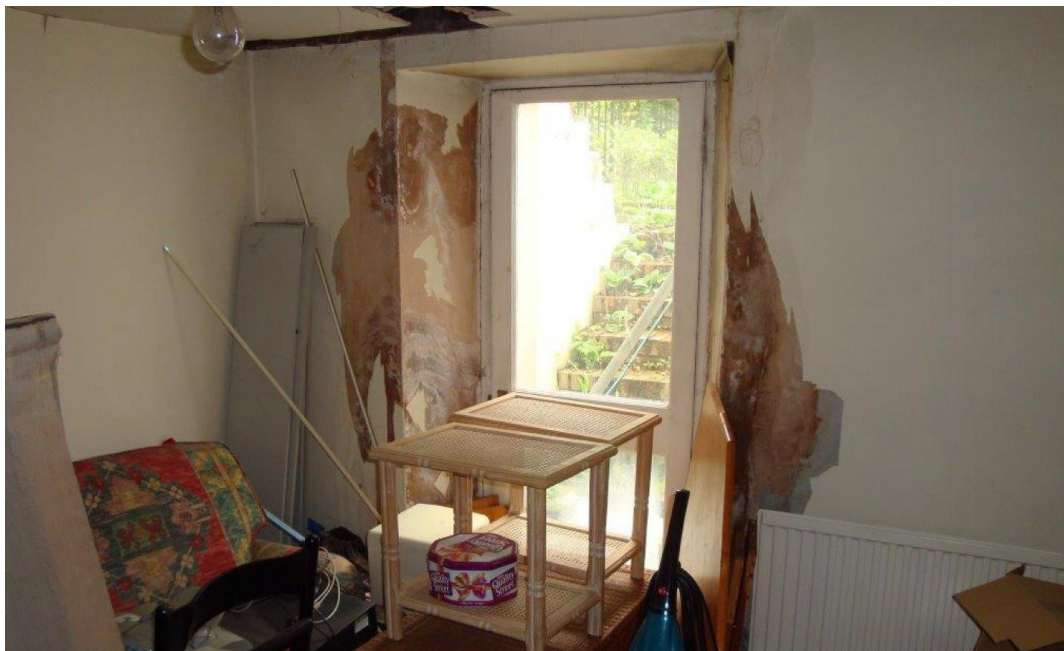
Lower Ground Floor Store Room.

Lower Ground Floor Bedroom.

The Lower Ground Floor Rooms have no original features having been converted in the M-LC20th. Where stripped due to damp, the walls are finished with modern pink skim and the ceilings appear to be plasterboard. The doors have modern frames and the doors themselves are MC20th plain fielded Victorian style doors with mortice locks hinting at a conversion in the post WW2 period.

5. On the Lower Ground Floor it is proposed to remove part of the partition wall between the Store and Bedroom and redesignate the Store as a kitchenette giving onto a new living room.

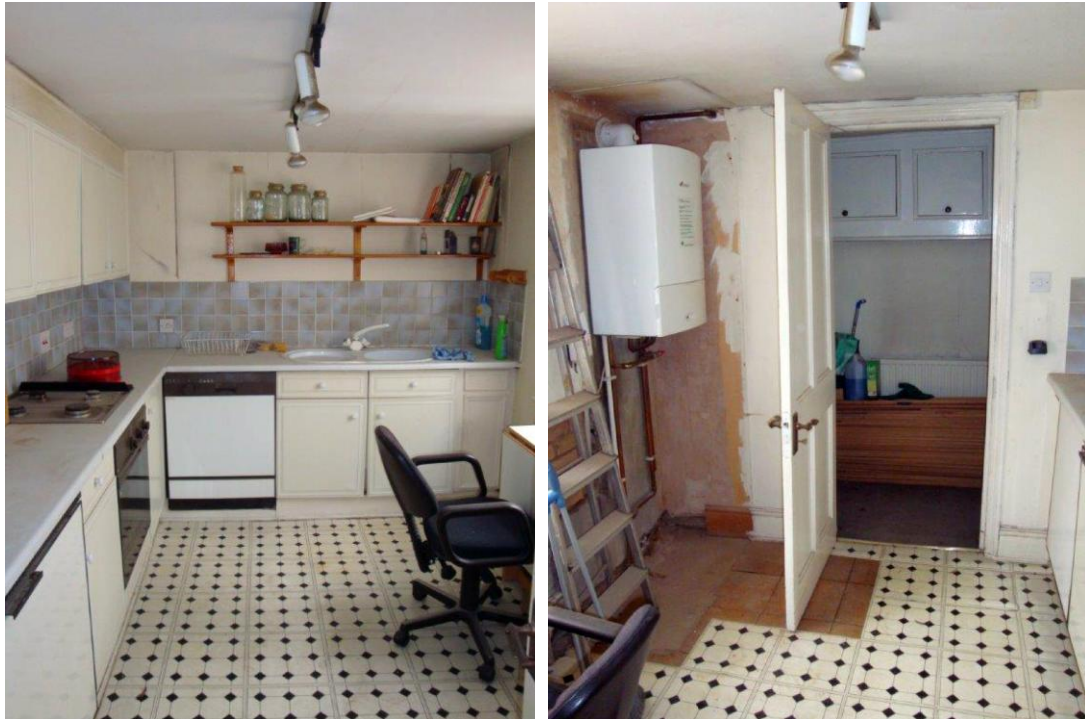
The Lower Ground Floor Kitchen looking S then N.

The Kitchen is LC20th and of no historical interest. The walls are finished with pink skim, the skirtings are modern and unpainted in places. The ceiling is finished in plasterboard.

The kitchen on the Lower Ground Floor is a recent addition and the gas boiler enclosure is still under construction. The walls are finished in pink skim and the ceilings are plaster-boarded. Prior to central heating the ground floor would have been very uncomfortable as only the kitchen has a (now blocked) fireplace. Areas of delamination show a problem with damp.

6. The Kitchen would then be stripped out and redecorated as a bedroom. The partition wall between the present Kitchen and Store would be removed and a new partition placed about 500mm to the east. The position of the firebreast indicates the present partition cannot be original as it is too close to be practical when the fireplace was in use. Therefore it must be MC20th.

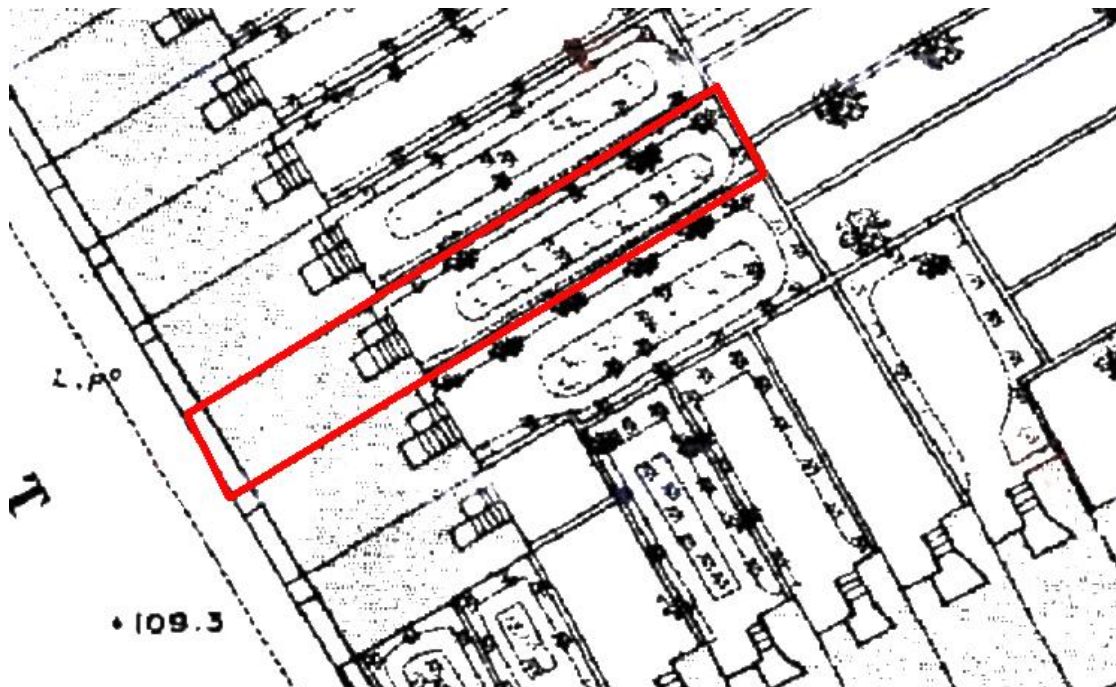
1871 Ordnance Survey. Each building is shown with two rear extensions.

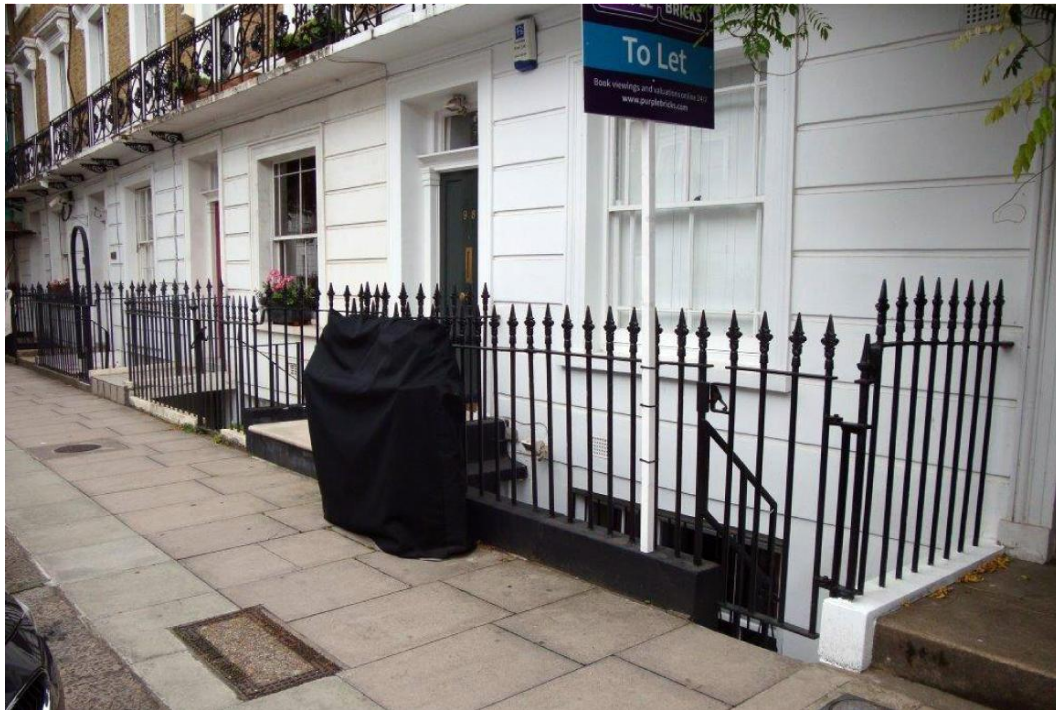
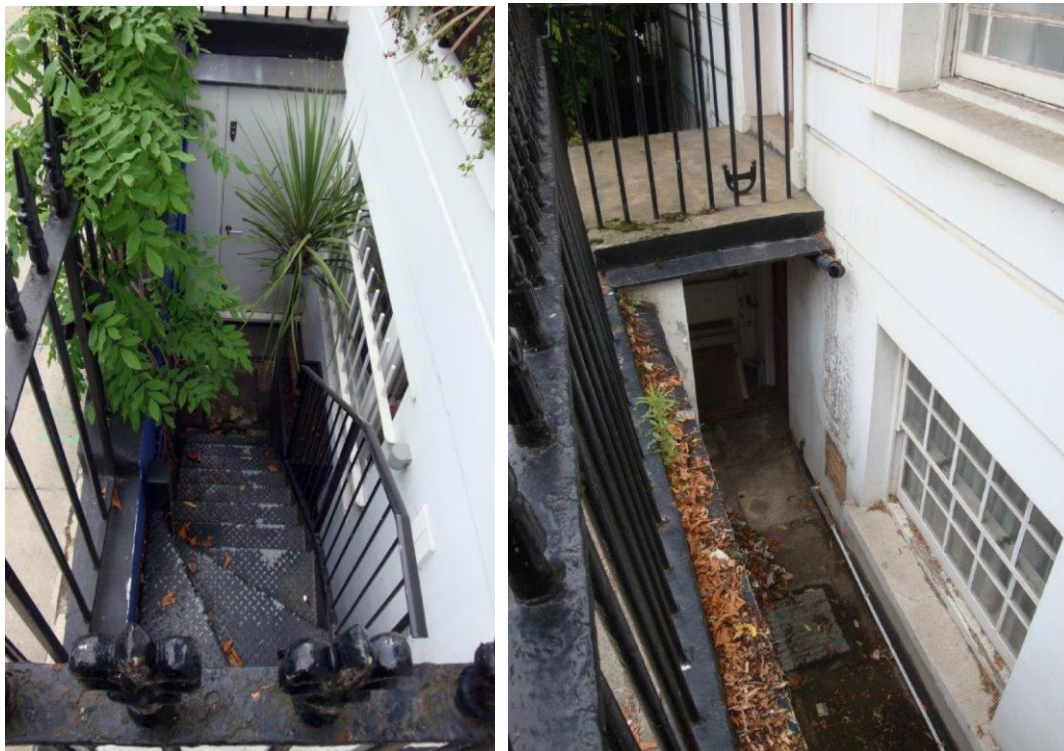
A typical staircase to near identical buildings.

A typical staircase down into a near identical light-well to that of No94 (shown right).

3. It is proposed to add a descending staircase from the front railings, having made a new gate, so that the occupant of the lower ground rooms can enter the rooms from the front of the building. This would result in the potential loss of part of the railings. However this can be overcome by making the gate out of the removed section. The proposed staircase is one of a simple, appropriate pattern. (See following sample photographs).
