41 Howitt Road, Hampstead, London NW3 4LU

Ground Movement Assessment – Revision 1

June, 2017

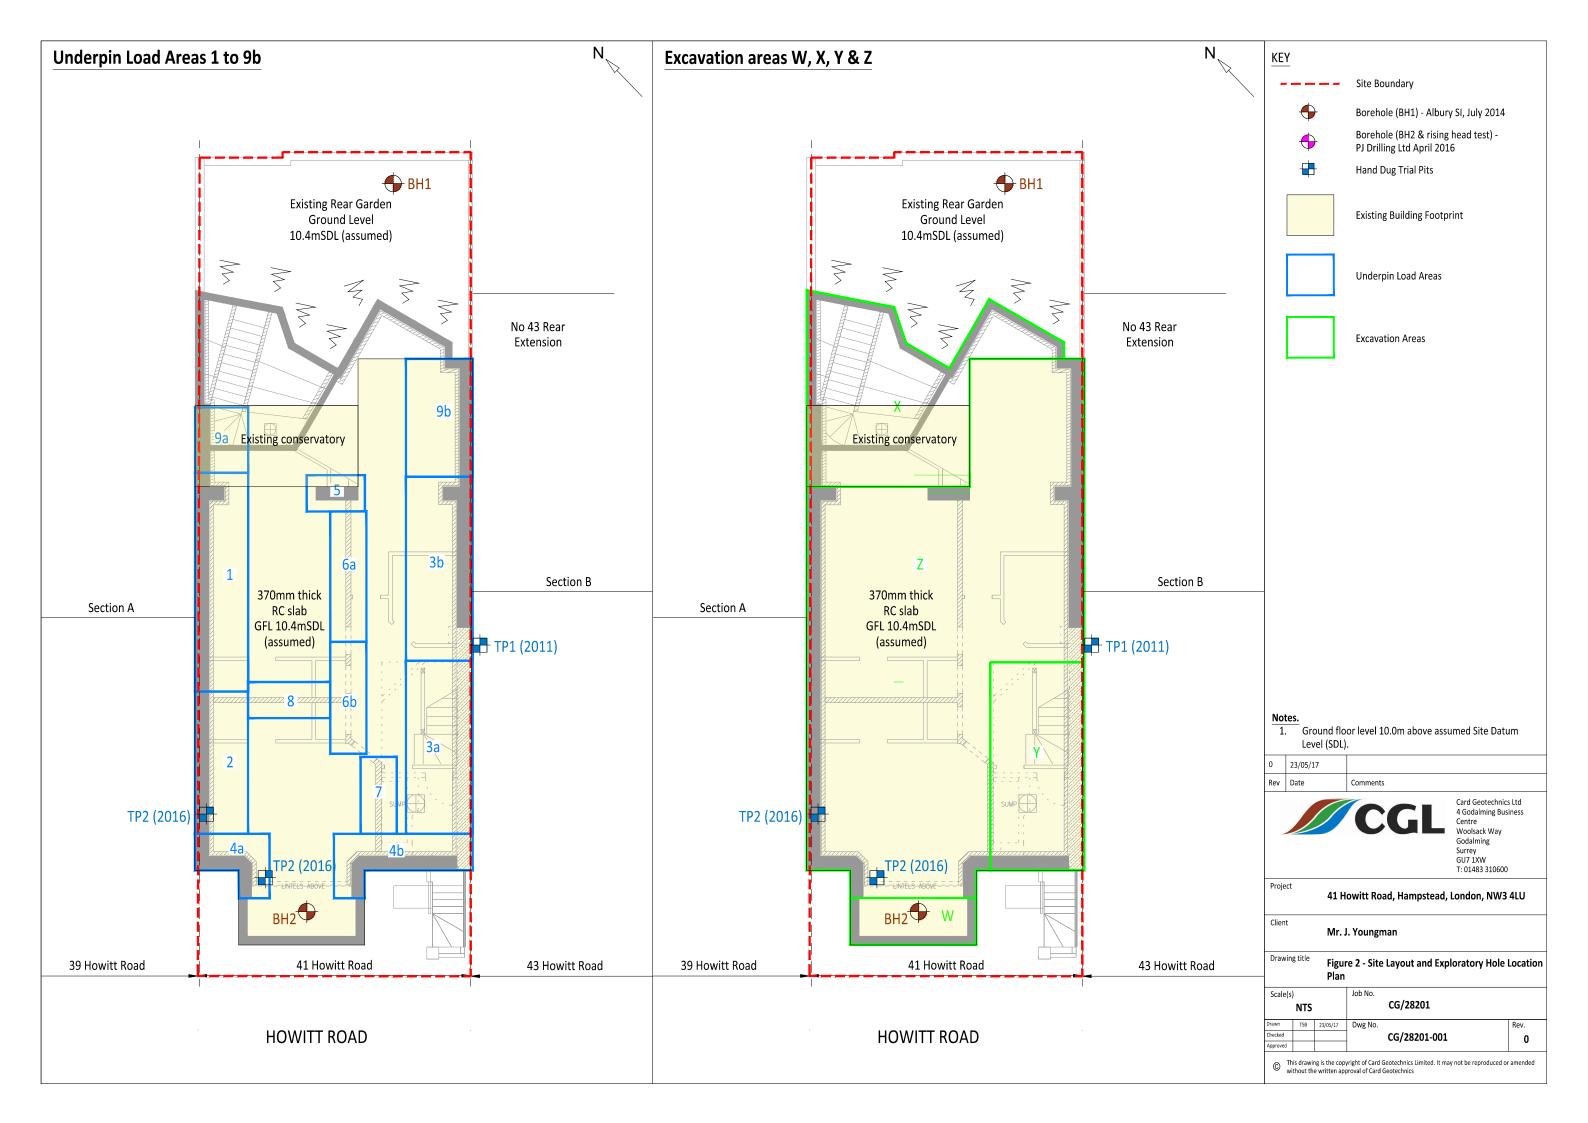
Figure 2 - Site layout plan

A site layout plan is provided in Figure 2. The property sits within a rectangular site orientated on a slight north-west/south-east axis. The road slopes gently downwards to the south-west. The property is an early 1900s 3 storey mid terrace house, sharing party walls with Nos. 39 and 43. No. 43 Howitt Road currently has a partial single level basement at the front of the property, which is underpinned to the same level as the proposed basement for No. 41. The rear party wall of Nos. 41/43 and the party wall with No. 39 will require underpinning for the construction of the new basement. There is a small existing single storey basement at No. 41, at the front of the property, which is accessed by steps leading down from the front entrance. Development plan drawing 1308.22.a details a trial pit, trial pit No. 1 which was excavated to investigate the footings for the extension to No. 43 basement in 2011. The trial pit confirmed the basement slab to be 400mm thick. Two further trial pits were excavated in 2016; Trial pit No. 2 excavated at the party wall with No 39 showed the footings to be at 400mm below ground level at No. 41, and 700mm or more below ground level for No. 39 next door. Trial Pit No. 3 proved the footings beneath the front wall to be founded at 700mm below ground level.

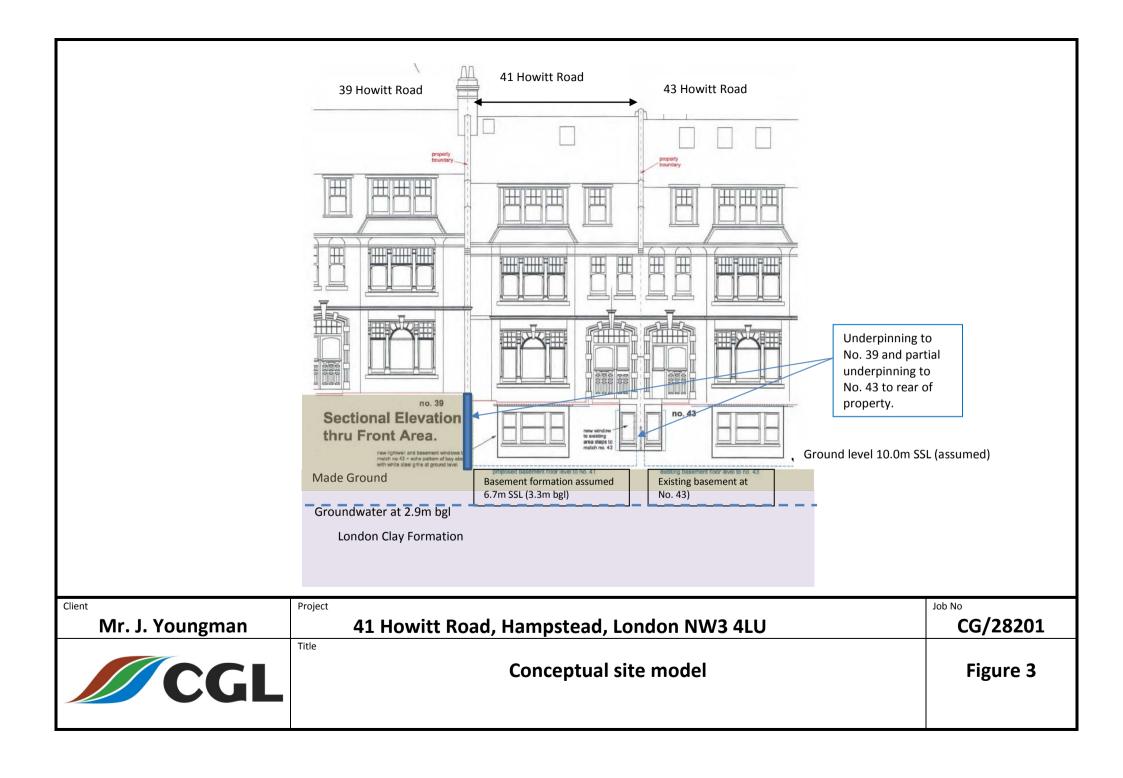
Figure 3 – Conceptual site model

The stratigraphy encountered in BH1 at the site is summarised in Table 1 and a conceptual site model is shown in Figure 3.

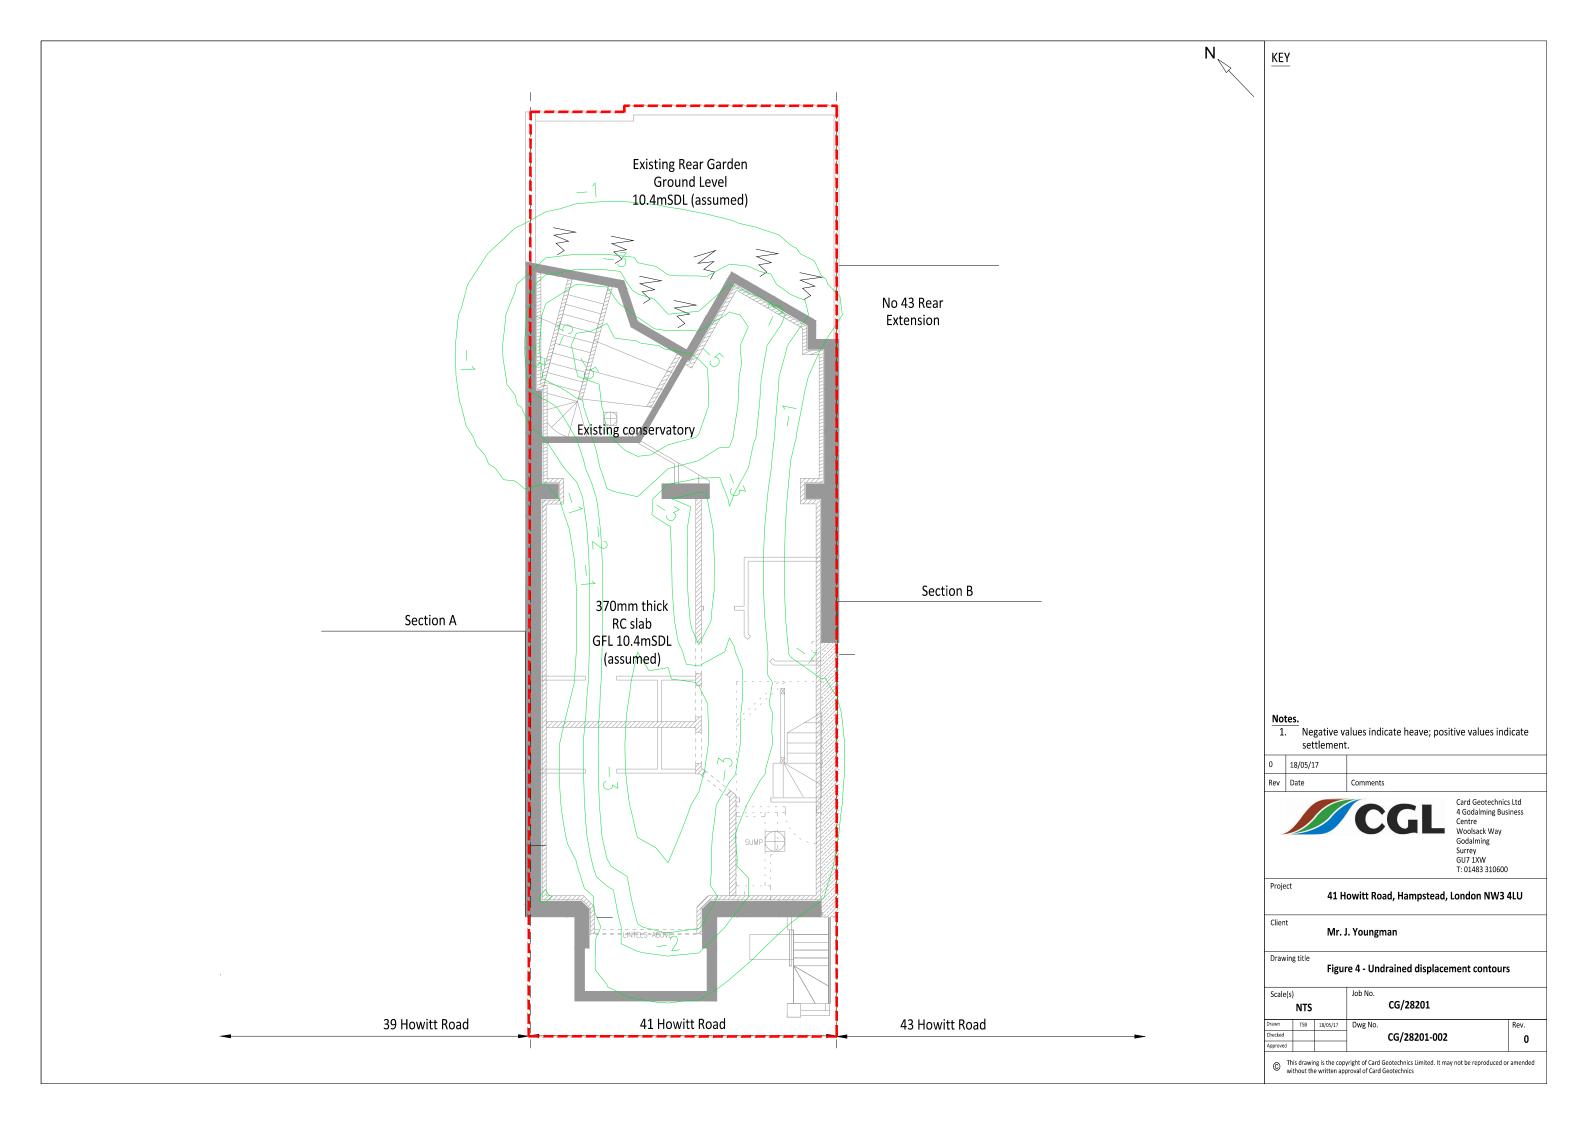
Figure 4 – Undrained displacement contours

At formation level the maximum short term ground movement is estimated to be 6mm of heave beneath the rear garden, and 4mm beneath the existing property, reducing to between 1mm to 3mm heave and up to 1mm settlement beneath the property boundary walls and beneath the underpins. Up to 3mm of heave is anticipated beneath the party wall foundation of No. 39, and up to 1mm of heave/settlement is predicted beneath the party wall foundation of No. 43. The estimated undrained displacement (short term) across the basement and beneath the party walls due to unloading by excavation, and structural loading of the existing building is presented as a displacement contour plot in Figure 4.

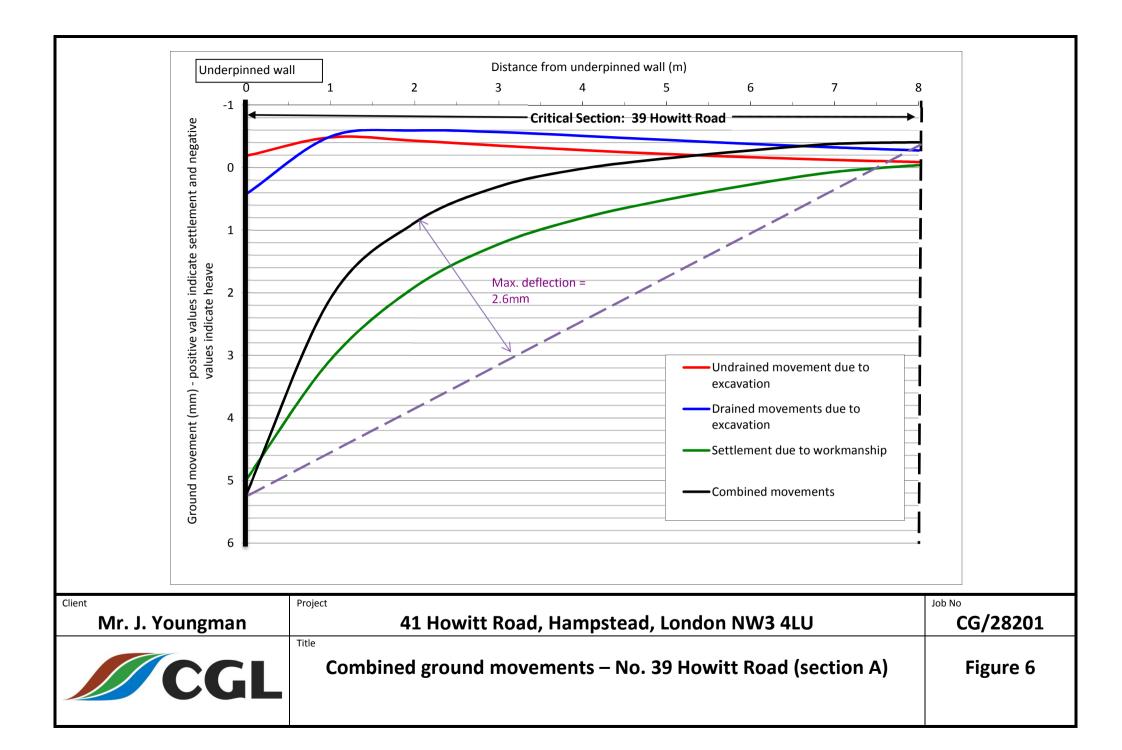
Figure 6 – Combined ground movements for Section A (No. 39 Howitt Road)

Ground movements for No. 39 Howitt Road have been taken from a displacement line at 9m SDL through the width of the property (8m wide) adjacent to the proposed basement. Combined vertical displacement across the width of No. 39 Howitt Road is estimated to be approximately 5mm reducing to less than 1mm on the far side of the property foundation.

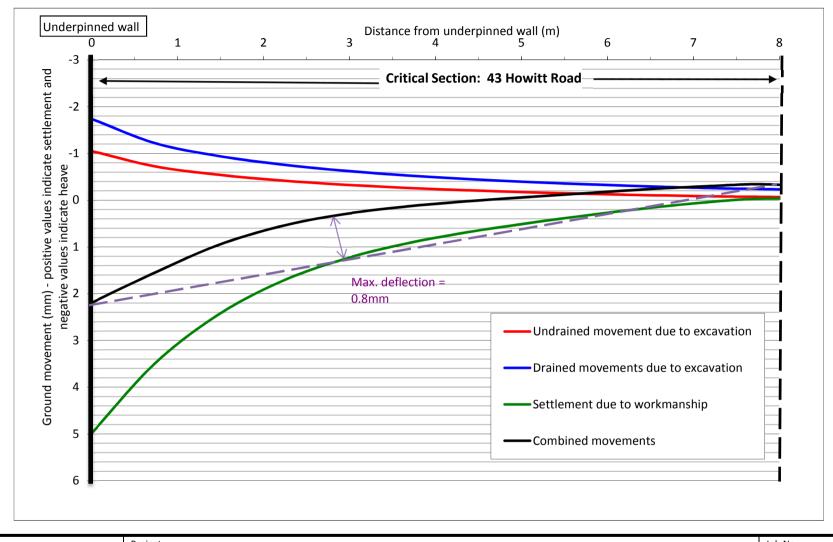
Client	Project	Job No
Mr. J. Youngman	41 Howitt Road, Hampstead, London NW3 4LU	CG/28201
CGL	Combined ground movements – No. 43 Howitt Road (section B)	Figure 7

Ground movements for No. 43 Howitt Road have been taken from a displacement line at 9mOD through the width of the property (8m wide) adjacent to the proposed basement. Combined ground movements across the width of No. 43 Howitt Road are estimated to be approximately 2mm, reducing to less than 1mm on the far side of the property foundation.

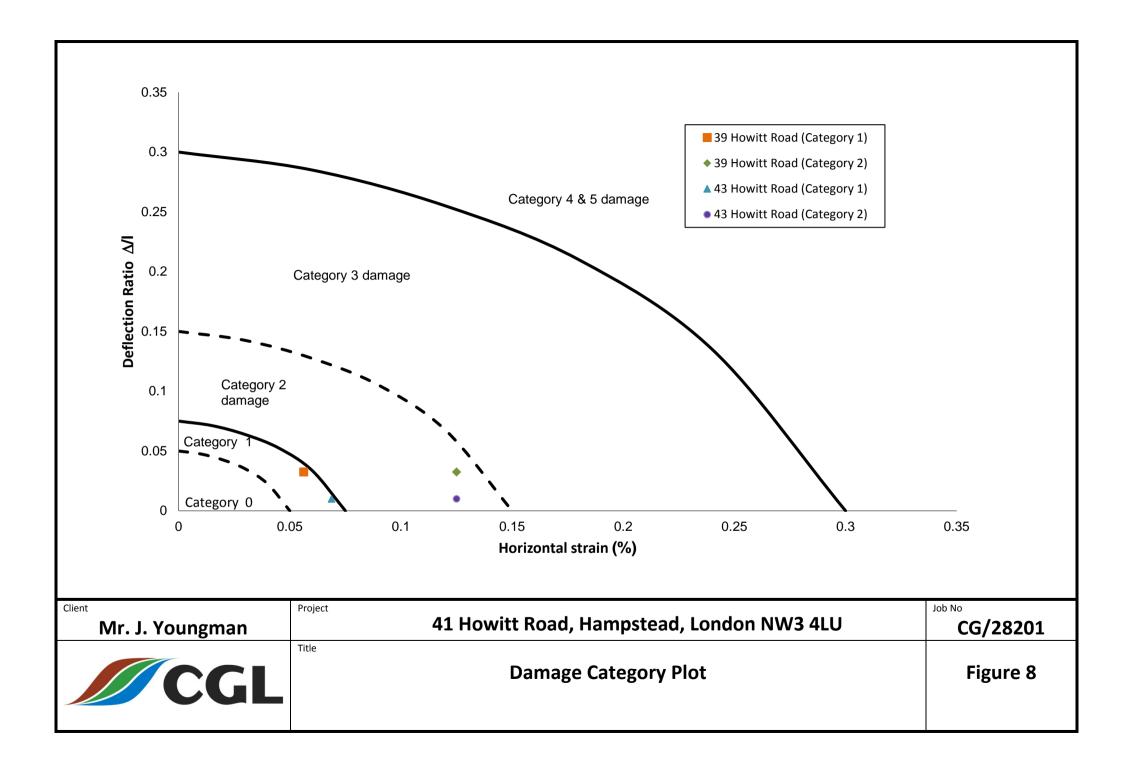
Figure 8 – Damage Category plot

As stated in Section 4.2 of this report long term wall deflection is expected to be very low (i.e. <2mm) however assuming lateral deflection of the underpins is limited to approximately 5mm, the predicted damage category imposed on the neighbouring properties due to the proposed basement development will still be within Category 1 corresponding to 'very slight' damage. The building interaction chart, showing all critical sections, is presented in Figure 8. It is noted that that the building interaction chart is plotted assuming limiting horizontal movement is fully realised.

Party Wall Reference	Horizontal movements ^c (mm)	Maximum deflection (mm)	Horizontal Strain Δ/L ^b (%)	Deflection ratio δ _h /L² (%)	Damage category
No. 39 Howitt Road (Section A)	<4.5mm	2.6	0.0563	0.0325	Category 1 ('very slight')
No. 43 Howitt Road (Section B)	<5.5	0.8	0.0688	0.0100	Category 1 ('very slight')
No. 39 Howitt Road (Section A)	<10.0	2.6	0.1250	0.0325	Category 2 ('slight')

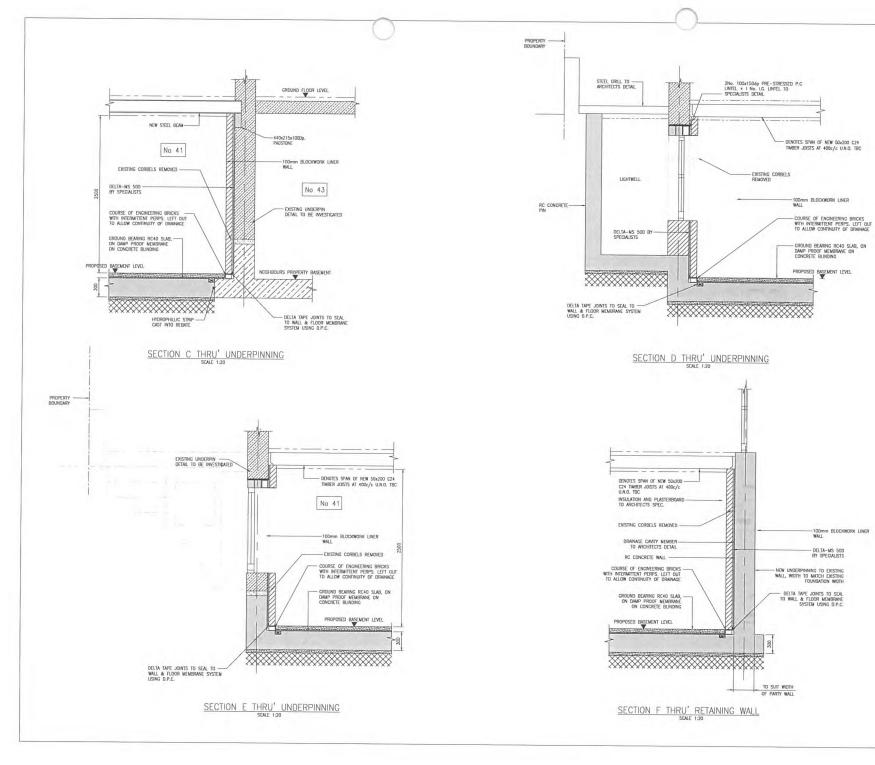
-100mm BLOCKWORK LINER WALL

DELTA-MS 500 BY SPECIALISTS

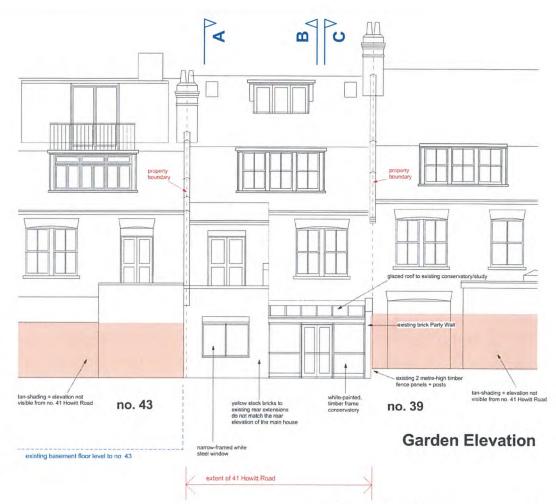
Photo 1: view of existing single storey rear extension to 41A Howitt Road and first floor extension above: rear of no. 43 is to the left.

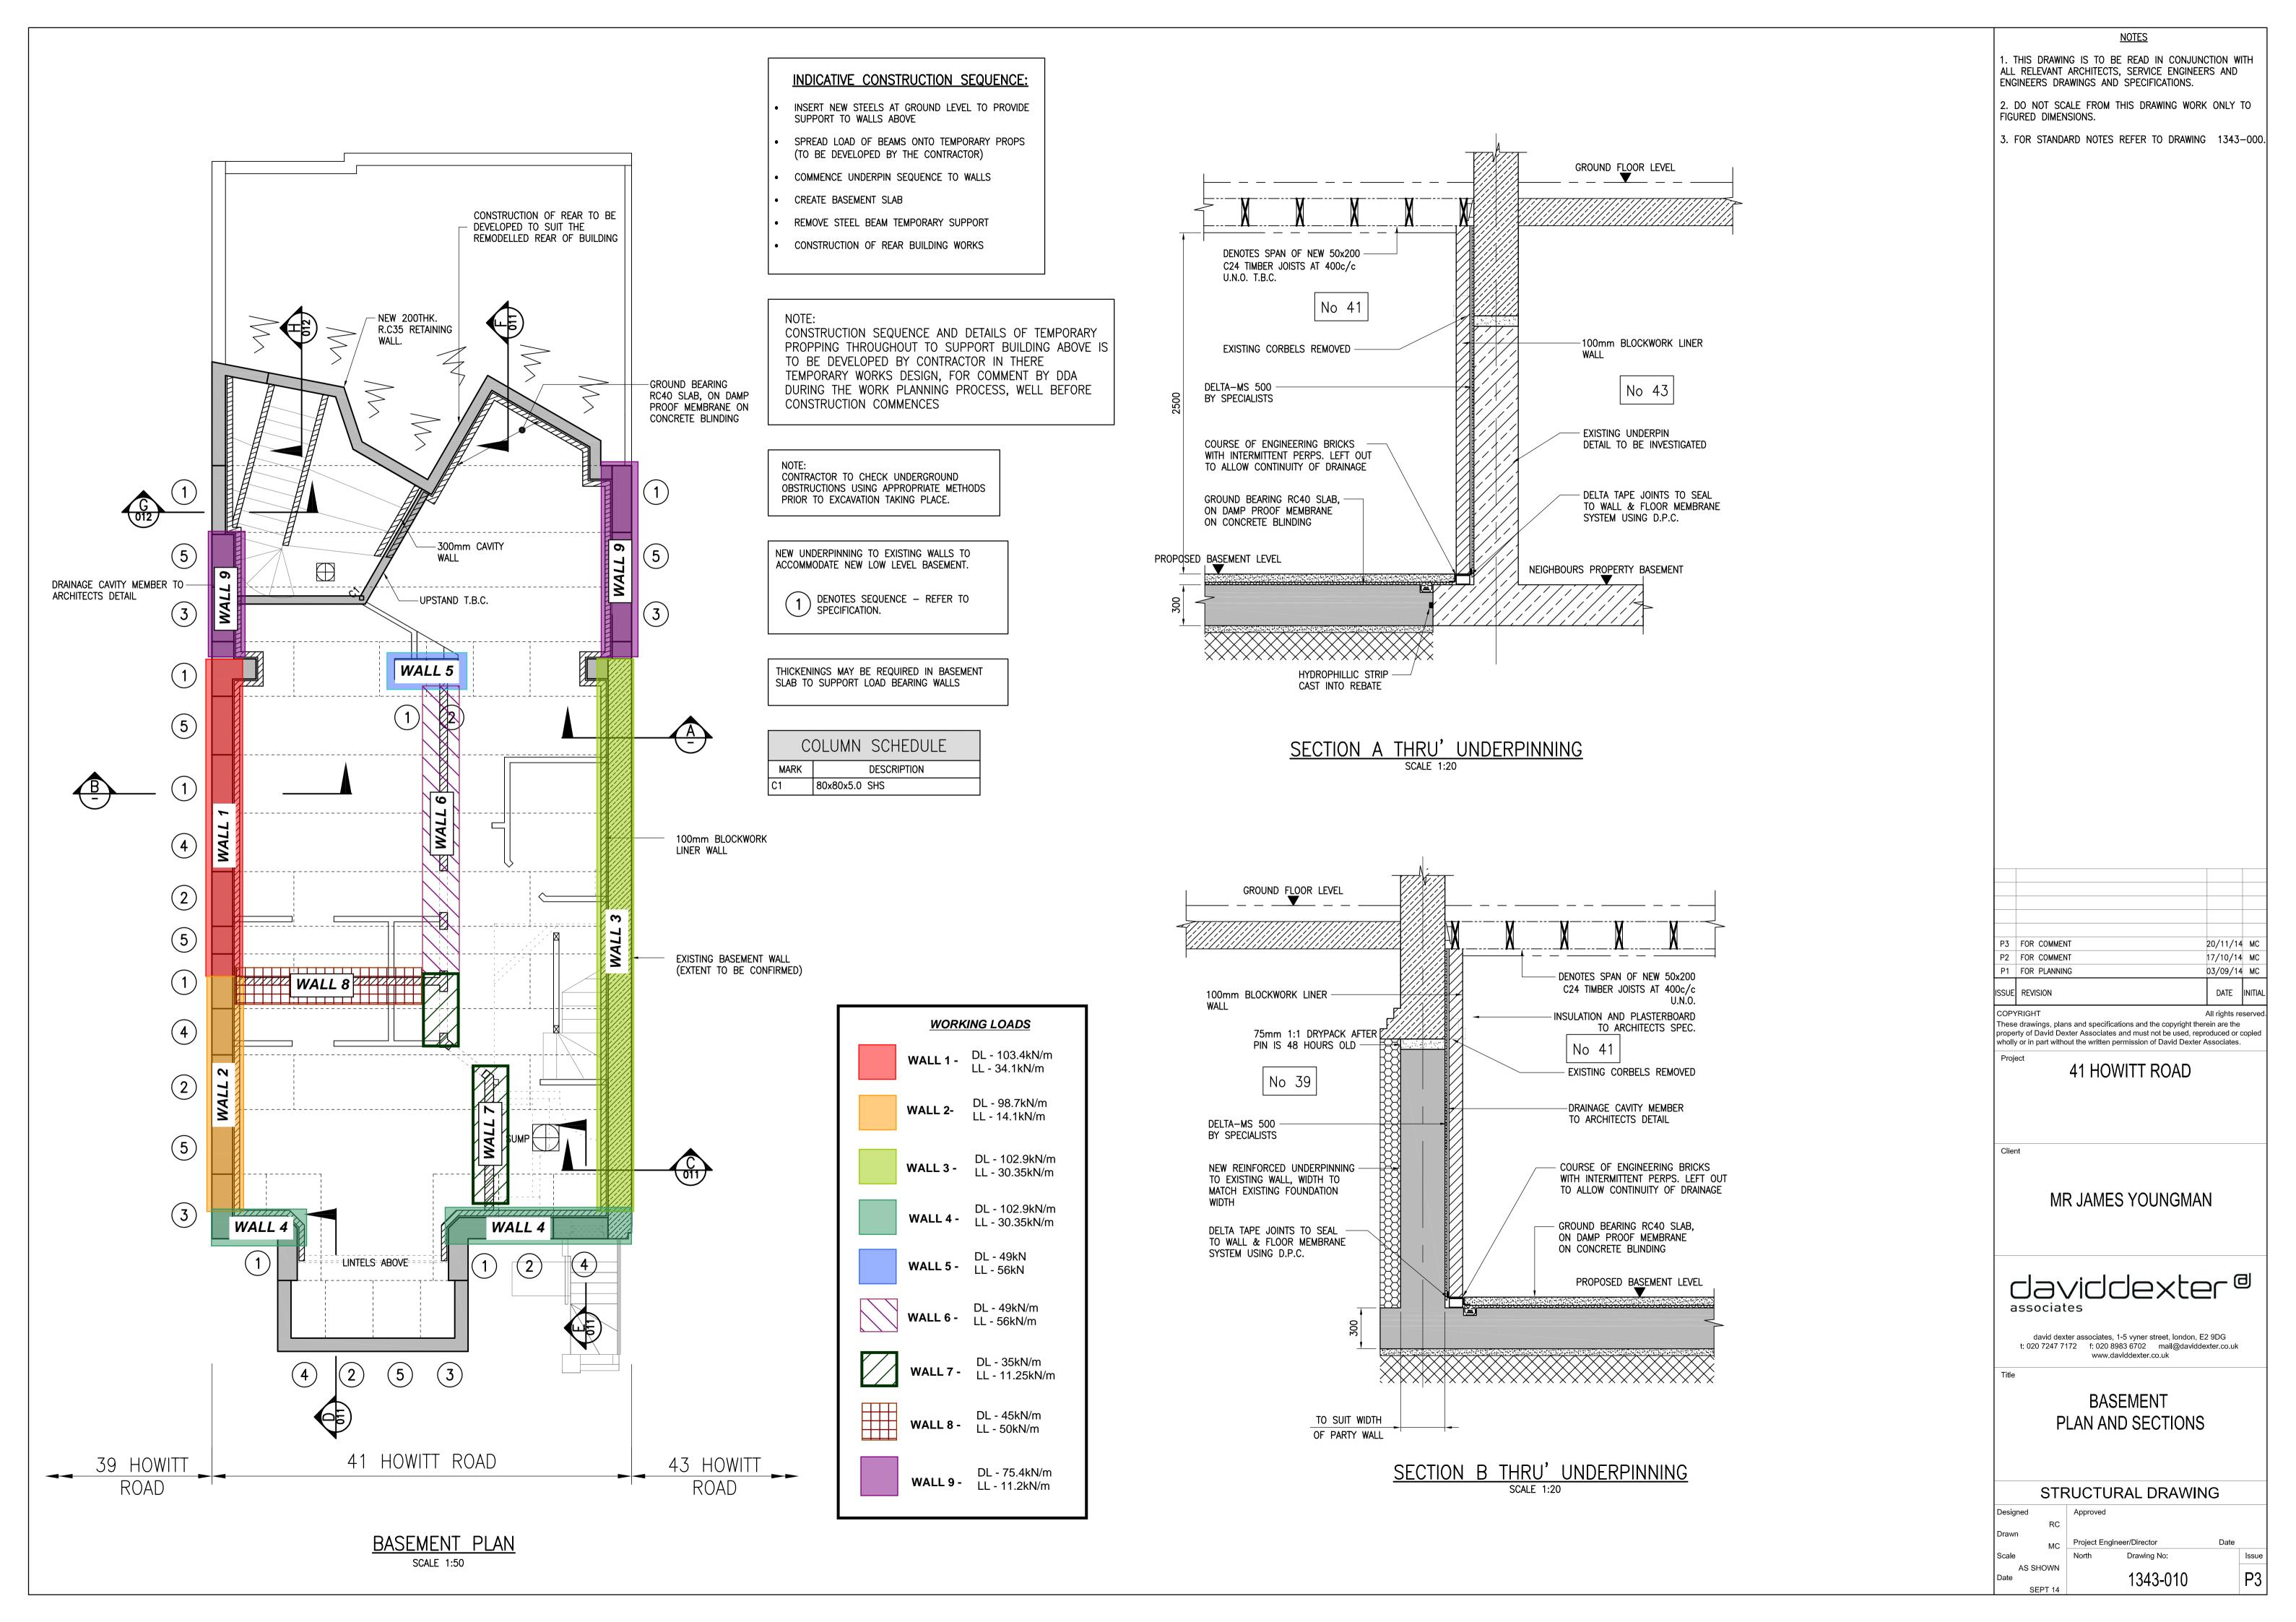
Structural load plans

a. Foundation areas refer to loading areas as shown on the structural load plan in Appendix C.
