05 September 2017  
Our Ref: P1019J1129/rs

## **35 TEMPLEWOOD AVENUE – GROUND MOVEMENT ASSESSMENT (GMA)**

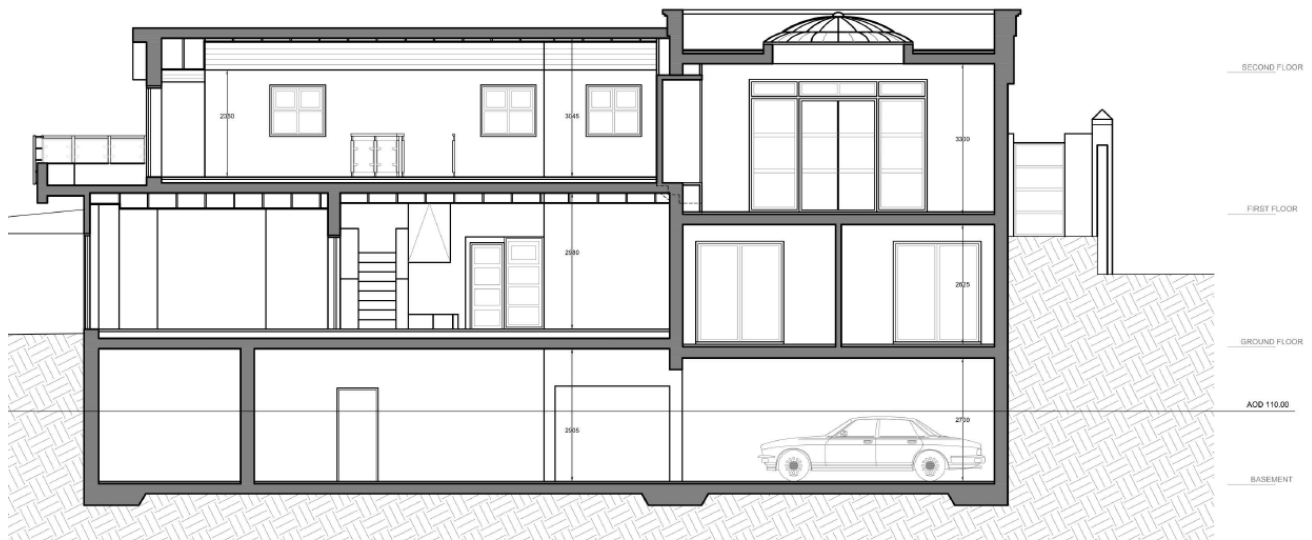
Figure 2.2: Typical long section

The existing lower ground floor (which is present over much of the existing building footprint) formation level is at around 111mOD and the proposed excavation slab formation level is 107.5mOD. Figure 2.2 & Figure 2.3 display typical long/cross sections of the proposed development with proposed footing locations highlighted in green.

Figure 2.2 shows the geometry and intensity of the footing loads as applied in the Pdisp model. The permanent building loads were evaluated on the basis of an indicative load takedown based on the proposed floor arrangements provided.
