**66 FITZJOHN'S AVENUE, LONDON NW3**

**RESPONSE TO QUERIES RAISED IN CAMPBELL REITH'S BASEMENT IMPACT ASSESSMENT  
AUDIT**

**SKETCH OF VOID / LIGHTWELL TO SIDE OF No.66 FITZJOHN'S AVENUE**

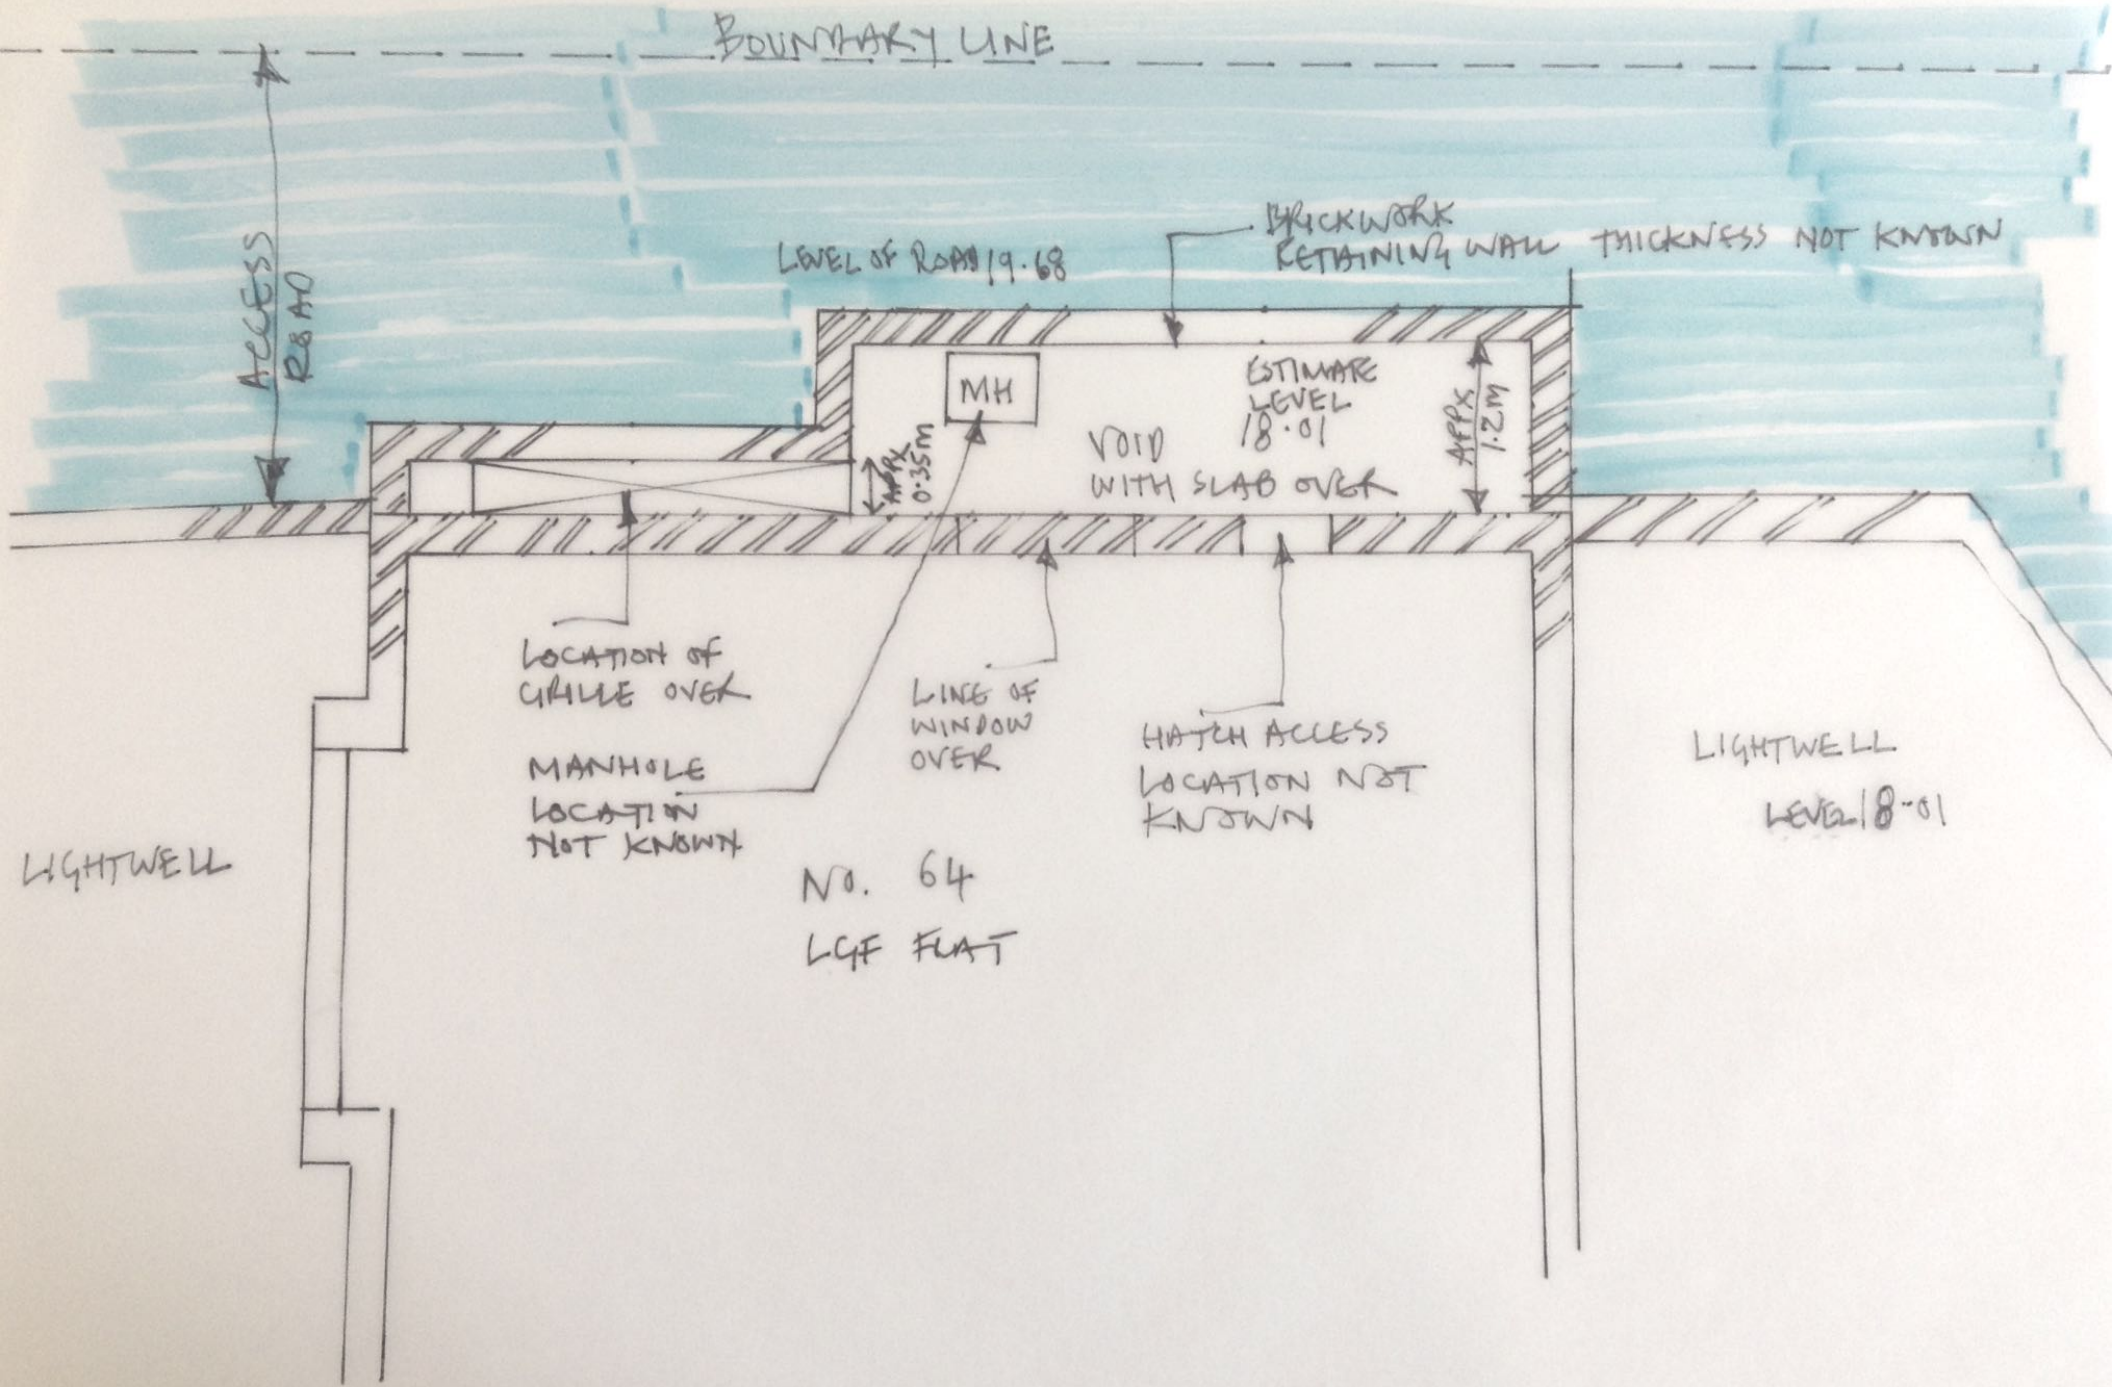
## **APPENDIX A**

BRICKWORK RETAINING WALL THICKNESS NOT KNOWN

VOID WITH SLAB OVER

APPRX 0.35M

APPRX 1.2M

MANHOLE LOCATION NOT KNOWN

HATCH ACCESS LOCATION NOT KNOWN

Contact has been made with the author of the objections/observations (letter Salprime Ltd 18.07.16) and they have described what is essentially a void or narrow light well running down the side of No.64 which, it is thought, was created to allow the land to the side to be levelled for the access road maintaining access to a manhole. A sketch of what has been understood from the author is attached as Appendix A. The author's concerns are with the slab over the lightwell which he describes as insubstantial, though it is thought to have acted satisfactorily as a road base for some years.

The resolution to this issue is straight forward and is most appropriately addressed under the Party Wall procedure. At that stage access can be gained to the light well so that it can be measured and properly assessed. If the slab over the lightwell is found to be inadequate or, indeed, if it simply cannot be proven to be adequate, then it would be strengthened or replaced. Replacement with a suitably reinforced and sealed concrete slab is most likely to be the preferred option as it will provide a more durable and robust solution for all for the future.
