Design and Access Statement

PROPOSAL: Reconstruction of Front Boundary Garden Wall

SITE: 18 Fairhazel Gardens, London, NW6 3SJ

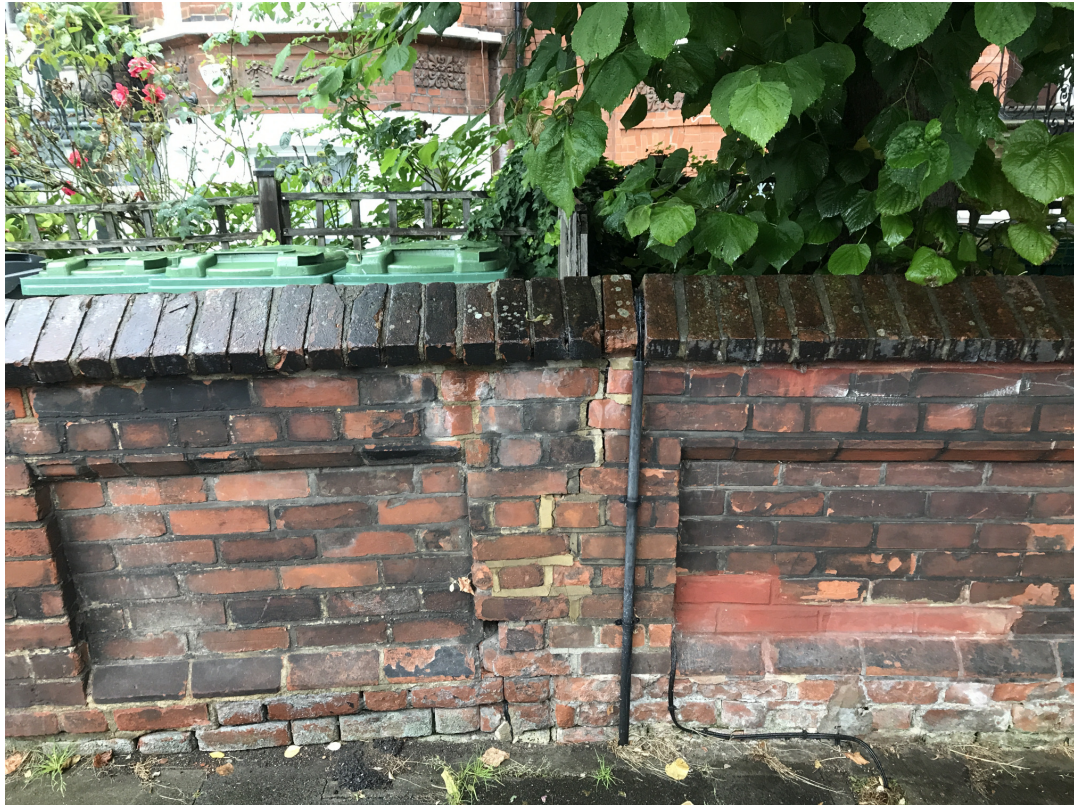
As shown in the photos below, the wall is in very poor condition with large structural cracks and with areas of decaying brickwork – particularly at the base. The structural damage is largely caused by a combination of shallow foundations on a clay soil base and a large lime tree very close by in the neighbouring garden. In addition to the damage to the main wall, the entrance pier is starting to lean over into the street. If left without reconstruction, the wall will continue to decay and crack and will become unstable.

Section of wall showing cracking damage and brickwork decay.

Proposed Works: The section of wall to be rebuilt is as set out in the accompanying drawing 217140/02. The existing wall is to be carefully taken down, setting aside all bricks and stonework in good condition for reuse in the replacement wall.

The new wall will reuse all bricks and stonework where possible with a mixture of replacement bricks to match. In particular, all feature curved bricks are to be carefully set aside for reuse. The new wall is to match the existing in all dimensions with exact replication of the feature panels to both sides, angled coping bricks and end pier.

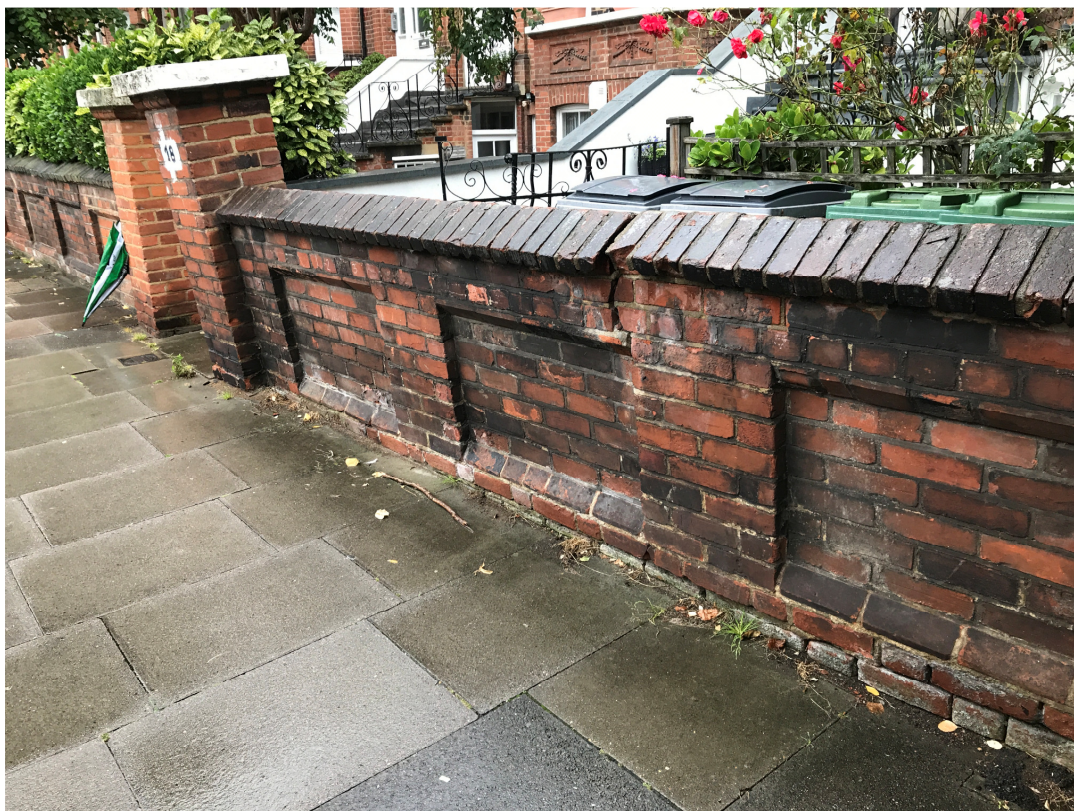
Section of wall showing further cracking damage and brickwork decay and a comparison of the two entrance piers shows the closest pier leaning over into the street.
