Proposed residential redevelopment  
106 King Henry's Road  
Camden

## Ground Investigation Report

**Proposed development  
106 King Henry's Road  
Camden  
London  
NW3 3SL**

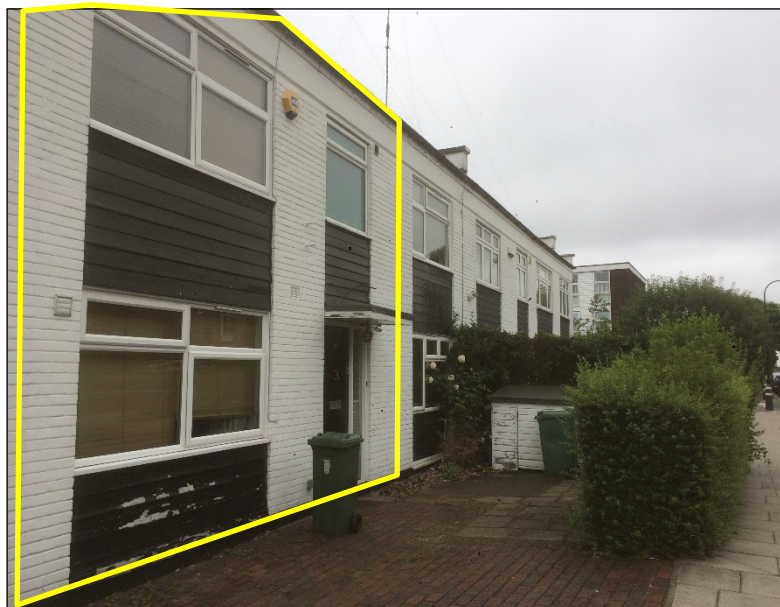
**Photograph 1**

View of the property looking north east.

3.2.2 The property comprises a two-storey terraced dwelling, of apparent masonry construction with timber cladding and a flat roof. A small rear paved garden area is present to the north. Ground levels across the site and the local area are reasonably uniform. Drawing 02 records our site observations. The following photographs illustrate site conditions at the time of our investigation.

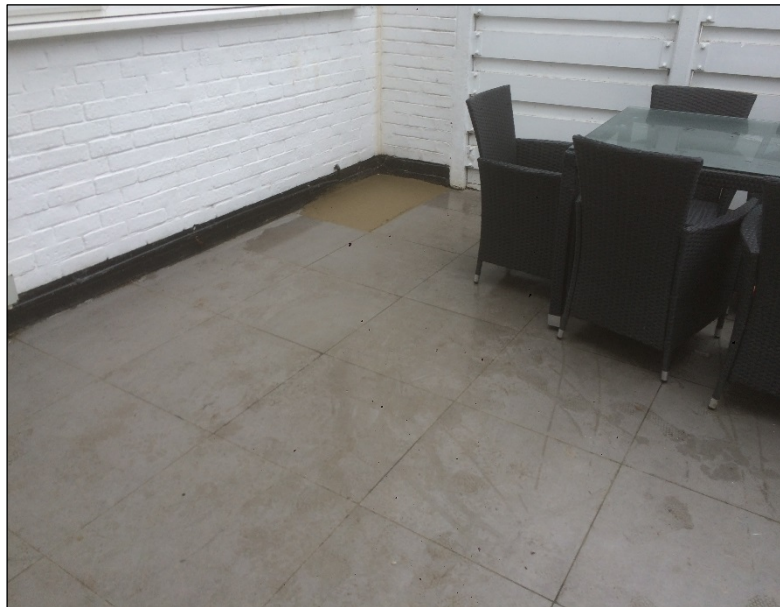
**Photograph 2**

View across the rear patio area looking south-west

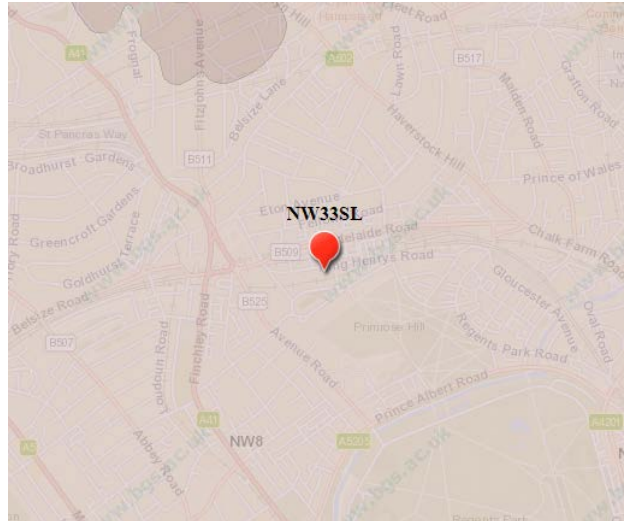
- 3.5.1.2 An extract copy of the geological map is presented below, with brown shading representing the outcrop of the London Clay Formation. The shaded dark brown represents the Claygate beds (on higher ground to the north) with the property located on London Clays (light brown shading). The property position is shown by the red marker.

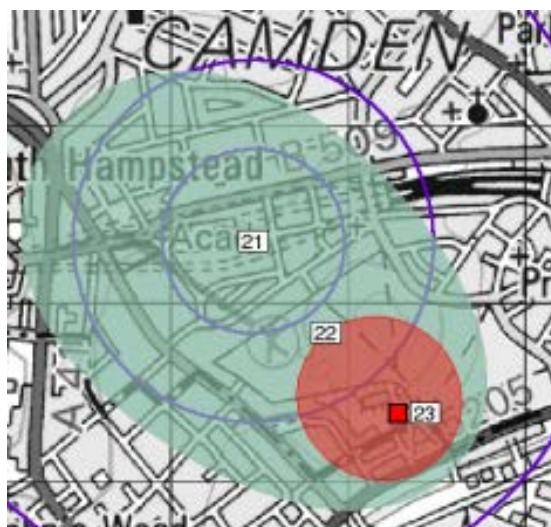
3.5.4.1 The site lies within a Source Protection Zone II. The zone is associated with a drinking water abstraction point located 618m to the southeast of the site. The edge of the inner protection zone lies 323m to the southeast. An SPZ II is defined by a 400-day travel time from a point below the water table. The zone has a minimum radius of 250 or 500 metres around the source, depending on the size of the abstraction. An extract of the plan recording source protection zones is presented below, with green shading representing outer protection zones and red inner protection zones.

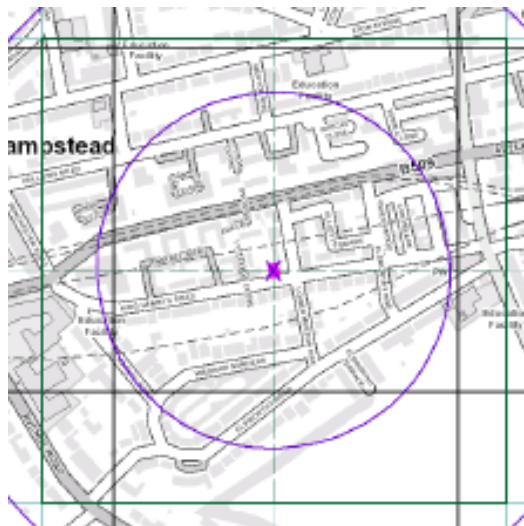
- 3.8.1.1 The site is not located within a fluvial or tidal flood plain. An extract copy of the Envirocheck flood risk map is presented below which shows no blue shading representative of flooding.

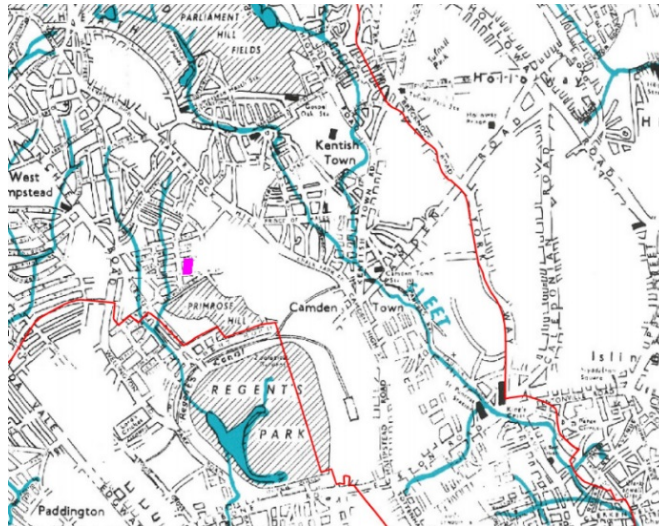
3.8.3.3 An extract of figure 11 from the Camden Geological, Hydrogeological and Hydrological Study (referenced in Section 1.4) is presented below. The blue lines show the locations of branches of formers in the area. The property is located within the red box and seems to be within close proximity to an upper branch of the River Tyburn.

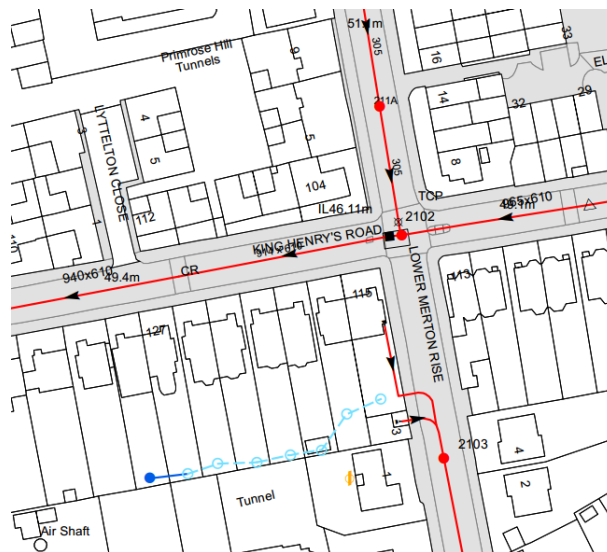
3.8.3.5 There is a 914 x 610 culvert in King Henry's Road recorded on Thames Water Asset register, an extract copy of which is presented below. The culvert follows a westerly route from the property.

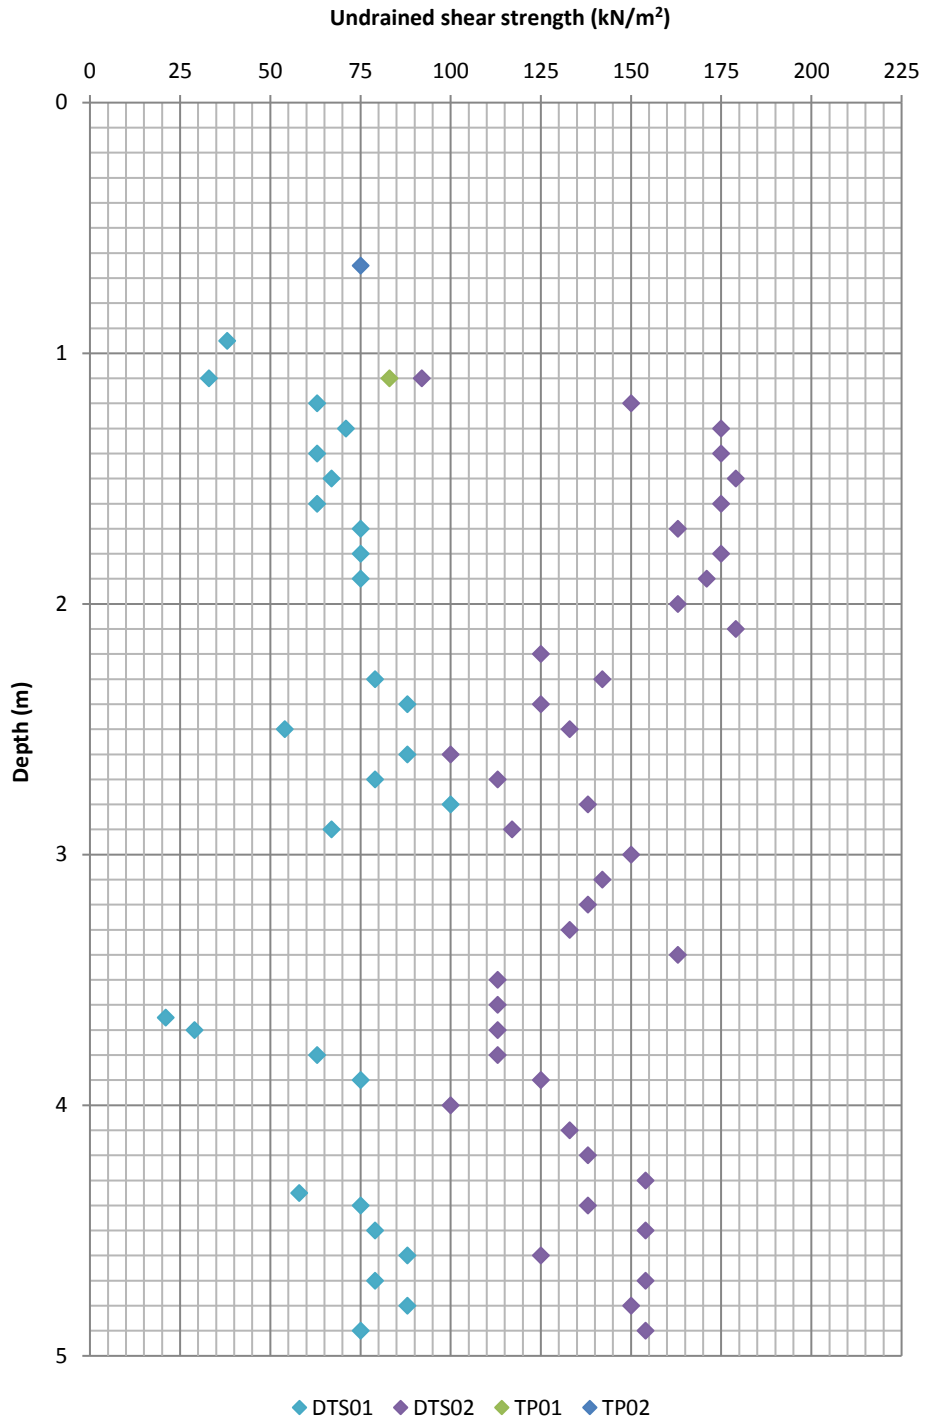
Title	Scale	Drawing number
Plot summarising results of pocket penetrometer determinations by location	As shown	04

- 1) Equivalent undrained shear strength derived by multiplying Pocket Penetrometer (PP) results by 50

- 4.4.4 Locally in DTS02, paving slabs were broken prior to excavation of the borehole. The surface was reinstated with concrete on completion.
- 4.4.5 A pocket penetrometer was used in the cohesive soils retrieved from the borehole. This tool is deemed to measure the apparent ultimate bearing capacity of the soil under test. The pocket penetrometer is calibrated in kg/cm<sup>2</sup>. The reading can be approximately converted to an equivalent undrained shear strength by multiplying the results by a factor of 50. The results are reported on borehole records. The pocket penetrometer is not covered by British Standards.

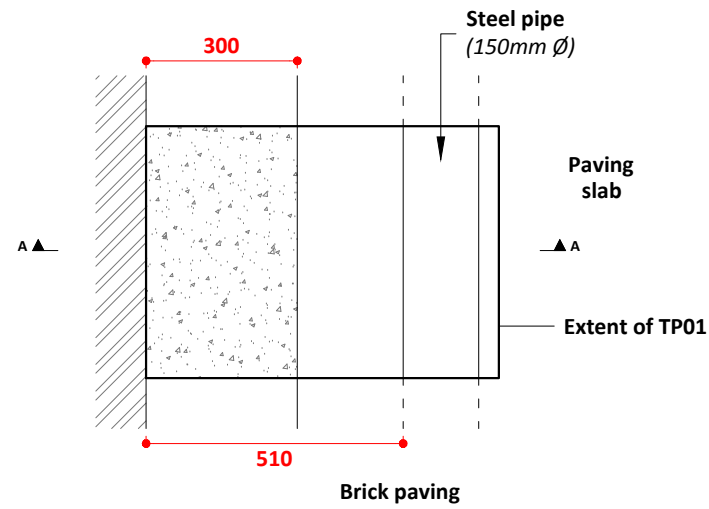
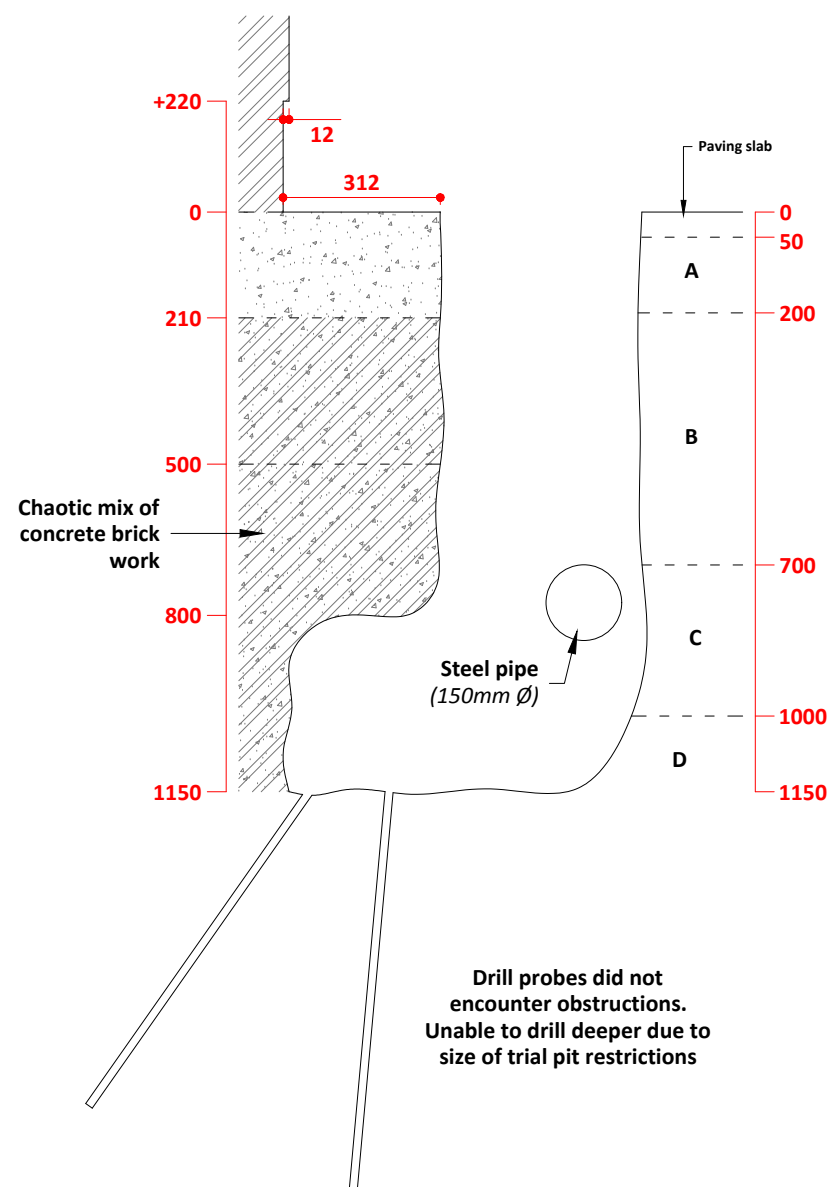
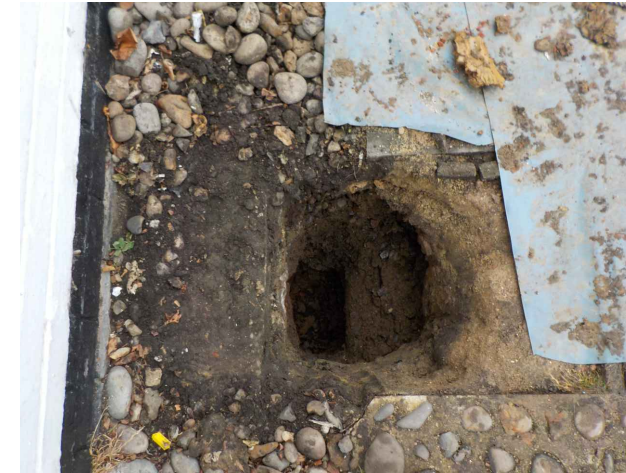
Location reference  
TP01  
Location plan on drawing number  
02  
Appendix  
D

- A. Loose dark brown slightly clayey slightly gravelly SAND. Gravel consists of fine flint. (MADE GROUND)
- B. Soft to firm grey brown gravelly very sandy CLAY. Gravel consists of fine to coarse sub-angular flint, brick and occasional concrete. (MADE GROUND)
- C. Firm to stiff brown gravelly very sandy CLAY. Gravel consists of fine to coarse angular brick and flint. (MADE GROUND)
- D. Firm orange brown slightly silty slightly sandy CLAY. (LONDON CLAY FORMATION)

Table summarising foundation arrangement observations				
Exploratory point	Depth of foundation	Projection from building line	Founding strata	Comments
TP01	1150	300	London Clay	150mm diameter pipe at approximately 700mm from surface. Solid concrete block footing to 210mm depth with unshuttered concrete footing to 500mm depth. Erratically placed concrete and brick from 500mm to 1150mm depth which includes a step in of approximately 200mm at 800mm depth.
TP02	600	140	London Clay	Concrete footing to 250mm depth with Erratically placed brick and concrete to 600mm depth.

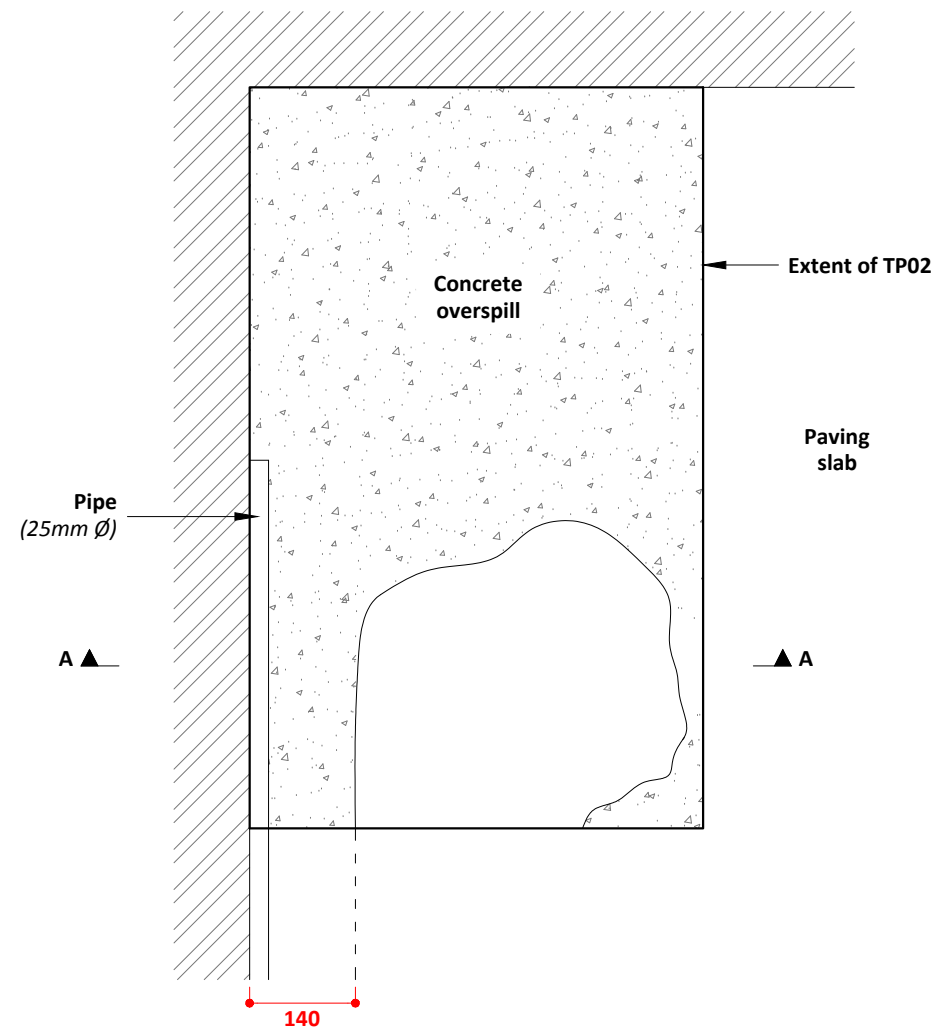
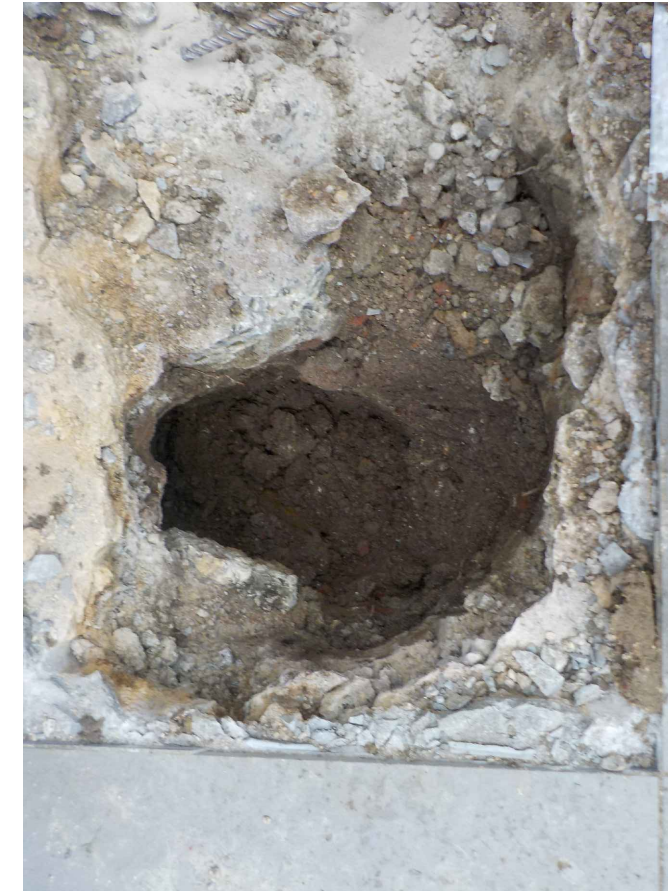
- A. Grey unreinforced CONCRETE. (MADE GROUND)
- B. Firm brown sandy gravelly CLAY. Gravel consists of fine to coarse brick, flint and concrete. (MADE GROUND)
- C. Firm orange brown slightly silty slightly sandy CLAY. (LONDON CLAY FORMATION)

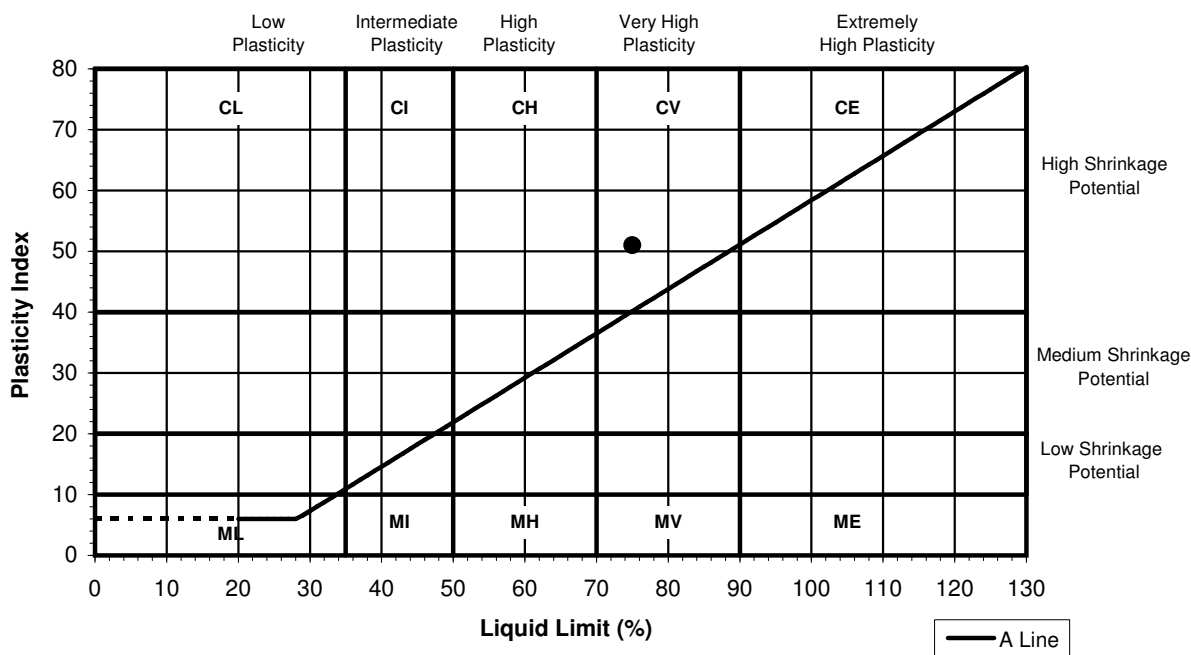
Laboratory Reference	Location	Depth (m)	As Received Moisture Content (%)	Liquid Limit (%)	Plastic Limit (%)	Plasticity Index	% Passing 425µm
45322568	DTS01	0.90	21	75	24	51	100

Certified that the laboratory testing was carried out in accordance with BS 1377-2: 1990: Method 3.2, 4.4 and 5

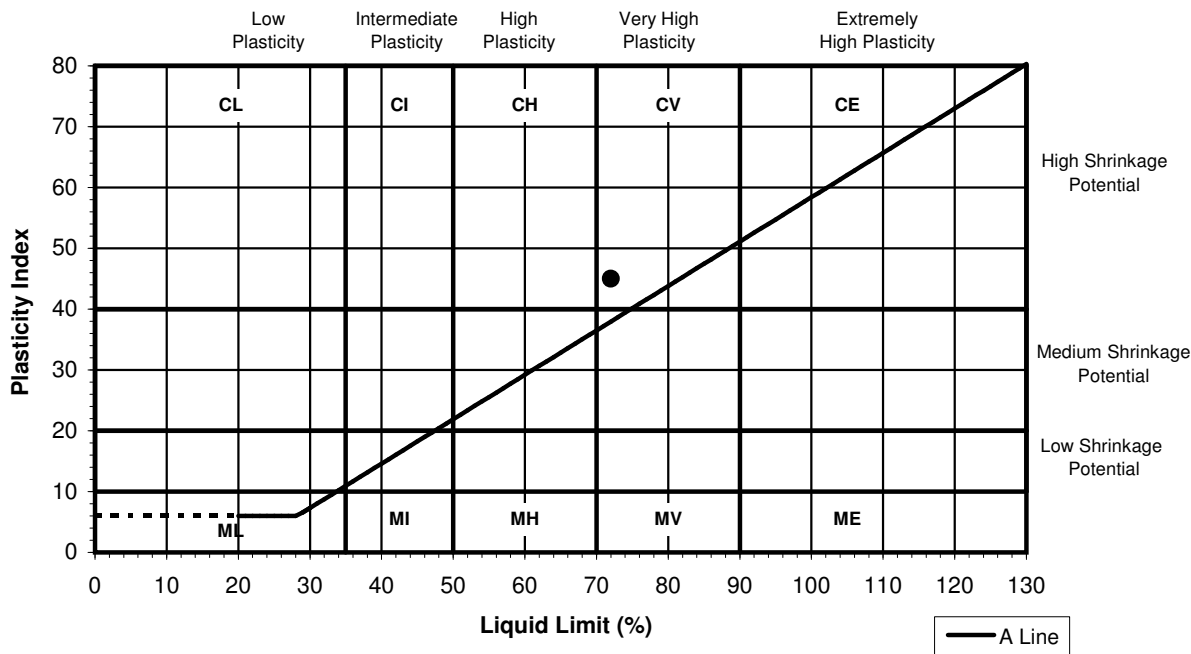
Laboratory Reference	Location	Depth (m)	As Received Moisture Content (%)	Liquid Limit (%)	Plastic Limit (%)	Plasticity Index	% Passing 425µm
45322569	DTS01	1.50	36	72	27	45	100

Certified that the laboratory testing was carried out in accordance with BS 1377-2: 1990: Method 3.2, 4.4 and 5

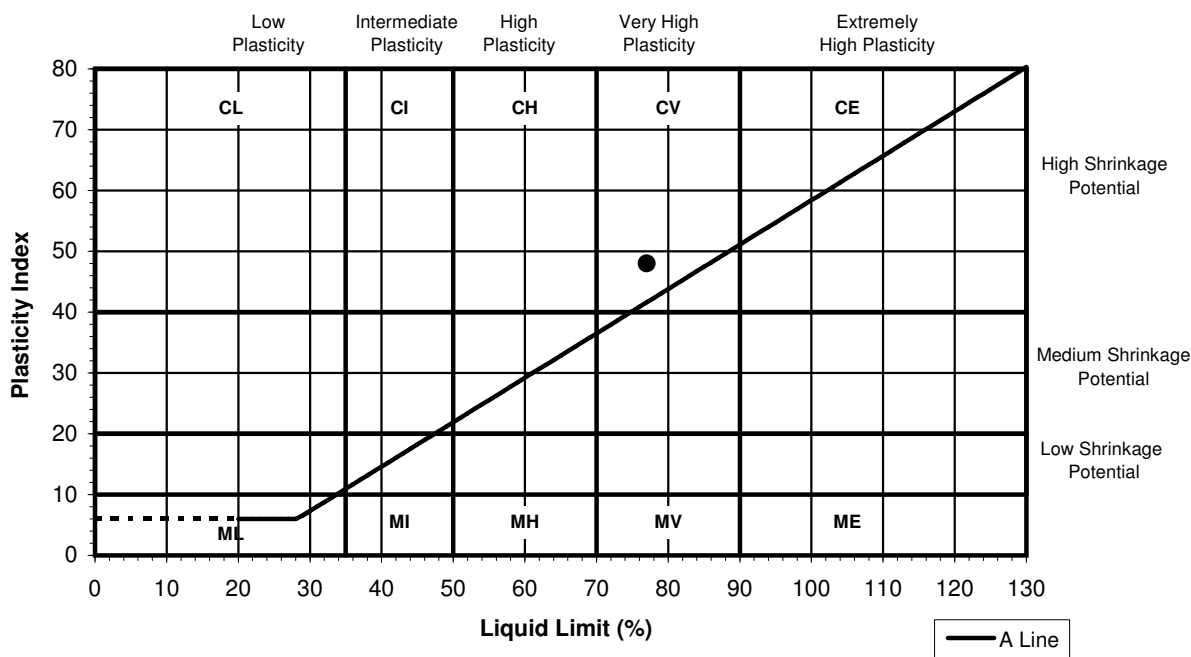
Laboratory Reference	Location	Depth (m)	As Received Moisture Content (%)	Liquid Limit (%)	Plastic Limit (%)	Plasticity Index	% Passing 425µm
45322570	DTS01	3.70	40	77	29	48	100

Certified that the laboratory testing was carried out in accordance with BS 1377-2: 1990: Method 3.2, 4.4 and 5

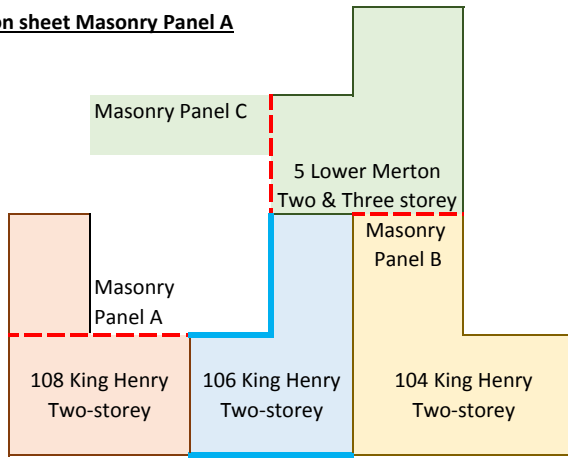
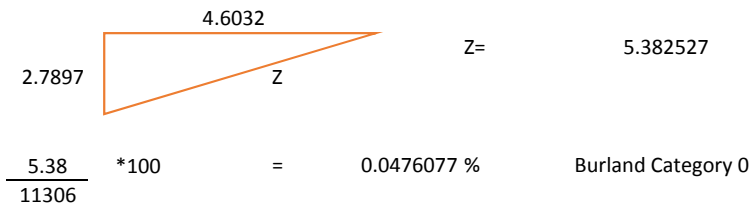
**Calculation sheet Masonry Panel A**

Dig depth (m)	3.5	Vertical		horizontal	
Inward yield (mm)	5.25	Radius (m)	Settlement (mm)	Radius (m)	Settlement (mm)
Surface settlement (mm)	3.5	0	3.5	0	5.25
		3.0625	2.625	3.5	3.9375
		6.125	1.75	7	2.625
		9.1875	0.875	10.5	1.3125
		12.25	0	14	0

**Masonry Panel A**  
Consider elevation of 108 King Henry Road - all measurements in mm

$\frac{5.38}{9764} * 100 = 0.0551262 \%$  Burland Category 1

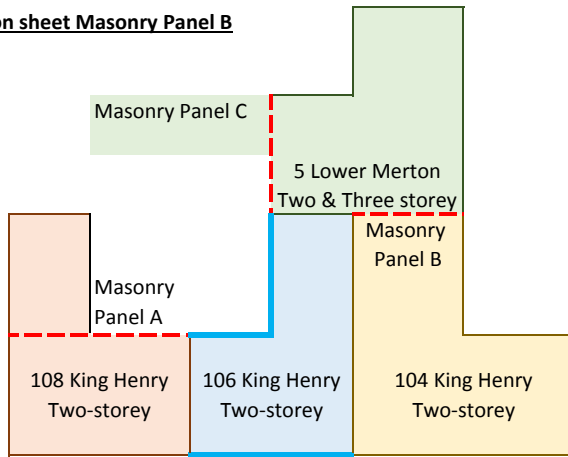
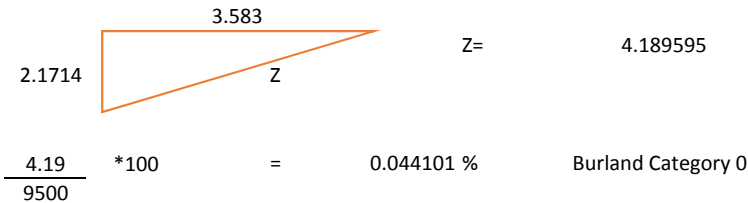
**Calculation sheet Masonry Panel B**

Dig depth (m)	3.5	Vertical		horizontal	
Inward yield (mm)	5.25	Radius (m)	Settlement (mm)	Radius (m)	Settlement (mm)
Surface settlement (mm)	3.5	0	3.5	0	5.25
		3.0625	2.625	3.5	3.9375
		6.125	1.75	7	2.625
		9.1875	0.875	10.5	1.3125
		12.25	0	14	0

**Masonry Panel B**  
Consider elevation of 104 King Henry Road - all measurements in mm

$\frac{4.19}{7600} * 100 = 0.0551262 \%$  Burland Category 1
