**26 Netherhall Gardens – Bat Survey Report**

Issue/Revision:	Draft	Final
Date:	August 2017	August 2017
Comments:		
Prepared by:	Emily Power	Emily Power
Signature:

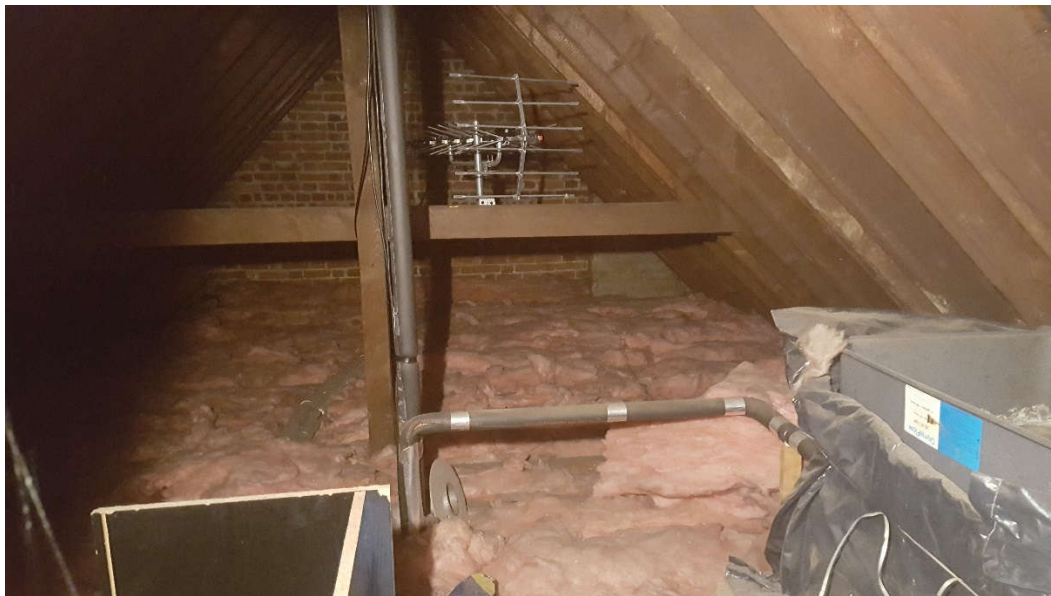
**Figure 1. Inside the loft space during the internal inspection**

- 1.3 An internal inspection of the loft space was undertaken in April 2017 which found no evidence of a bat roost within the building. Several potential roost features were identified on the exterior of the building, including gaps between tiles, missing tiles, and gaps under lead flashing around the chimney and dormer windows.

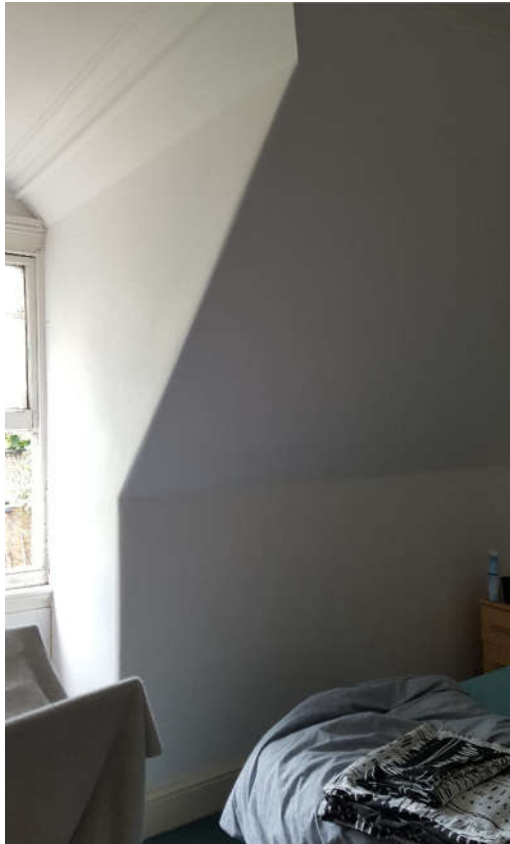
**Figure 2. The internal void at the south-east corner of the building on the top floor**

- 
- 3.17 It is not possible to access the internal void around the dormer window and chimney breast on the top floor in order to undertake an internal inspection in this area.

- 3.18 This does present a notable limitation to the survey methodology as the suspected roost was noted in this location. Given the absence of any access hatch however an internal inspection was not a viable option, without physically cutting a hole in the wall. On the basis that pipistrelles are roosting in this location this is not considered to significantly impact any conclusions drawn in this report however; pipistrelles roost in cracks and crevices and do not require open roof voids. No obvious access into the roof void in this location was noted, and it is assumed that the condition of the roof space in this location is similar to that elsewhere in the roof, with roofing felt in good order hindering access from external roosting features.

- 5.27 Access should be obtained into the internal void, which sits on the south-eastern corner of the building on the top floor, to allow an internal inspection to take place. This should also be undertaken in the winter months to minimise disturbance to any bats. Should any evidence of bats be found, or any egress/ingress points be found, this structure will need to be compensated for in the design of the new building to allow bats continued access to this space.

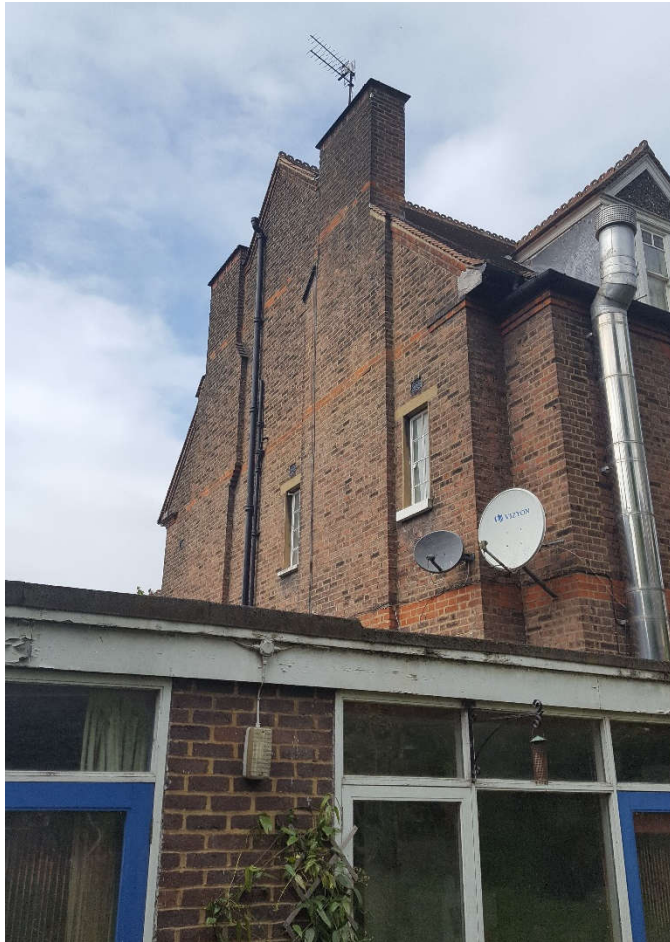
**Figure 3. View of the south-eastern side of the building, with confirmed roost under tiles next to the chimney**

- 4.6 The emergence and re-entry surveys undertaken at the application site confirmed the presence of a common pipistrelle roost under the lead flashing beside the chimney stack on the east side of the south face of the building. Three pipistrelles were observed emerging at this location during the first survey at 21:17, 21:23, 21:36 and on the 15/05/2017.

- 5.23 The removal of roof tiles and lead flashing should be undertaken by hand, under the supervision of a licenced ecologist. Bat boxes should be installed in an appropriate place in the garden so that it can be used for shelter in the event that a bat is found while tiles are being removed.
- 5.24 Bat boxes and bat tiles will be incorporated into the fabric of the new building as compensatory roosting space. These should mirror the specifications of the existing roost as far as possible, being of a similar height, on the same elevation. Additional bat boxes should be placed around the roof to maximise the likelihood of the bat boxes being used.
- 5.25 The figure below gives examples of bat boxes and bat tiles that can be seamlessly incorporated into the design of the new building.

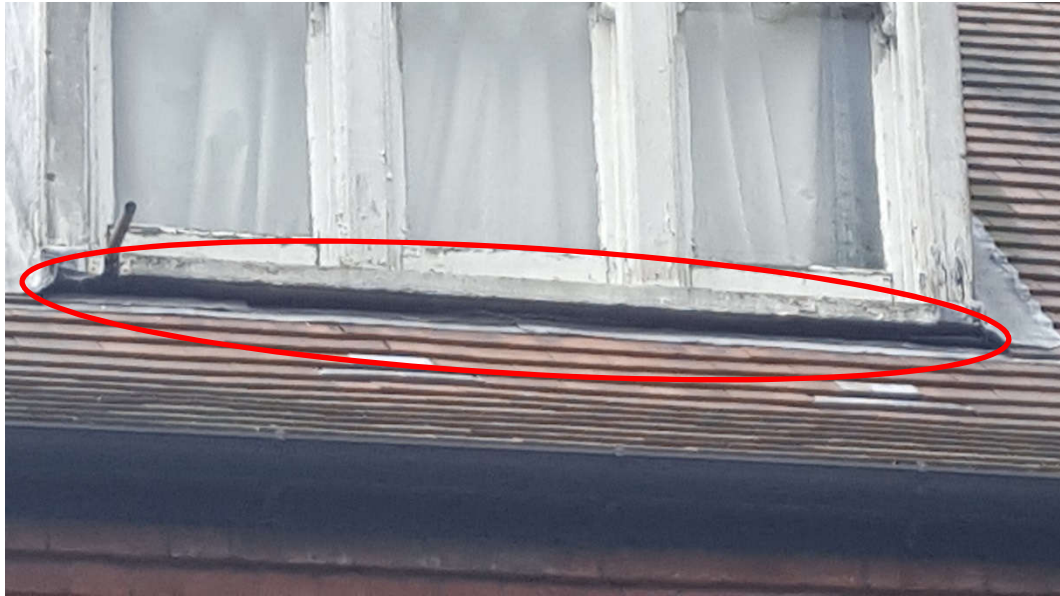
**Figure 5. Close up view of lifted flashing under the south-east dormer window**

- 4.9 A further bat roost is suspected under the lead flashing around the south-east dormer window, although this was only observed at one of the three surveys and was subject to some uncertainty. Five common pipistrelles were observed emerging from this area of the building, one at 21:12, and the other four in quick succession at 21:17 on the 15/05/2017.
