# REMIEDIATION PROPOSALS REPORT

Athlone House  
Hampstead Lane  
Highgate  
London N6

Client: Virtus Real Estate

J16075A

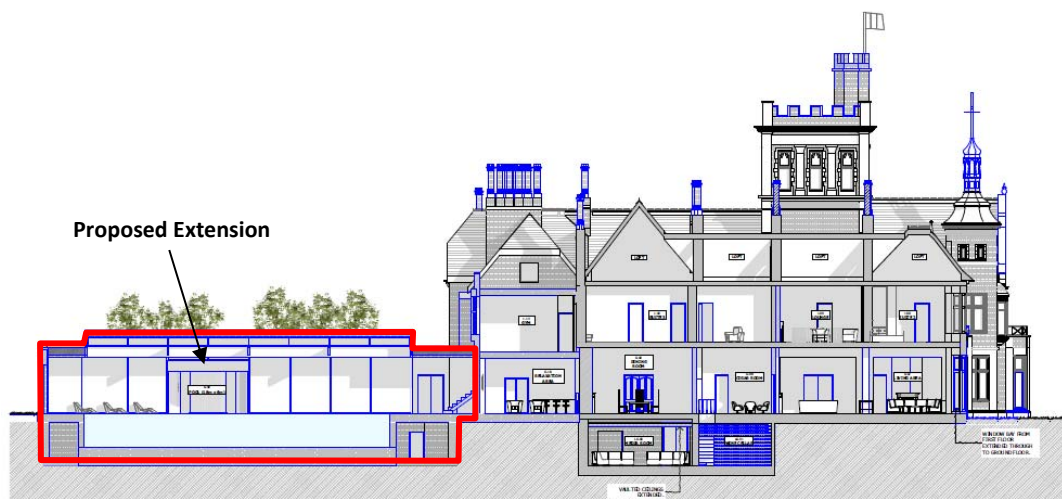
A proposed site layout plan is included in the appendix, whilst a cross-section through the new basement and swimming pool is shown below, along with an indicative image of the proposed natural water swimming pond.

Planning permission has been granted for the refurbishment and extension of the existing detached property, which will include the construction of a single storey rear extension that will house an indoor swimming pool within a single level basement. In addition to the works to the main house, permission has also been granted for the refurbishment and extension of two outbuildings along the northern boundary, in addition to a 2000 m<sup>2</sup> outhouse in the northwestern corner of the site and the conversion of a natural pond into a natural water swimming pond. This report is specific to the proposed development.
