PARLIAMENT HILL, CAMDEN

PHASE 1 DESK STUDY

PROJECT RECORD		
PROJECT NAME	PARLIAMENT HILL, CAMDEN	
CLIENT	FARRANS CONSTRUCTION	
REPORT DETAILS		
TYPE	PHASE 1 DESK STUDY	
REFERENCE	1522\GH\6-2016\493	
ISSUE DATE	JUNE 2016	
AUTHOR	GEMMA HEYWORTH BSc (Hons) CONSULTANT

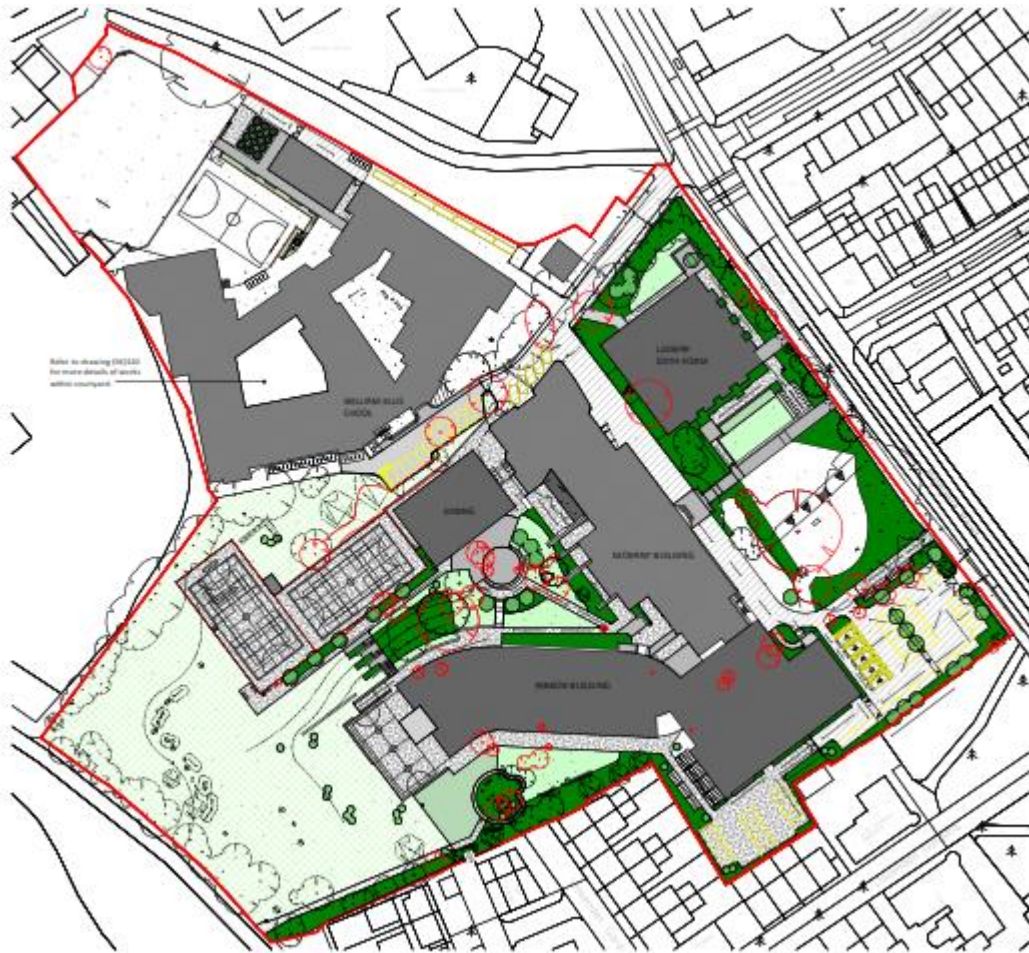
Figure 2: Proposed Site Layout

- 1.2 The site, irregular in plan, is centered at National Grid Reference 528369, 186019, and occupies an approximate area of 3.6 ha as shown in Figure 1. The site currently comprises William Ellis School and Parliament Hill School and is located within a predominantly residential area of north London, bordering Parliament Hill to the north and west. Farrans Construction requires this Phase 1 Desk Study to support a new planning application, involving the construction of several new school buildings and redevelopment of both school sites. It is understood that the proposed development may also incorporate single storey basement construction over portions of the site. The Northern William Ellis School site has a large building complex which will be subject to renovation and extension whilst the Southern Parliament Hill School site currently consists of a complex of large buildings, many of which are to be demolished and replaced. Figure 2 illustrates the proposed development scheme.

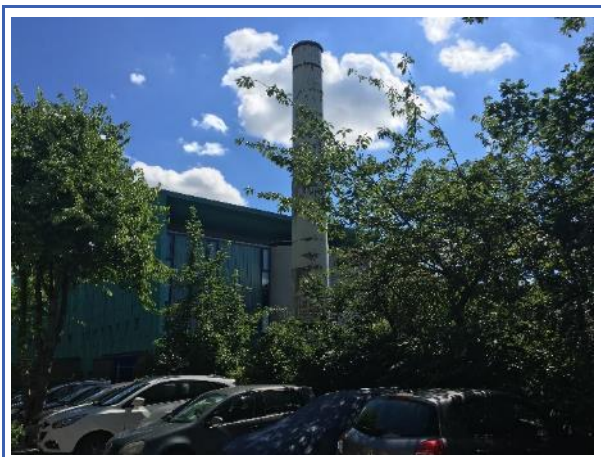
- 2.5 Heating and hot water is provided by commercially sized gas fired boilers located in plant rooms throughout the site. The basement plant room on the PHS benefited from a large chimney stack of concrete construction. The chimney is used to vent exhaust fumes from three commercial gas fired boilers, although the chimney could date to before them. No evidence of any incinerators were observed during the walkover. Air handling units located were located within the central 'Ribbon' building on the PHS site. Given the size of the boilers, an environmental permit for the venting of exhaust would not be required.

*Chimney Stack (PHS)*

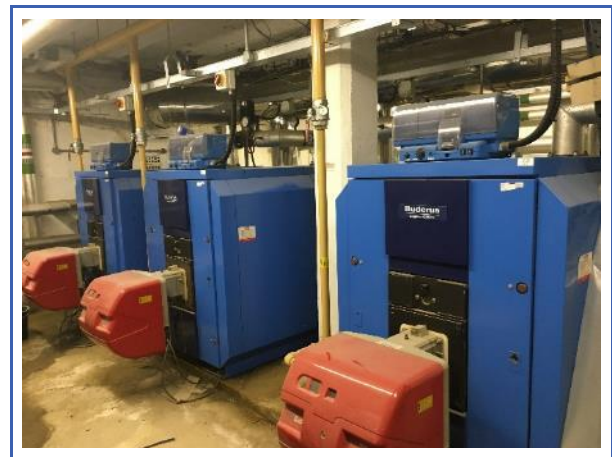
*Gas fired boilers (WES)*

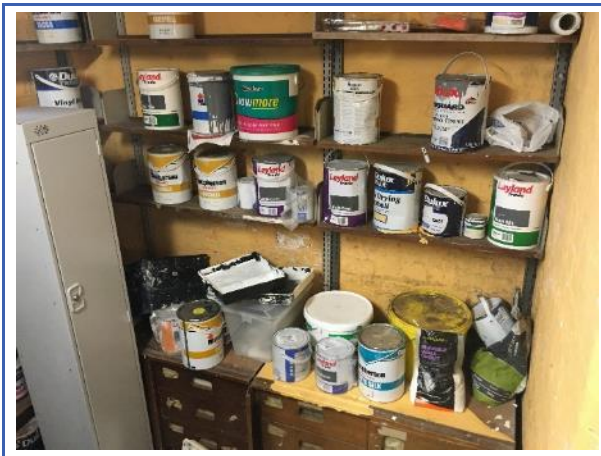
- 2.7 Within the PHS caretakers workshop was a small area of racking with various paints and thinners. A steel cabinet was also present with minor quantities of fuel (<5L) for small hand operated gardening tools).

*Paints and thinners (PHS)*

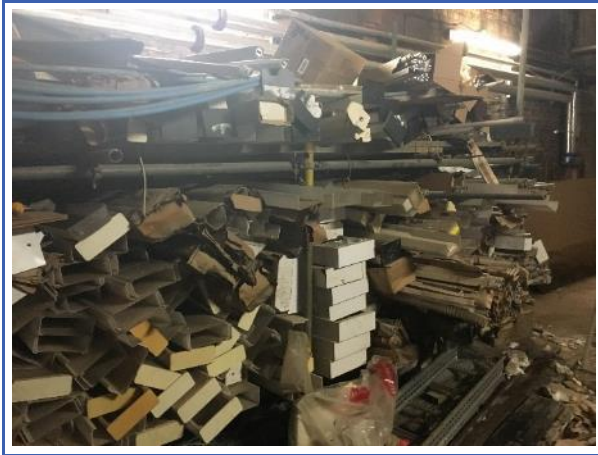
- 2.8 Cleaning chemicals were only kept in small quantities (<5L) at both sites within cleaning stores.
- 2.9 Florescent strip lights are used within the various buildings. The spent florescent tubes are stored in a waste storage 'coffin' within the service yard and are removed from site by a specialist contractor when the coffin is full. Within a basement room at PES racking was present with an estimated 200 spent tubes that were historically deposited there. Spent

fluorescent strip lights generated in quantities over 200kg per annum (approximately 500) will require them to be collected as hazardous waste

*Waste fluorescent tubes (PHS)*

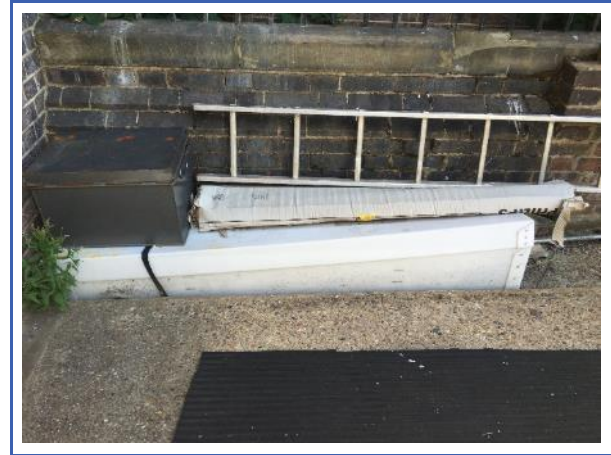
*Fluorescent tube coffin (PHS)*

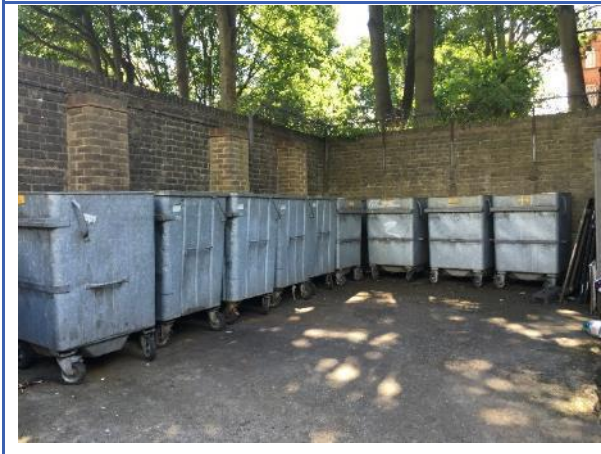
- 2.12 Based on the site use, potentially contaminative waste streams are not considered likely. General domestic type waste is likely stored in small volumes for regular collection by an appointed and licensed waste contractor. Bin stores are located in the south of the PHS and central east of the WES. Housekeeping was noted to be good with no evidence of contamination arising from the storage of waste.

Waste Storage (PHS)

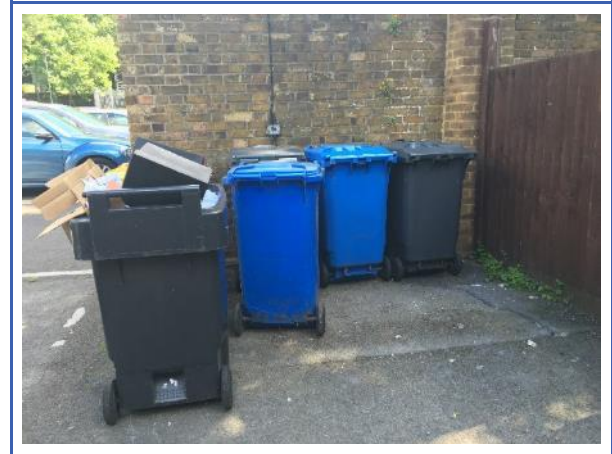
Waste Storage (PHS)

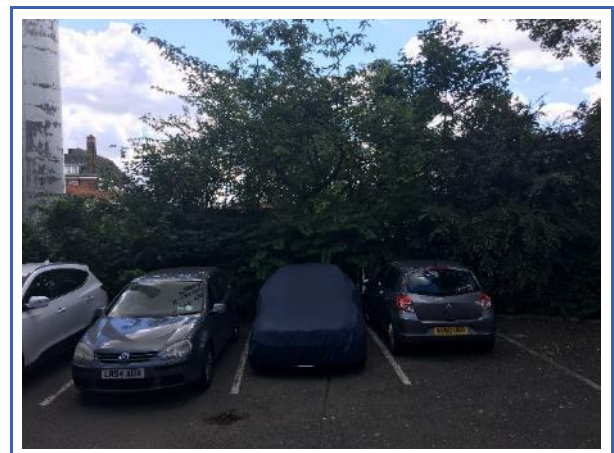
- 2.18 Two stands of Japanese Knotweed were observed at on the PHS site. A large stand was located along the southern boundary between the party wall and the gymnasium. It could not be confirmed if the JKW had spread off-site (public open space accosted with residential flats) although considered highly likely. A second stand was observed on the northern boundary fence between PHS and WES. No other invasive species (e.g.Giant Hogweed, Himalayan Balsam) were identified during the site walkover, however the site visit conducted does not constitute a full 'injurious weeds and invasive plants' survey.

*Stand of JKW north of PHS (Photo taken from WES)*

- 5.3 The two stands of Japanese Knotweed should be assessed and appropriately treated by a competent professional.
- 5.4 If future works are to be carried out in the location of the redundant high voltage cable, then the cable should be carefully removed or capped to ensure that it is not damaged and no oils escape.
