RESULTS OF A 24-HOUR NOISE LEVEL SURVEY
CARRIED OUT AT THE REAR OF THE RETAIL PREMISES
LOCATED AT 196-198 HAVERSTOCK HILL, LONDON NW3
AND A REPORT ON THE NOISE CONTROL MEASURES
REQUIRED TO MINIMISE THE NOISE IMPACT
OF THE PROPOSED NEW EXTERNAL PLANT

Client: CL14 Ltd/Watts Group Limited
Project: 196-198 Haverstock Hill, London NW3
Emtec Ref: QF9140/PF6025/RP1
Issue Date: 7th August 2017

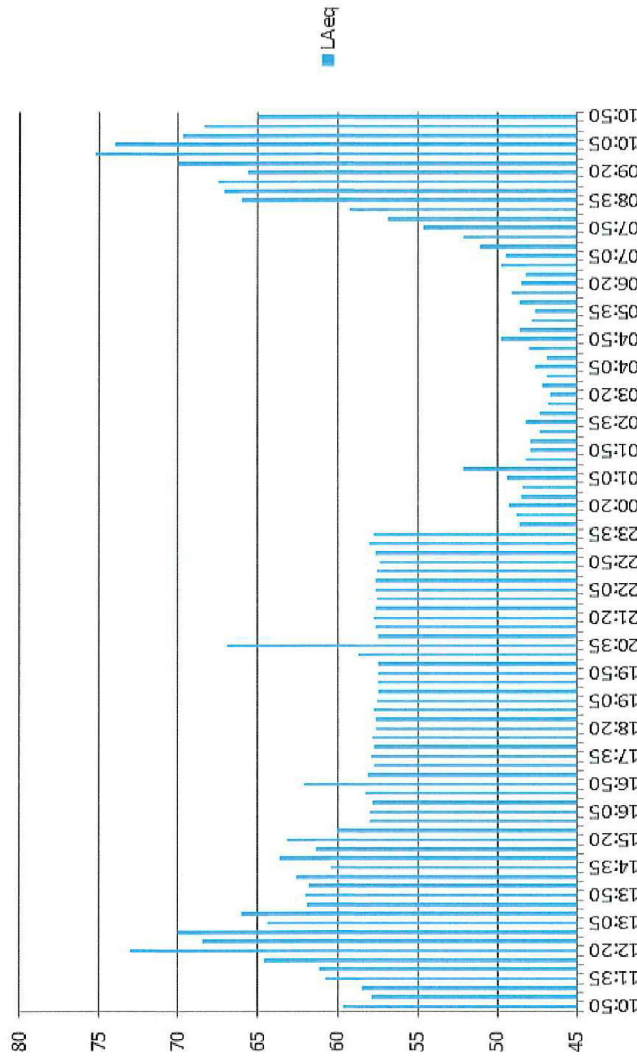
<div> Unit L, Turnpike Way, High Wycombe Bucks HP12 3TF Tel: 020 8848 3031 Fax: 020 8573 3605 </div> </div>							
			REVISION							
CLIENT: CL14 Ltd	PF No: 6025	APPROVED BY: MGR	A	B	C	D	E	F	G	H
			SKETCH No. QF/9140/T1							
PROJECT: 196-198 Haverstock Hill, London NW3	Q	A	M	I	DESIGN AUTH: MGR

The 'A' Weighted Leq levels measured over each 15 minute interval throughout the 24-hour period (denoted by LA_{eq} , (15 mins)) are displayed as a bar graph on the attached Sketch No QF/9140/T1 at the back of this report.

TITLE: LAeq Levels	ISSUE DATE: 03/08/2017	DRAWN BY: MGR	<div>

As can be seen from the LAeq noise levels (see sketch No.QF/9140/T1) the plant operated from approximately 8am to 23.35pm and the steady noise of the ventilation fan was equivalent to a noise level of just over 57dBA.

The LA90 background noise levels were also equivalent to approximately 57dBA during the same time period.

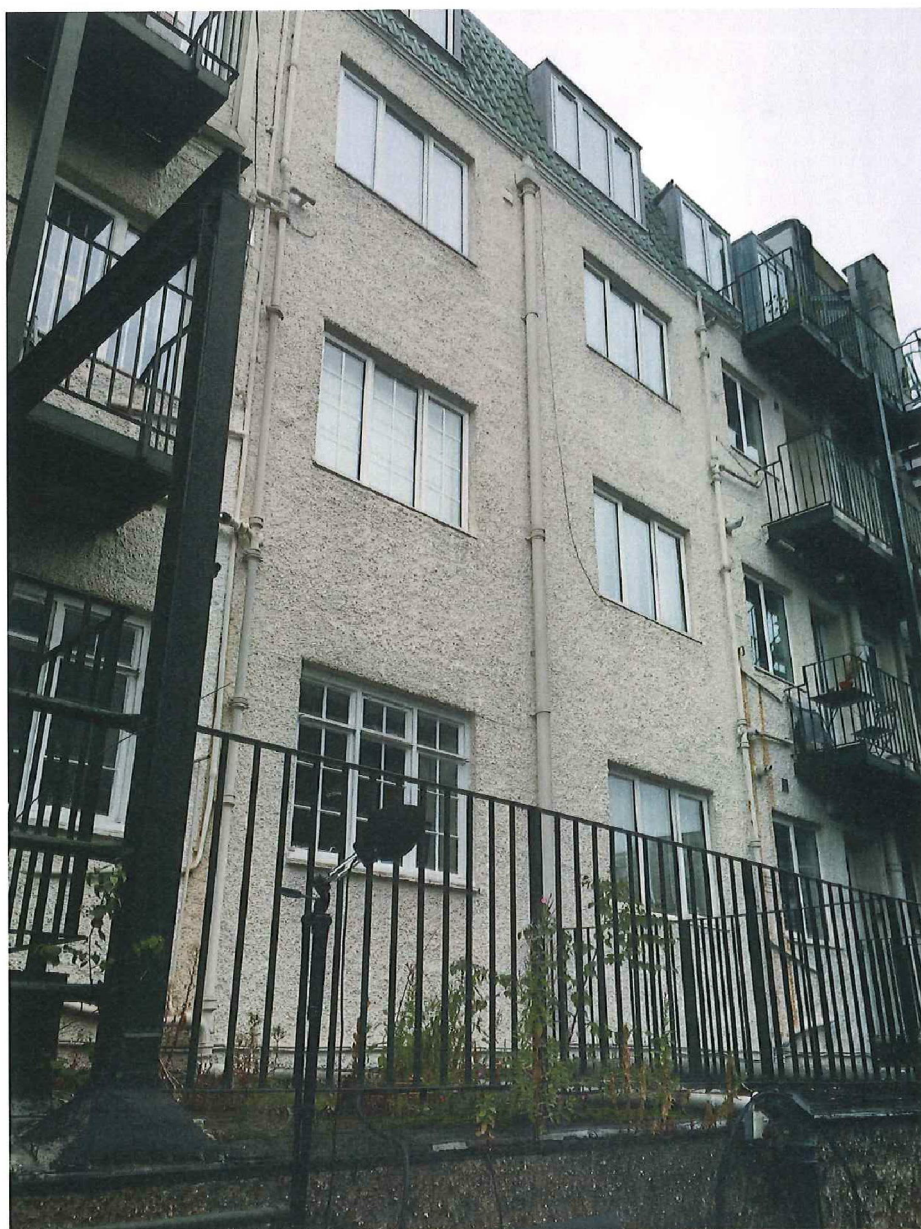
Noise levels were measured at a position on the first floor roof of the rear part of the building that is adjacent to the rear service road. The photographs A and C show the microphone attached to the railings at the back of the first floor roof and in front of the windows of the residential flats.

The microphone was fitted onto a boom that was attached to the metal railings and was approximately 2 metres above the roof surface. The rest of the measurement equipment was located in weatherproof enclosures with low impedance cables running from the microphones to the instrumentation.

Photo A – Location of Microphone Next to Railings in Front of the Residential Flats Over the Rear of the Ground Floor Retail Units at 196 Haverstock Hill, NW3

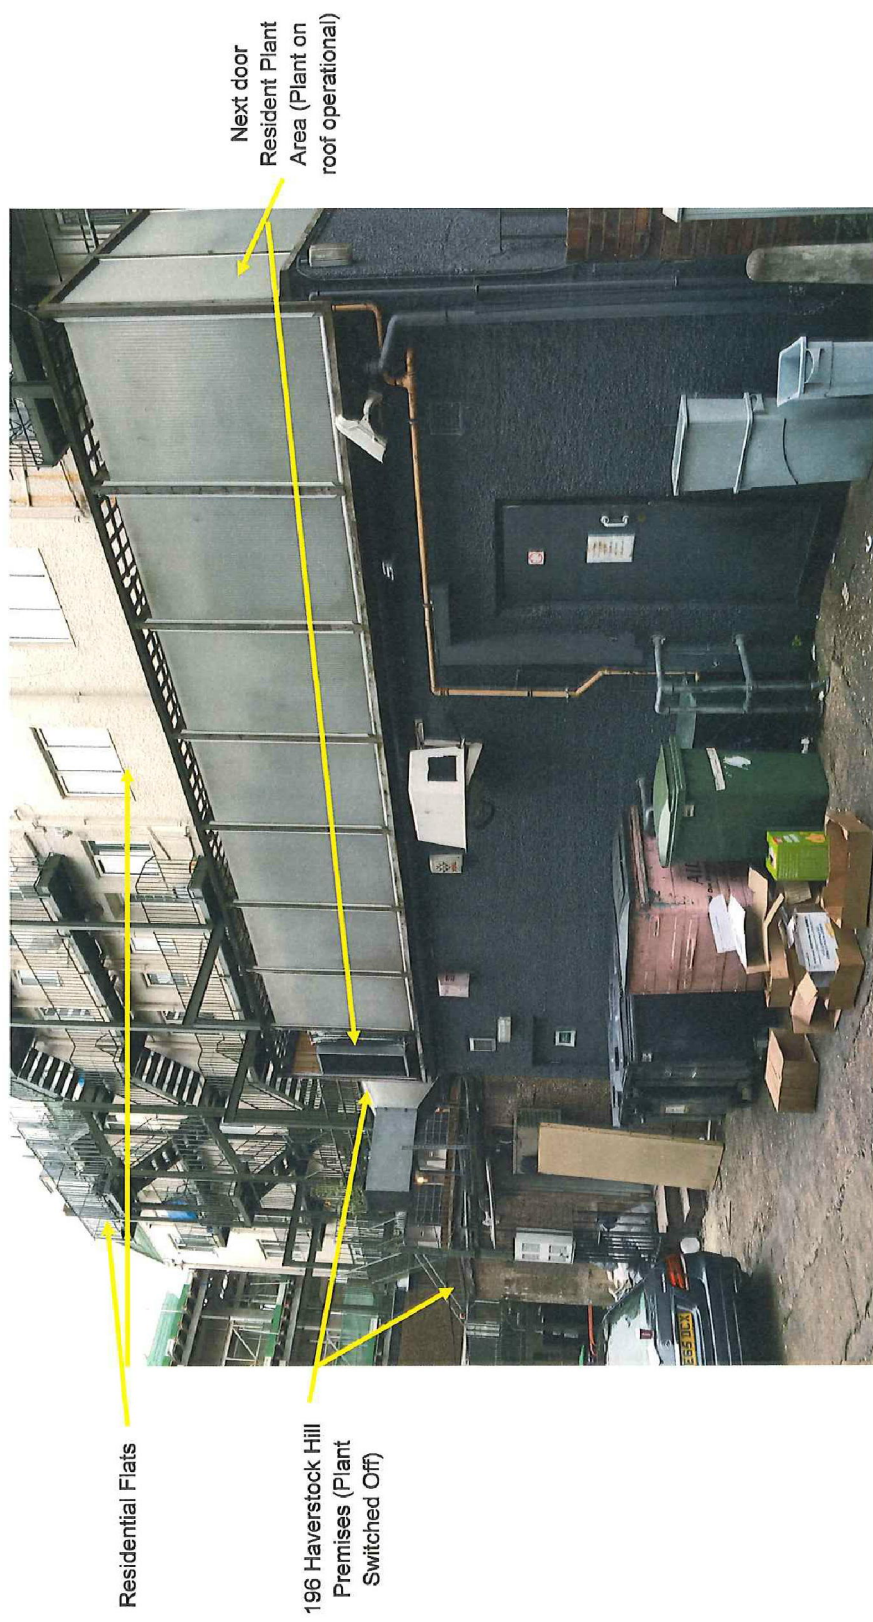
Existing air conditioning condensers and ventilation plant, associated with the next door restaurant, are mounted onto the rear first floor roof (see photo B) and these units were operating at the start and finish of the survey.

Photo B – Rear of Ground Floor Retail Units Showing Plant on First Floor Roofs & Residential Flats Behind

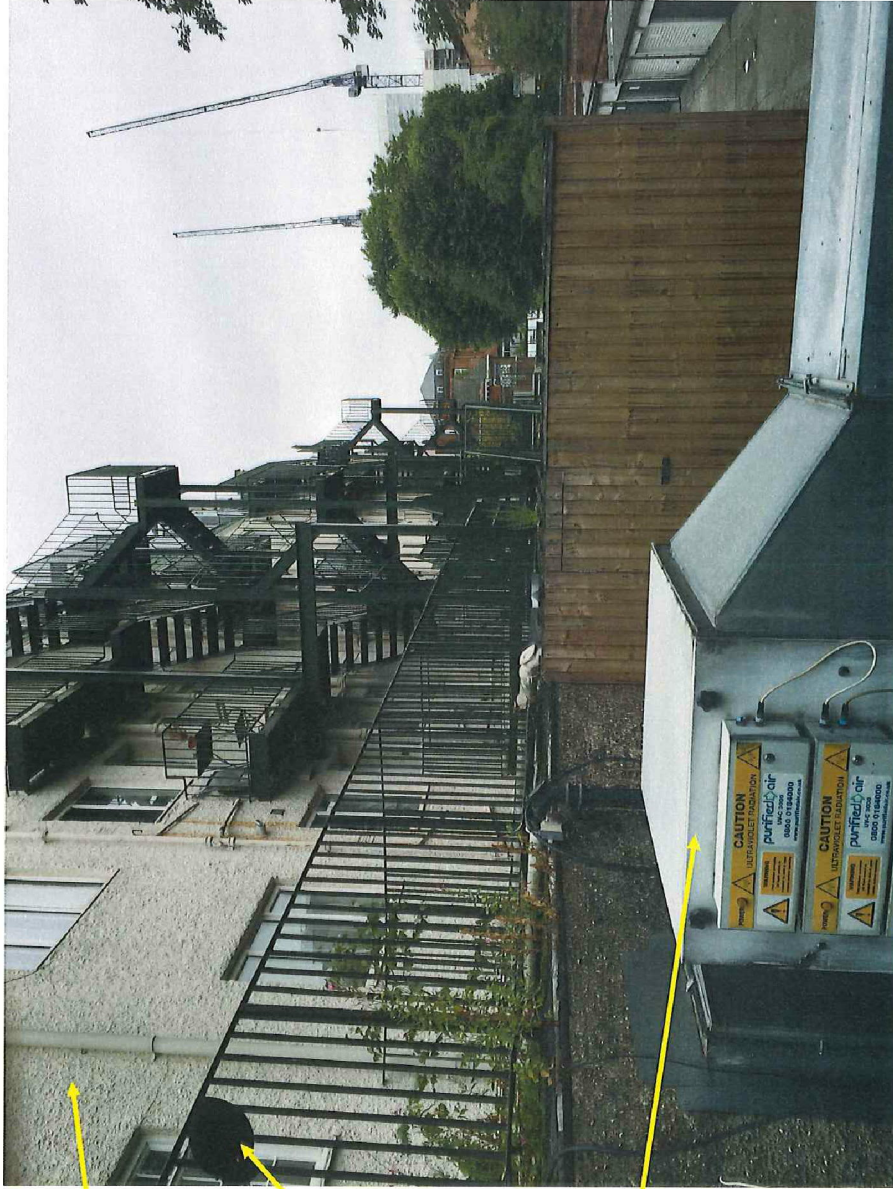
Residential Flats

Microphone

Redundant Plant
Associated with
196

Photo C – View from 196 Haverstock Hill Roof Looking North West Along Rear of Ground Floor Retail Units

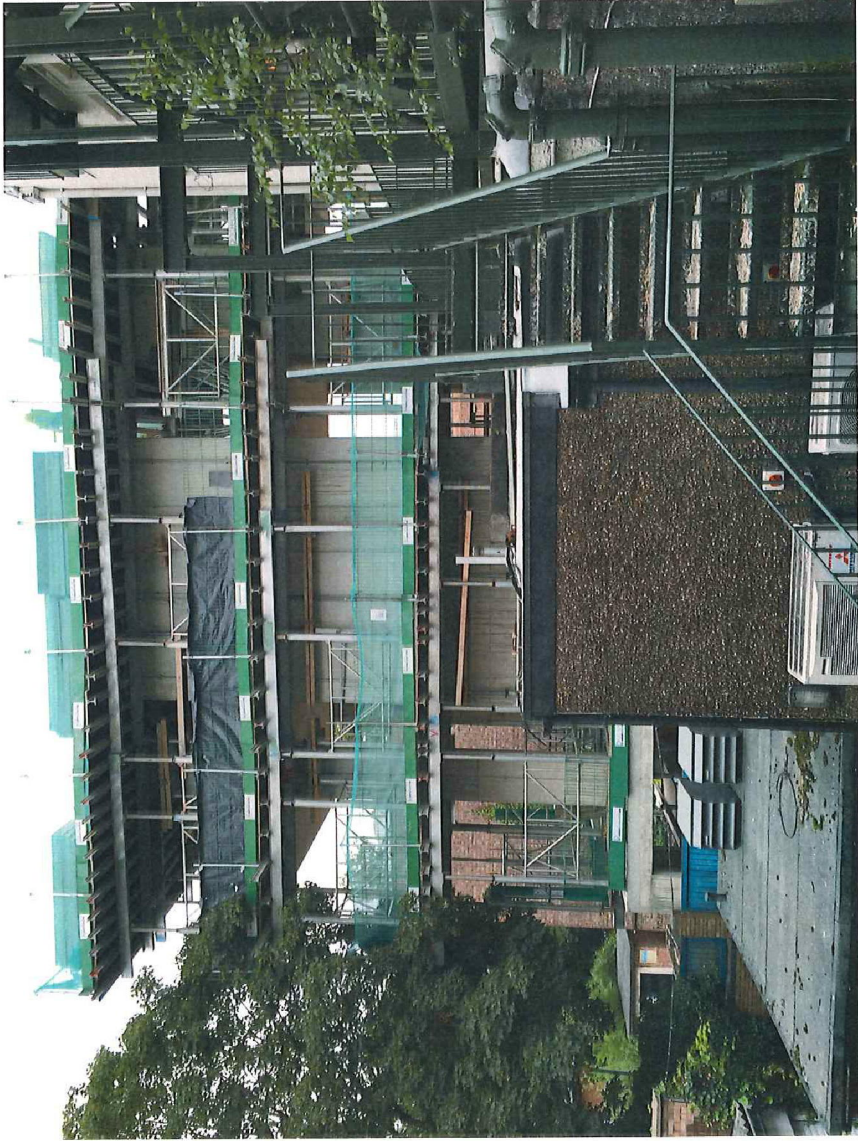
There was construction work being carried out on the new residential development at the end of the rear service road (see photo D) so daytime noise levels will be affected by the noise from these operations.

Photo D – View from 196 Haverstock Hill Roof Looking South East Towards New Residential Block of Flats

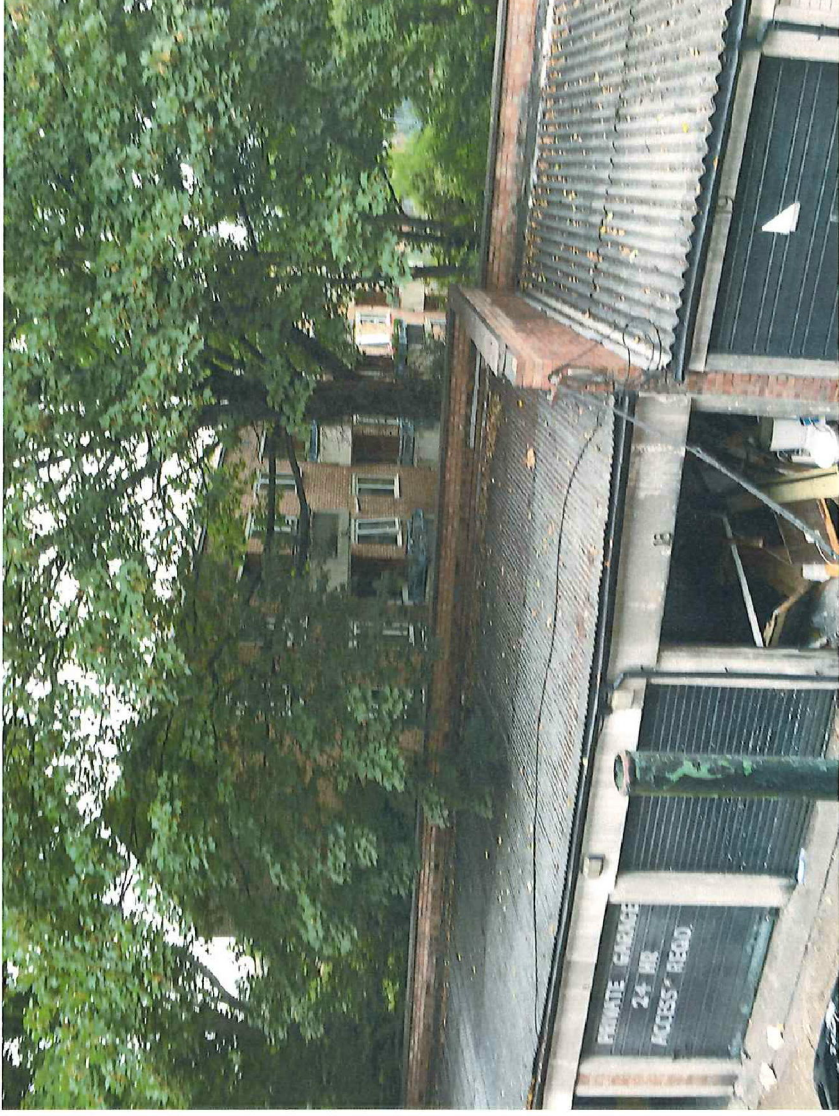
Photo E – View from 196 Haverstock Hill Looking East Towards Residential Properties off Aspen Grove
