Part Dismantling and Rebuilding of Front Facade Justification Statement

125 Clerkenwell Road, London EC1R 5DB

October 2017

Monahan Blythen Hopkins Architects

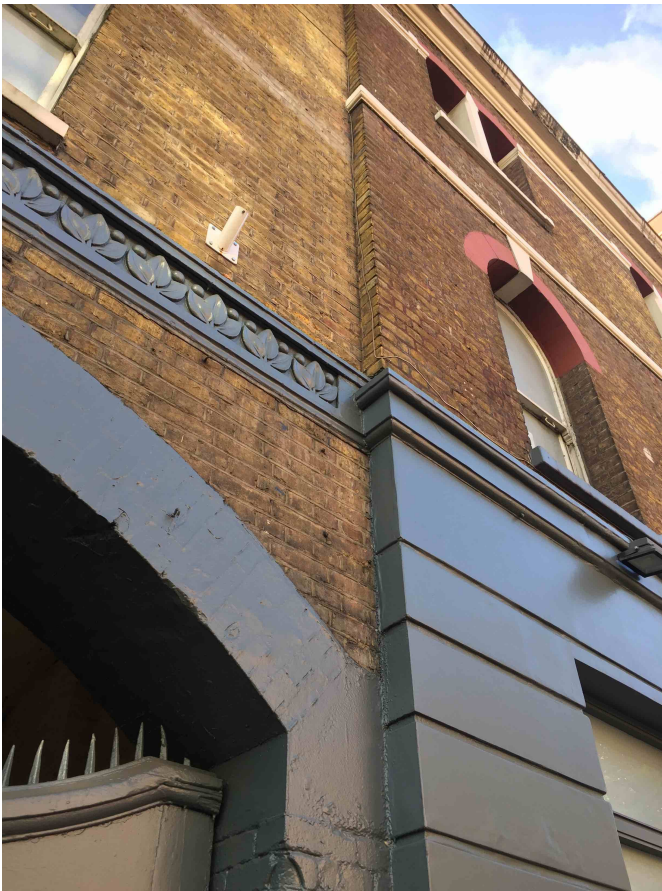
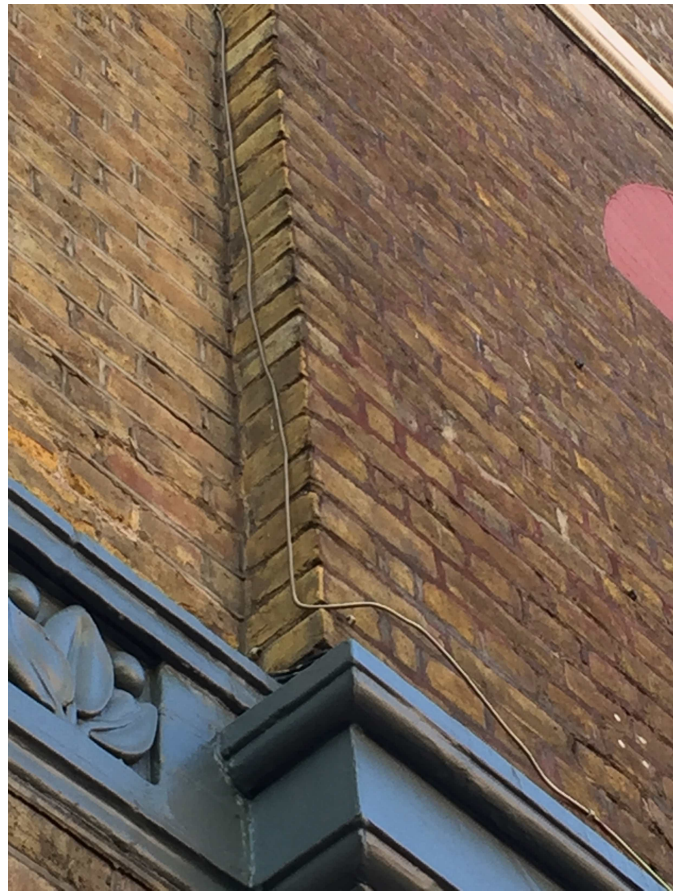
Two images of the junction of the undercroft section of facade to the left and remainder of facade at right. Note the half brick set back and marked contrast between the appearance of the brickwork due largely to the red mortar at right. In the more detailed image, note the poor condition of the red mortar joints

The brickwork to the undercroft section is also different in appearance having a lighter mortar to the brick joints as opposed to the red mortar to the adjacent main facade which has created a significant contrast in the appearance of the brickwork of the two different elements. The red mortar to the main part of the facade is in poor condition and is not original.

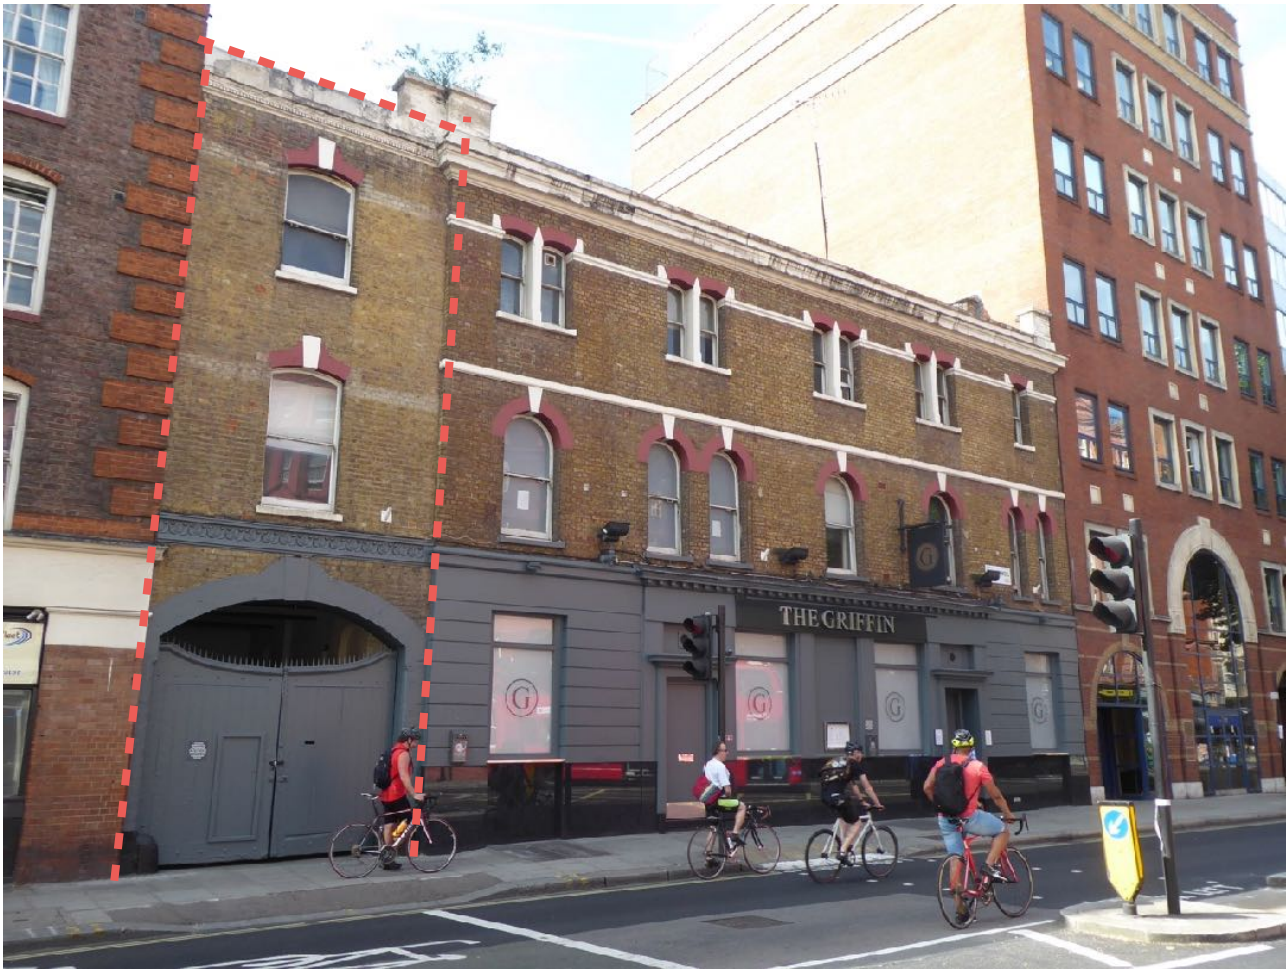
Front facade of 125 Clerkenwell Road showing the infill section in the context of the full elevation. The proposed section of the facade to be dismantled and then re-built is the eastern-most section of the elevation (within red dotted line) which is set back by half a brick.

To the east end of the facade is the indented section where the arch and undercroft giving access to the rear yard (originally the brewery rear yard). As is clear from the photographs included in this report, the architectural language of this indented section of facade differs considerably from the more decorative and charming language of the rest of the facade, although at some time it appears that two bands had been painted onto the brickwork now only visible as two faint smudged horizontal bands to the heads of both the first and second floor windows (see attached photographs).

Notwithstanding the less architecturally attractive treatment of the indented undercroft section, as previously set out in the design and access statement of this application, it is proposed that this section of facade is carefully dismantled and the existing bricks, cills, decorative frieze, keystones as detailed on the application drawings are carefully set aside and placed in safe storage until they are required to be re-used to rebuild this section of facade.

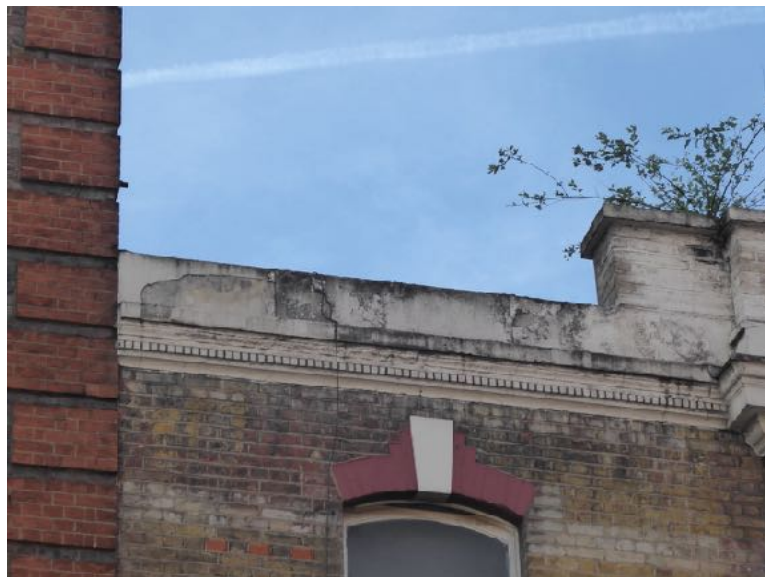
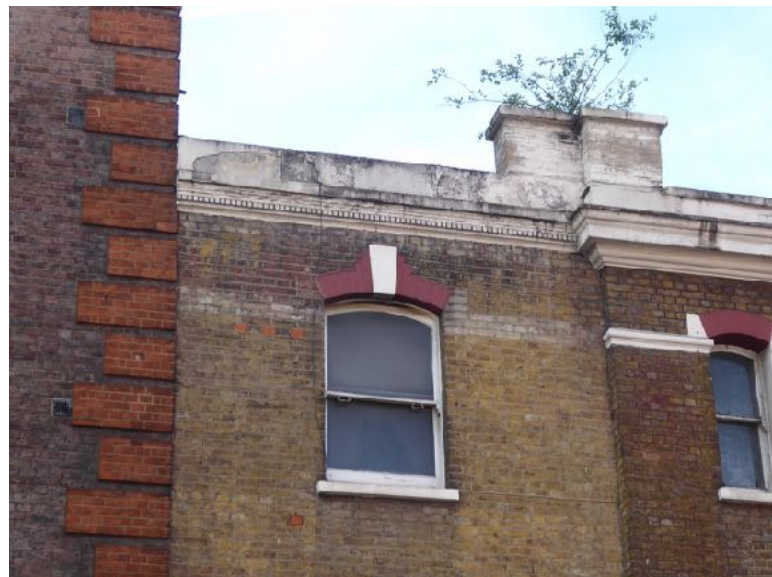
Photographs looking up at the parapet and dentil featured cornice, and second floor window head. Note the patchy historical brick repairs to the wall with red brindle bricks. Note also the smudged areas where the decorative string bands had been painted onto the brickwork.

It is possible to observe that there have historic repairs to the indented facade section as there are patches where red brindle bricks have replaced the yellow stock bricks, particularly at the top left hand section below the parapet cornice.

As set out in the Design and Access document, due to the poor condition of the cornice and parapet, it is unlikely to be possible to reuse the elements which make up this feature so it is proposed that this would be replaced to exactly match the existing one including the dentil detailing to the cornice.

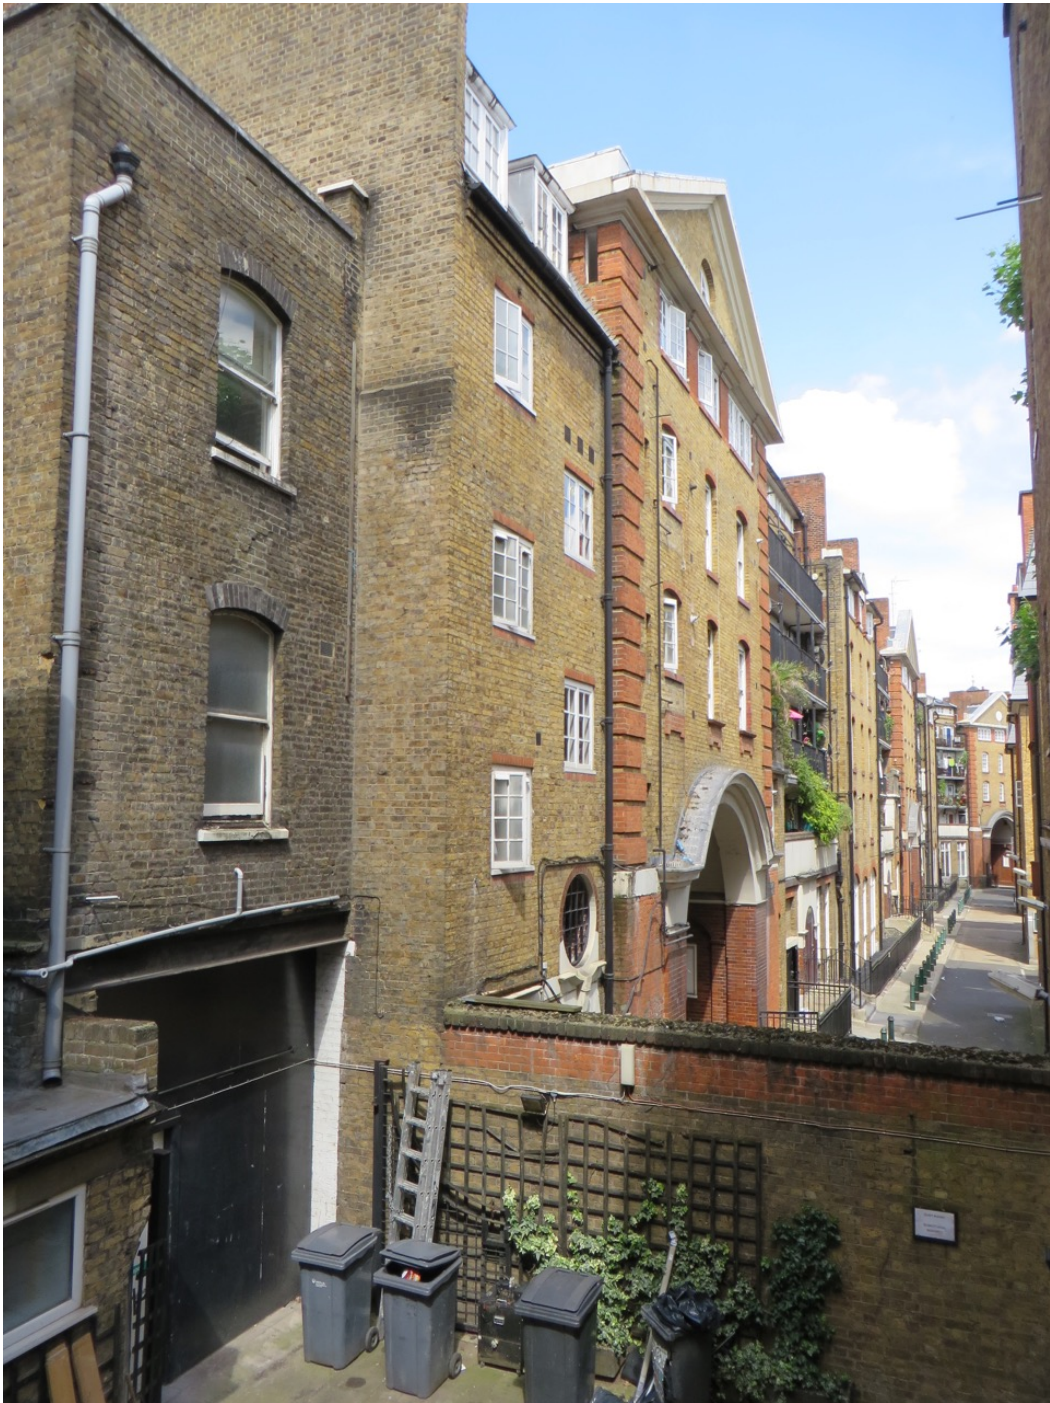
Rear view of infill element illustrating that it was built up against the flank wall of 123 Clerkenwell Road and showing the steel beam supporting the upper floors which spans onto a pad stone built into the flank wall of the adjacent property.

It can be observed that the section of the building adjacent to the flank wall of 123 Clerkenwell Road is partially supported off a steel beam to the rear yard side that spans on to the flank wall where a pad stone has been built into the wall of this neighbouring property see photograph on page 10). Also, at the street side, it appears that the projections of brick quoins to the front wall of 123 Clerkenwell Road have been cut to the corner where the public House meets the flank wall at roof level (see page 9). These elements of building work indicate that the infill section of facade forming the undercroft was therefore in all likelihood built after 1909 once 123 Clerkenwell Road was completed.

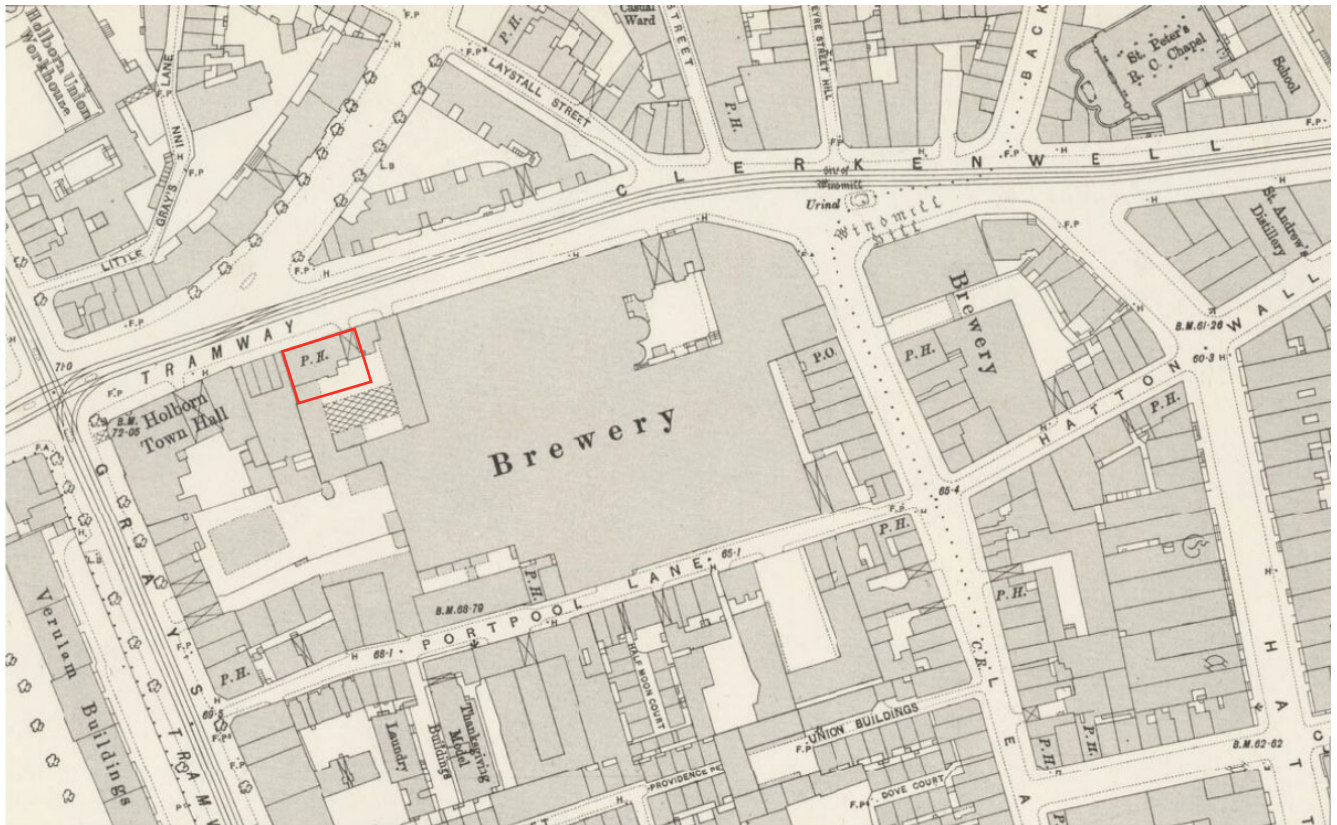
Map B: Map of the site dating from 1896. Note that by this time the public house on the original site had been demolished and had been replaced with a new building providing an undercroft for access to the large yard behind the public house. Also note how the cottages to the rear of the site have been demolished as has Crown Court itself with the access road to this now built on by the brewery.

On the 1896 map (map B), the mews terraced housing had been demolished to make way for further expansion of the brewery and The Griffin public house is now in its current location. By this time, a substantial yard to the brewery is situated to the rear of the public house and the map indicates that a building with an undercroft had been built providing access to the yard from Liquorpond Road as it was no longer possible from Crowns Court road which had by now been developed on by the brewery.

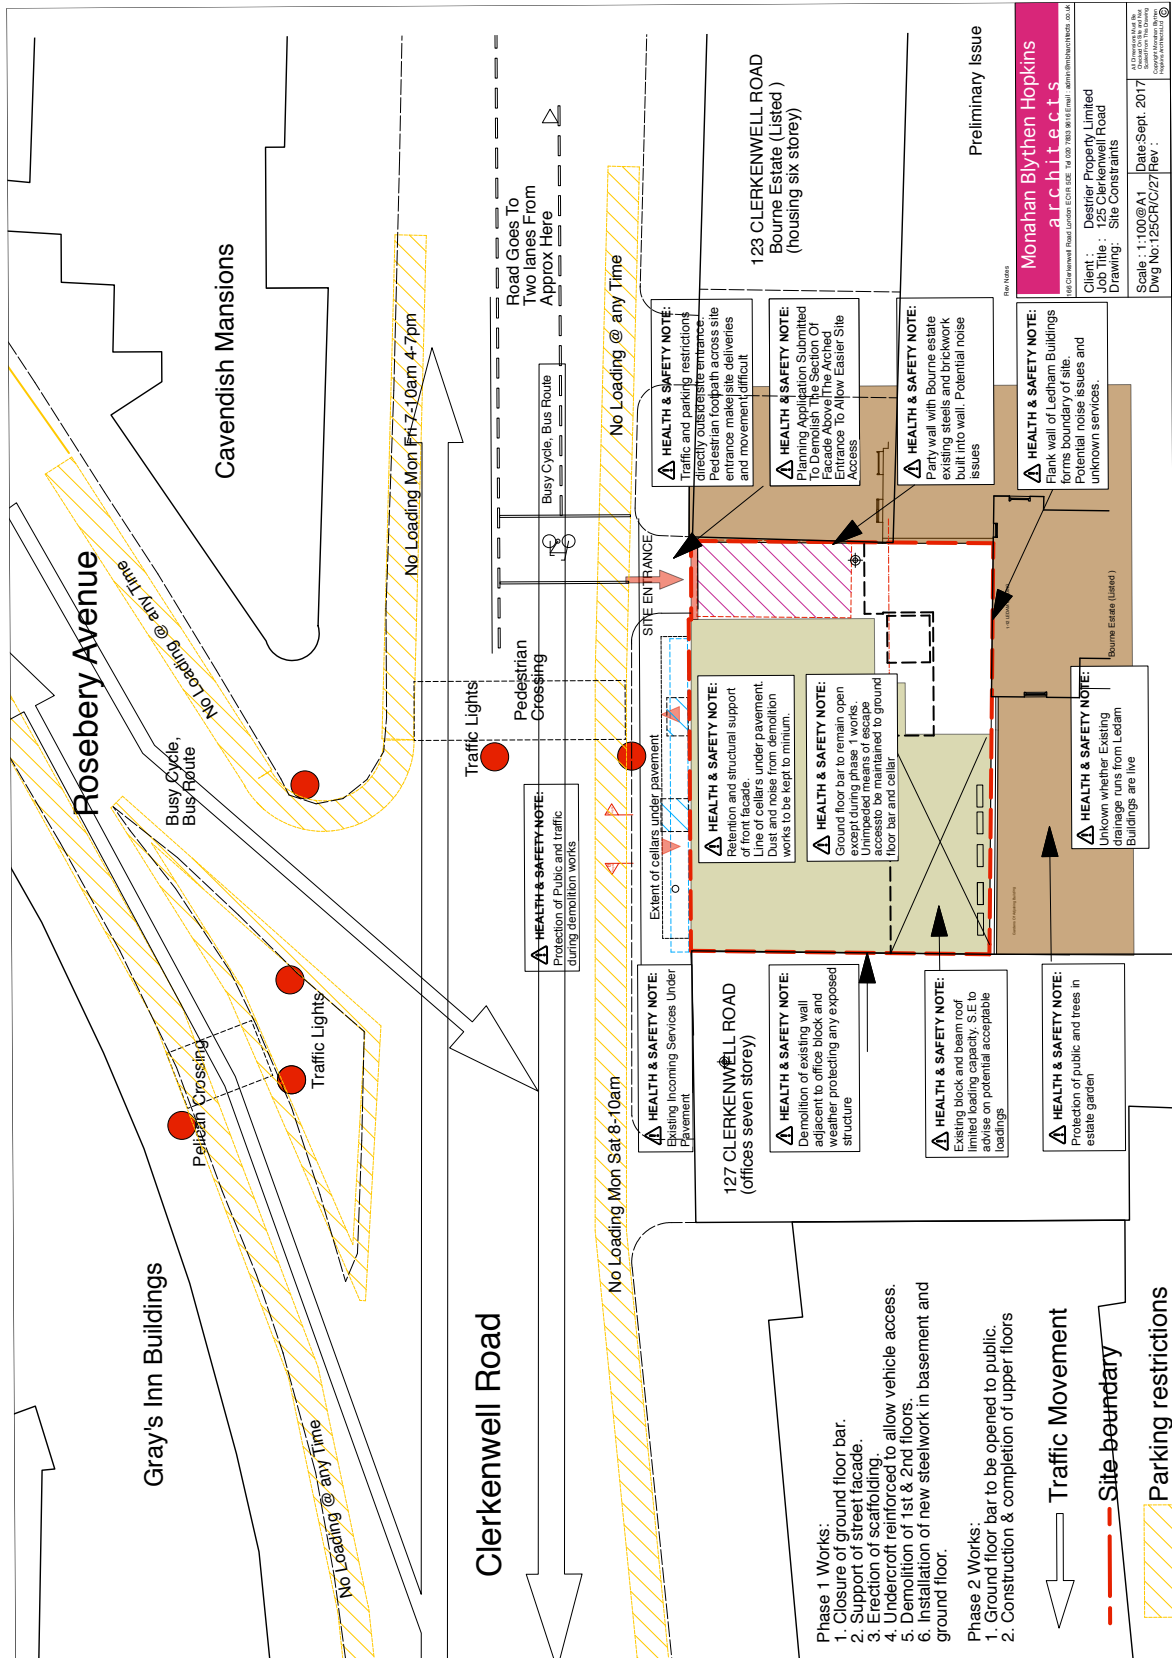
9. Site Constraints Plan

Plan showing the constraints of the site including issues of health and safety identified for the site including issues of access to the site and the support of the front face during the building works.

The site is located on Clerkenwell Road which is a Transport For London route and is immediately adjacent to a set of traffic lights and a pedestrian crossing close to the junction with Rosebery Avenue. This is a busy cycle and bus route and loading is restricted in front of the building and around the site at any time (refer to site constraints drawing on page 14).
