SITE

EXISTING

Present Day

Schedule of Significance

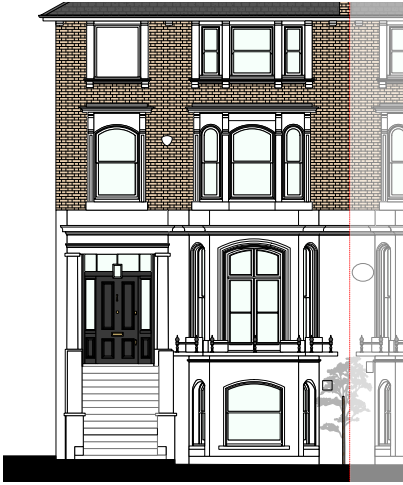
Figure 4.1 Existing Front Elevation. **Figure 4.2** Existing Rear Elevation **Figure 4.3** Existing Garden Section **Figure 4.4** Existing Garden Section **Figure 4.5** Existing Garden Room Side Elevation **Figure 4.6** Existing Garden Room Front Elevation **Figure 4.7** Showing the retention wall facing the Rear Elevation **Figure 4.8** View of the Existing Garden Room

The property is a semi-detached four storey dwelling house comprising the whole No 14, including a front and a rear garden and a studio dwelling at the rear of the garden. The house is faced in stucco at the lower ground and ground floor level with projecting porches supported by iconic columns and with yellow stock brick used on the upper floors.

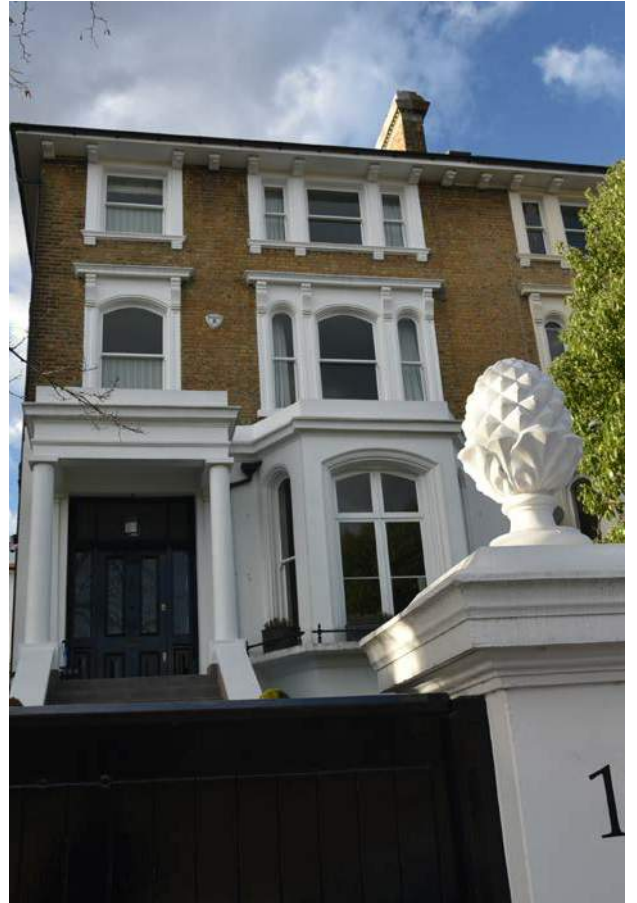
Figure 4.9 View of the front Elevation **Figure 5.0** View of the back Elevation **Figure 5.1** Existing Garden Room **Figure 5.2** Showing the existing staircase and balustrade **Figure 5.3** Showing the Rear Garden **Figure 5.4** Dining Room

The current property forms a part of a group of imposing and consistent group of villas along Eton Road. The similarities in frontage, mass and form between the property and its neighbours mean that the current property has a strong historic character to its front facade. For this reason most of the proposed alterations will take place internally and at the rear.
