RESULTS OF A 24-HOUR NOISE LEVEL SURVEY CARRIED OUT ON THE SECOND FLOOR ROOF AT THE REAR OF THE OFFICE BUILDING LOCATED AT 114-118 PARKWAY, CAMDEN AND A REPORT ON THE NOISE CONTROL MEASURES REQUIRED TO MITIGATE THE IMPACT OF ANY PROPOSED NEW EXTERNAL PLANT

Client: Project: Peter Deer Associates/Gazelle London 114 -118 Parkway, Camden, London NW1

QF9100/PF6036/RP1

25th August 2017

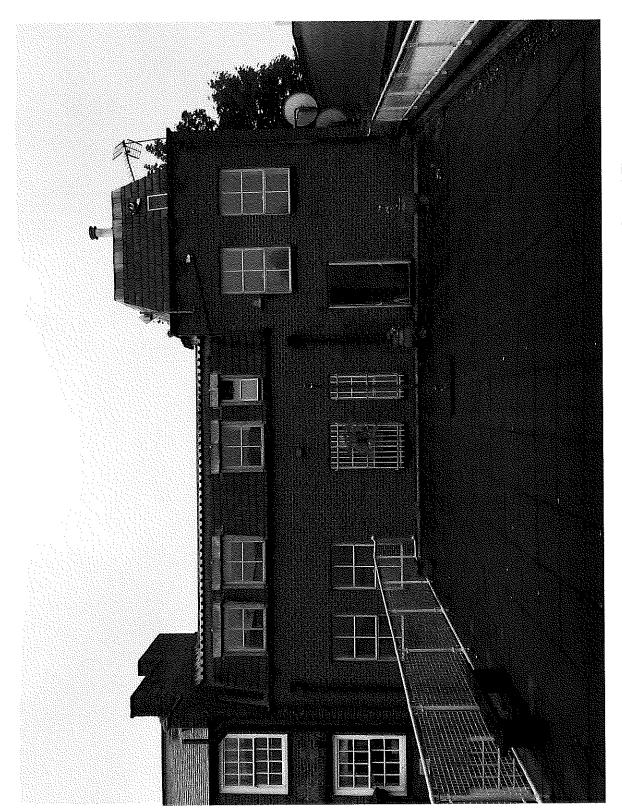
Photo B - Rear of 114-118 Parkway with Large Flat Roof Area on the Second Floor

The front of the building is shown on the attached Photo A. The rear elevation of the building and the second floor flat roof area are shown on the attached Photos B to F.

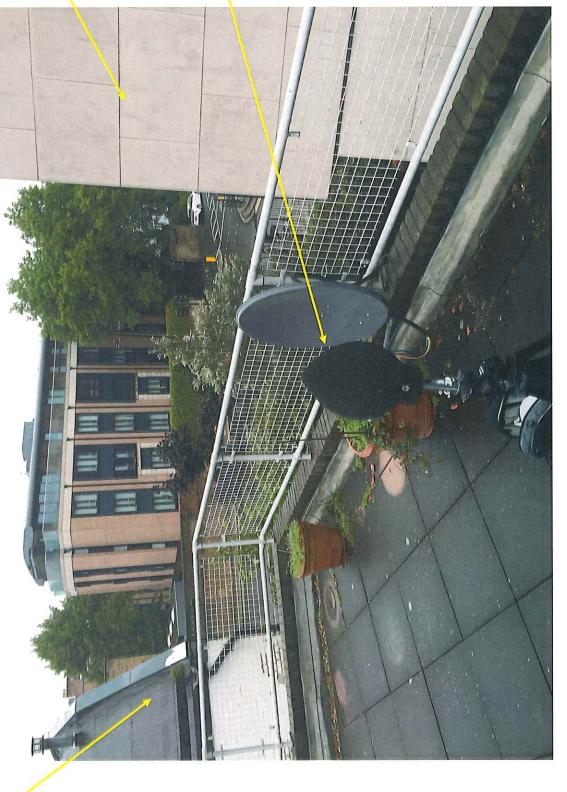
Photo E - Microphone Location with Oval Road/ Gloucester Avenue Intersection Behind

The location of the microphone is shown on the attached Photos C, D and E.
