The following has been prepared in connection with listed building consent and planning application for the alteration and refurbishment of 55 Gray's Inn Road, particularly in understanding the age of the rear closet wing.

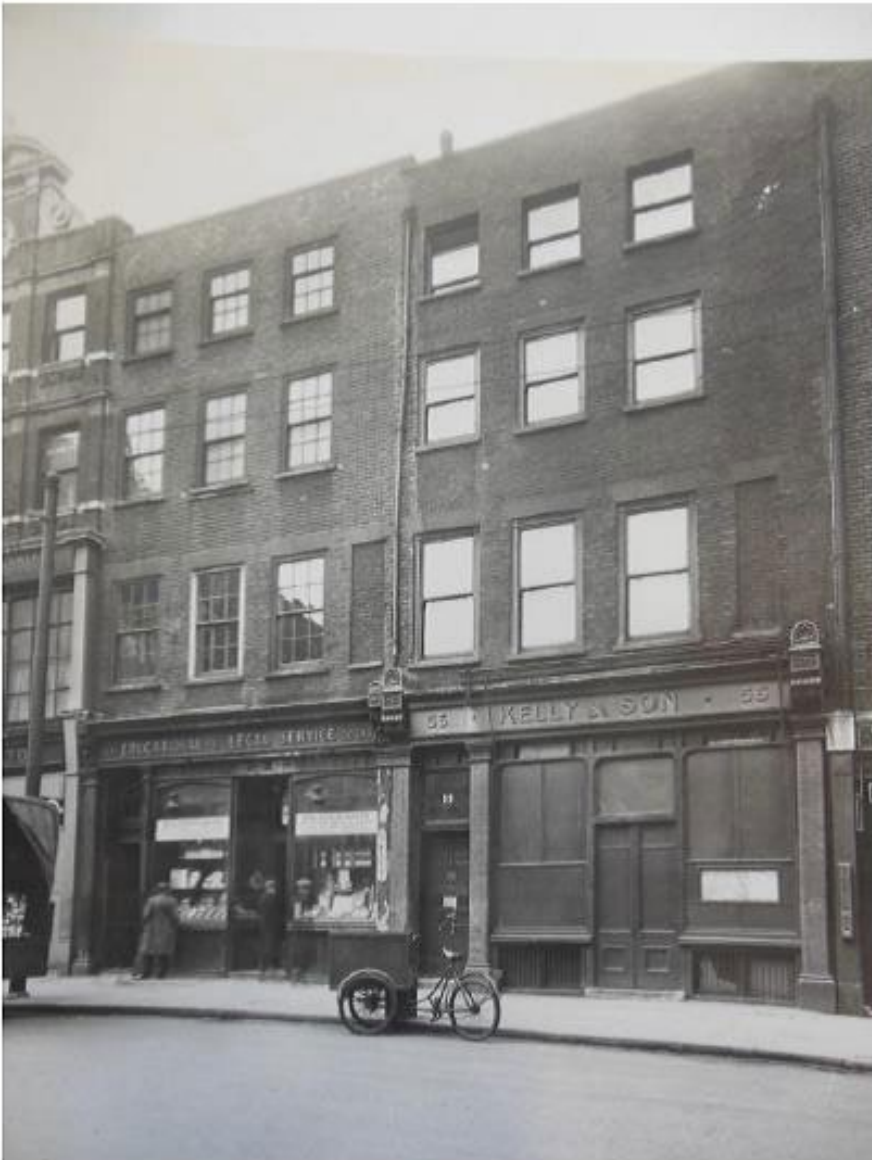
- Image 1 is a photograph taken circa 1946 of 55 Gray's Inn Road, which shows its relationship to its neighbour and counterpart number 53 (later to be demolished and redeveloped in the 1970s).
- Both share a very similar front elevation with closely matched window proportions and the notable blind half window detail of number 55. This photograph implies that the two buildings followed a standard form for that part of the road and terrace.
- Drainage application plans for number 53 (Image 2) from the late 19th century show a similar floor layout and building proportion to that of number 55. Notably these plans show the rear-closet wing rising to a flat roof at first floor level. Although this does not confirm that the two buildings were identical it suggests a degree of consistency between the two.
