**Basement
Screening and Scoping Report**

**5 Back Lane, Hampstead,
London, NW3 1HL**

Ref: 18649/R1.1

October 2017

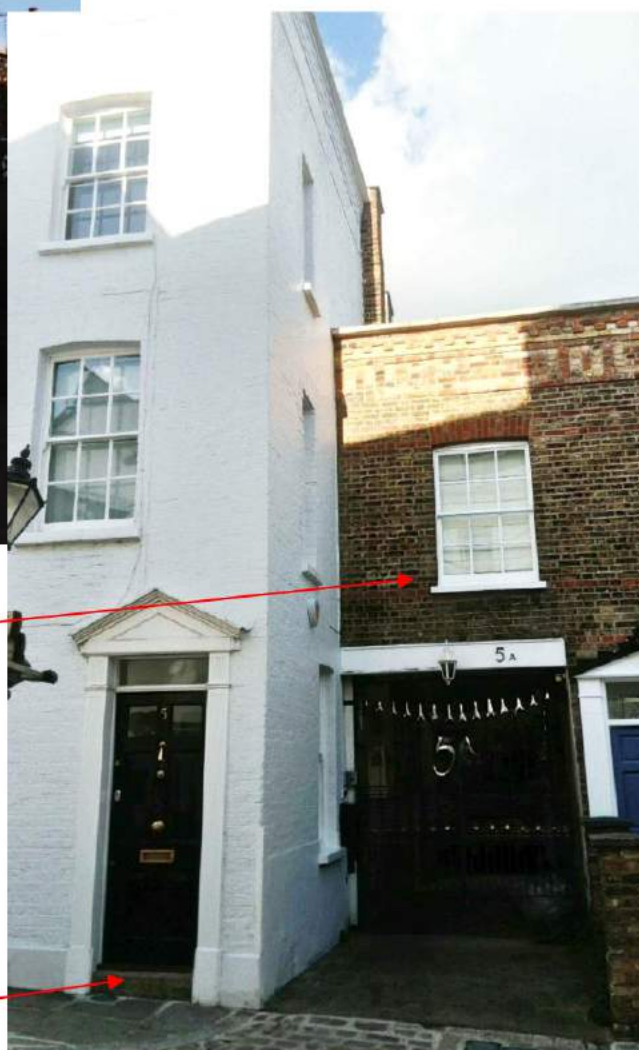
Photo 2 (right): The external wall between No.5 and No.7 Back Lane. The passage way adjacent to the ground floor of No.5 leads to No.5a Back Lane.

Step up from Back Lane footway to
front entrance of No.5

- 2.8 No.5 Back Lane fronts directly onto the public footway with no external garden or amenity area to the front of the property. The front entrance sits above a single step up from the Back Lane footway (Photo 2). To the rear of the house is a fully walled garden, divided by the rear extension into two sections. The section adjoining No.3 to the north-west side, accessible via a sliding door in the dining area, is part covered by wooden decking above what is believed to be paving slabs, and partly a soft landscaped area containing a lined round pond and Japanese Maple tree (height unconfirmed). The section on the south-east side, adjacent to the passage leading to No.5a, consists of a 'crazy' paved pathway leading down to a level patio at the northern end of the garden (Photo 4). There is a step down from the sloping path to the patio. There are planting areas running parallel to the garden path and alongside the northern wall. There is a wooden cupboard adjacent to this wall and three trees: a substantial Pear tree (height unconfirmed but estimated at 9.5m), and two further small trees not marked on the FORMstudio drawings, leaning over the south-eastern wall above the passage; heights also unknown but estimated at 3-4m.

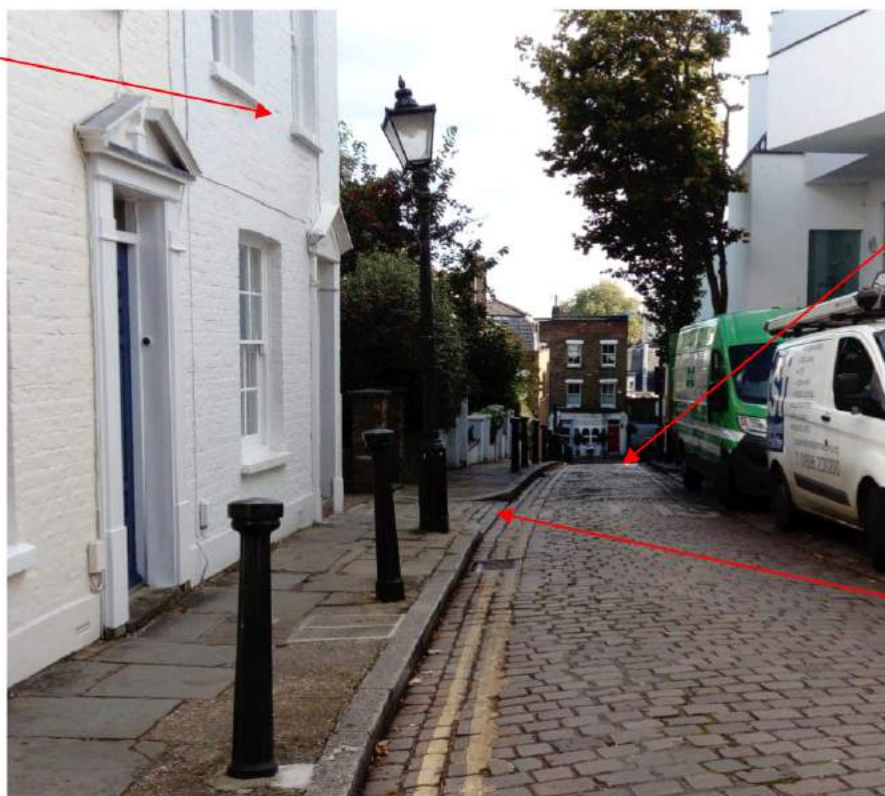
Carriageway sloping south-east, away from No.5

Access passageway to No.5A

- 2.1 No.5 Back Lane is a three-storey terraced house (see Photo 1 in Appendix A) within the Hampstead Conservation Area, in the London Borough of Camden. Back Lane can be accessed by vehicles at its south-east end where it adjoins Flask Walk, or at its north-west end where it meets Heath Street, and via the pedestrianised Streatley Place to the north-east. No.5 is situated on the north-east side of Back Lane, adjoining No.3 to the north-west. To the south-east, No.5 adjoins the upper floors of No.7 which span over the driveway to No.5a (as shown in Figure 1 and Photo 2 in Appendix A). No.5a Back Lane is located to the north-east of No.5, and adjoins No's 5, 6 & 7 Lakis Close.

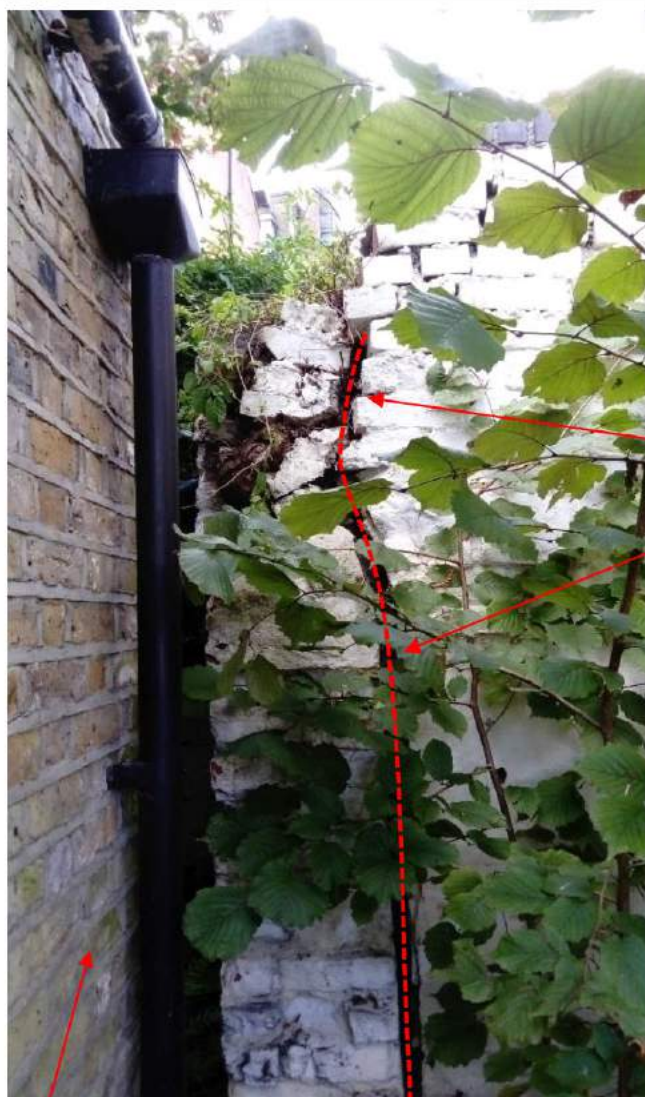
Photo 5: Corner of the boundary wall between No.5 Back Lane and No.2 Streatley Place, looking north-west. The north-west/south-east trending section of the wall is leaning into the rear garden of No.5, this is the opening of the joint where there is a lack of bonding between the walls.

Cracking/lack of bonding along the boundary wall with No.2 Streatley Place

- 2.9 Major cracking was observed around the corner wall between the gardens of No.5 and No.2 Streatley Place (Photos 5 & 6). The wall is leaning towards No.5, and large tree roots or branches of vegetation appear to be pushing the north-west trending wall away from the north-east trending wall. There did not appear to be any associated structural damage to No.5's adjacent extension. An entirely separate large creeper was noted within the 3/5 garden boundary wall.

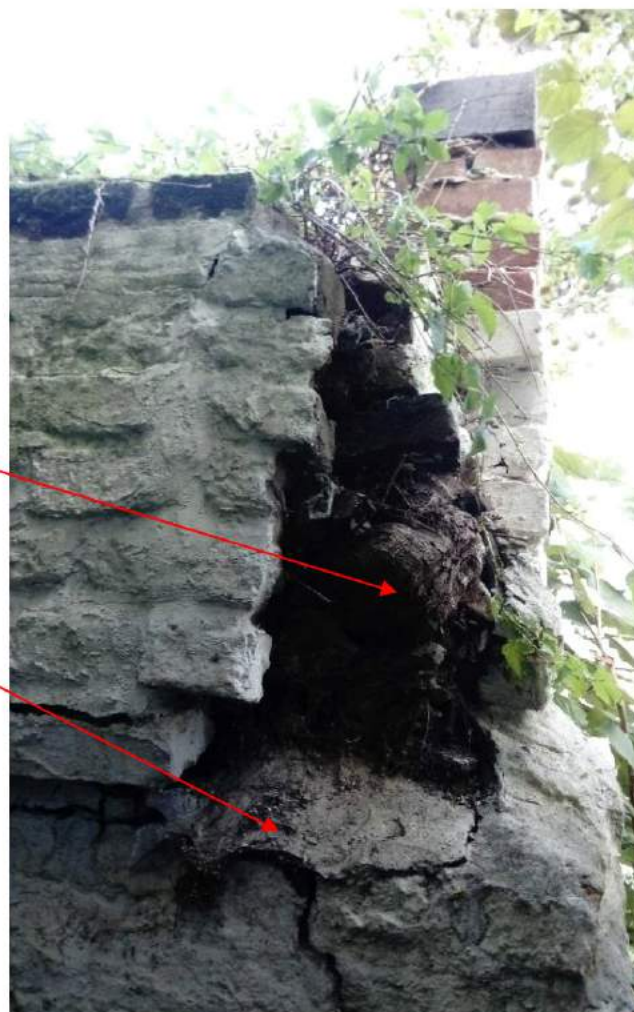
Tree root/branch or other vegetation within crack

Cracking along boundary wall with No.2 Streatley Place

Photo 6: Corner of the boundary wall between No.5 Back Lane and No.2 Streatley Place, looking north-east. A tree root/branch or other vegetation type on the No.2 side appears to be causing or exploiting the cracks in the wall.
