6.2.1 Existing Plan

6.2.3 Existing Landscape

6.2.4 Demolition - Structural Report

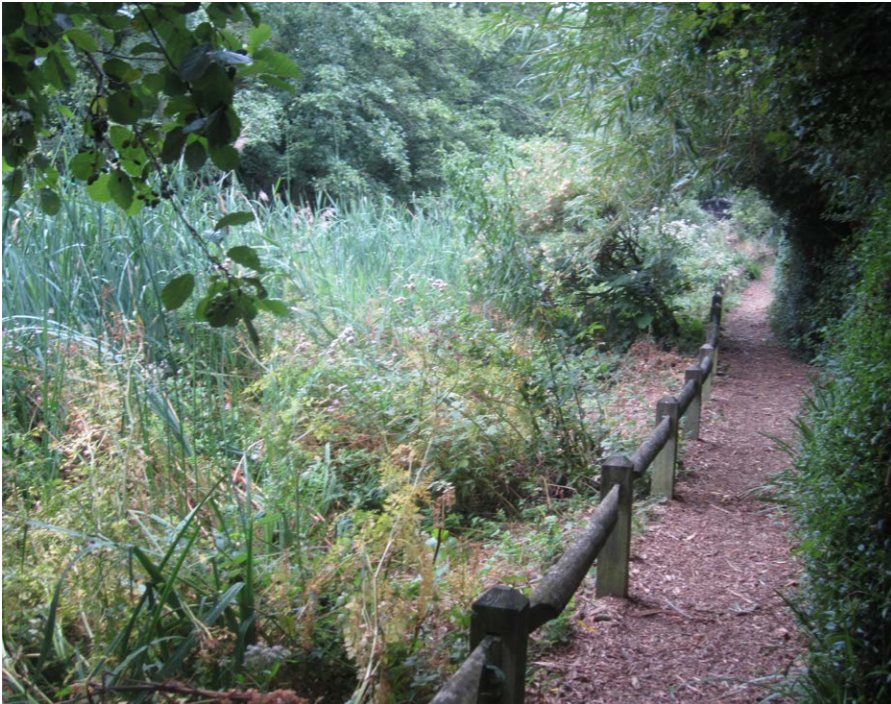
Woodchip / mulch path covering across the whole site

The existing landscape is piecemeal and not designed for a high intensity or volume of visitors. With the new bridge and the proposed new building the landscape needs updating to be resilient to future uses.

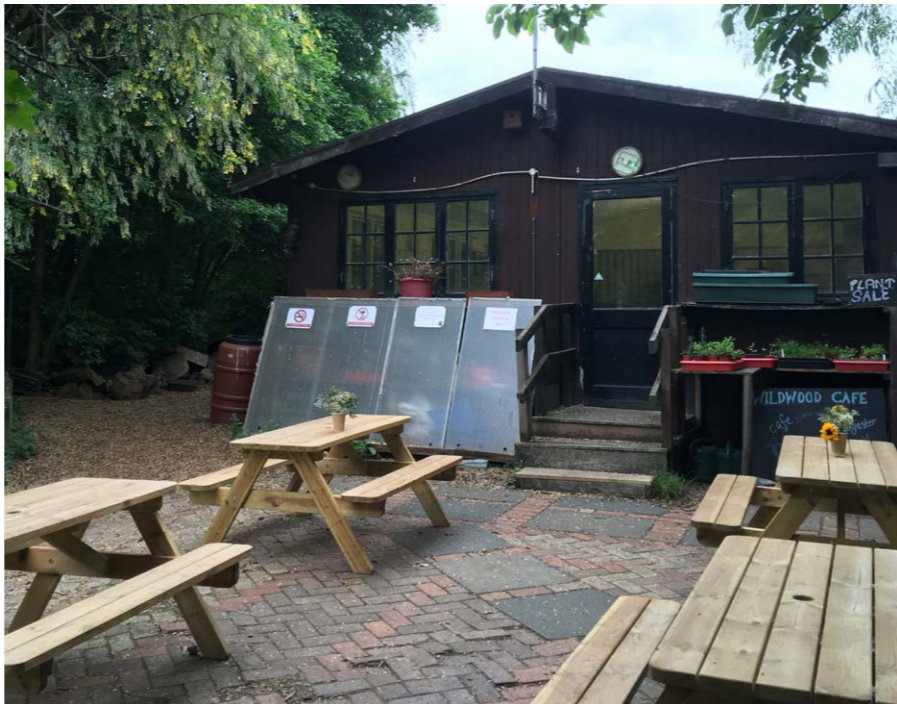
Block paving patio and picnic area to the rear of the existing visitor centre

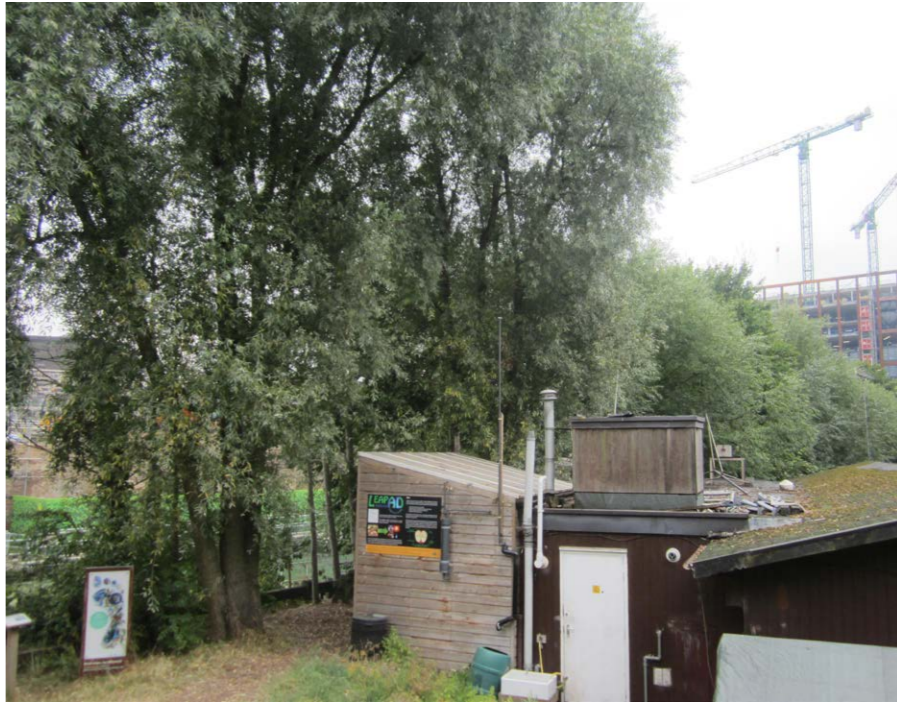
Large trees blocking canal views. Poor navigation around the site

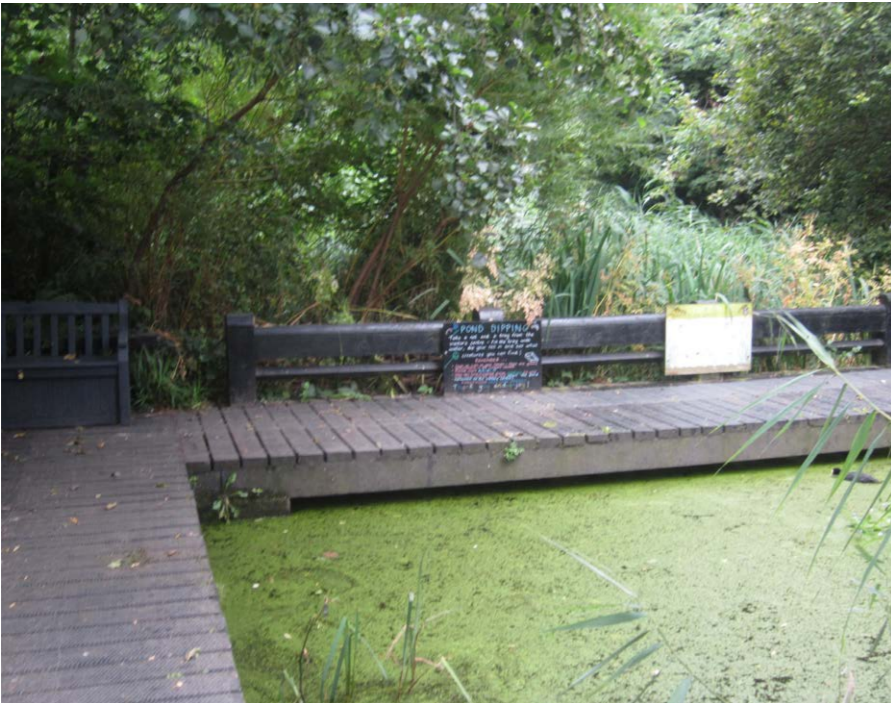
Tired interpretation

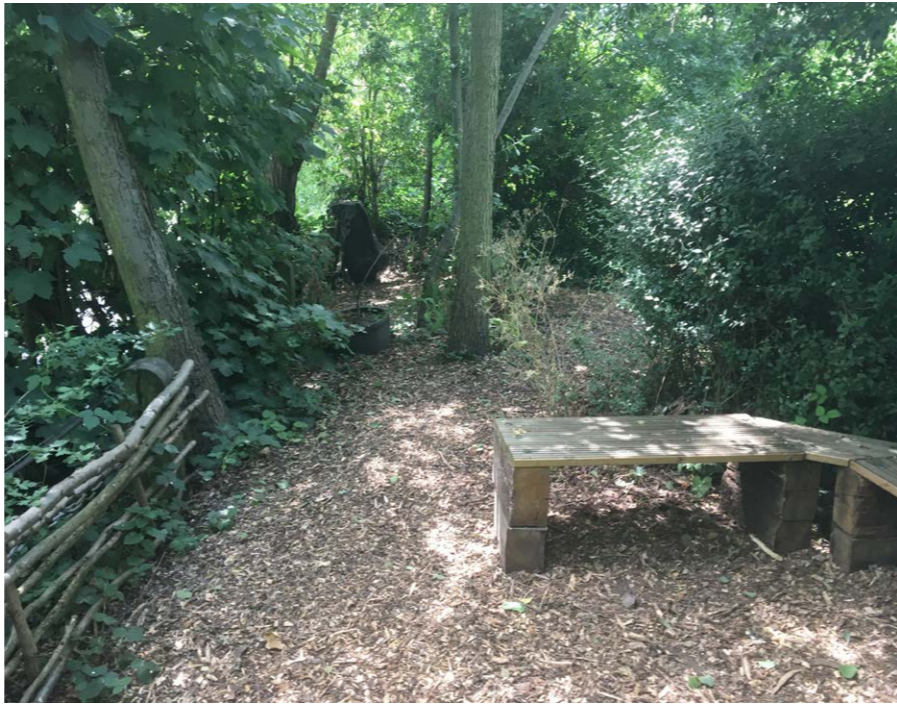
No path hierarchy

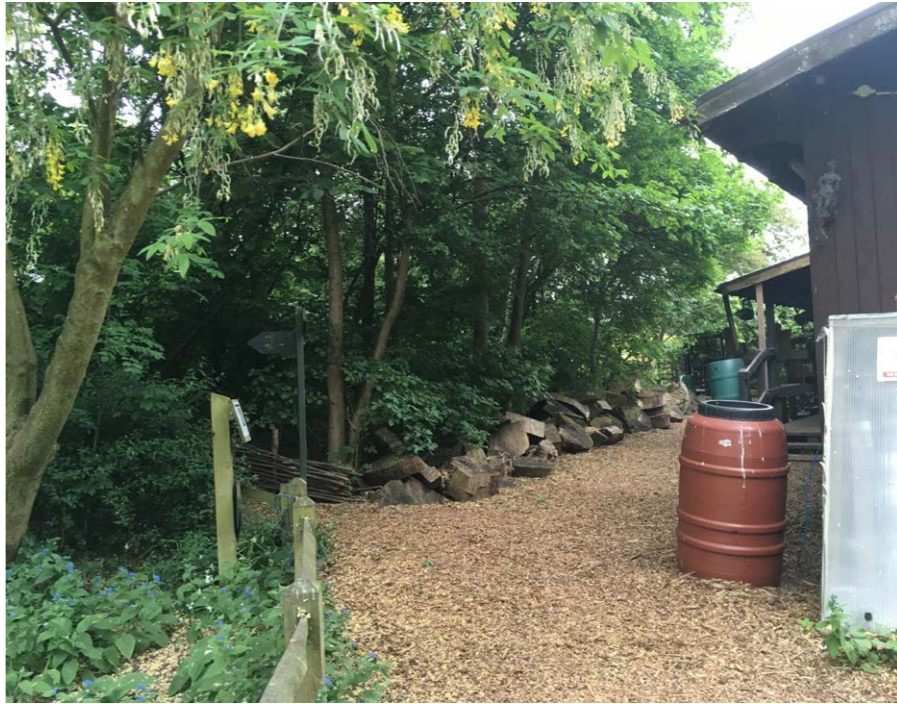
Site overcrowded / littered with furniture and accessories

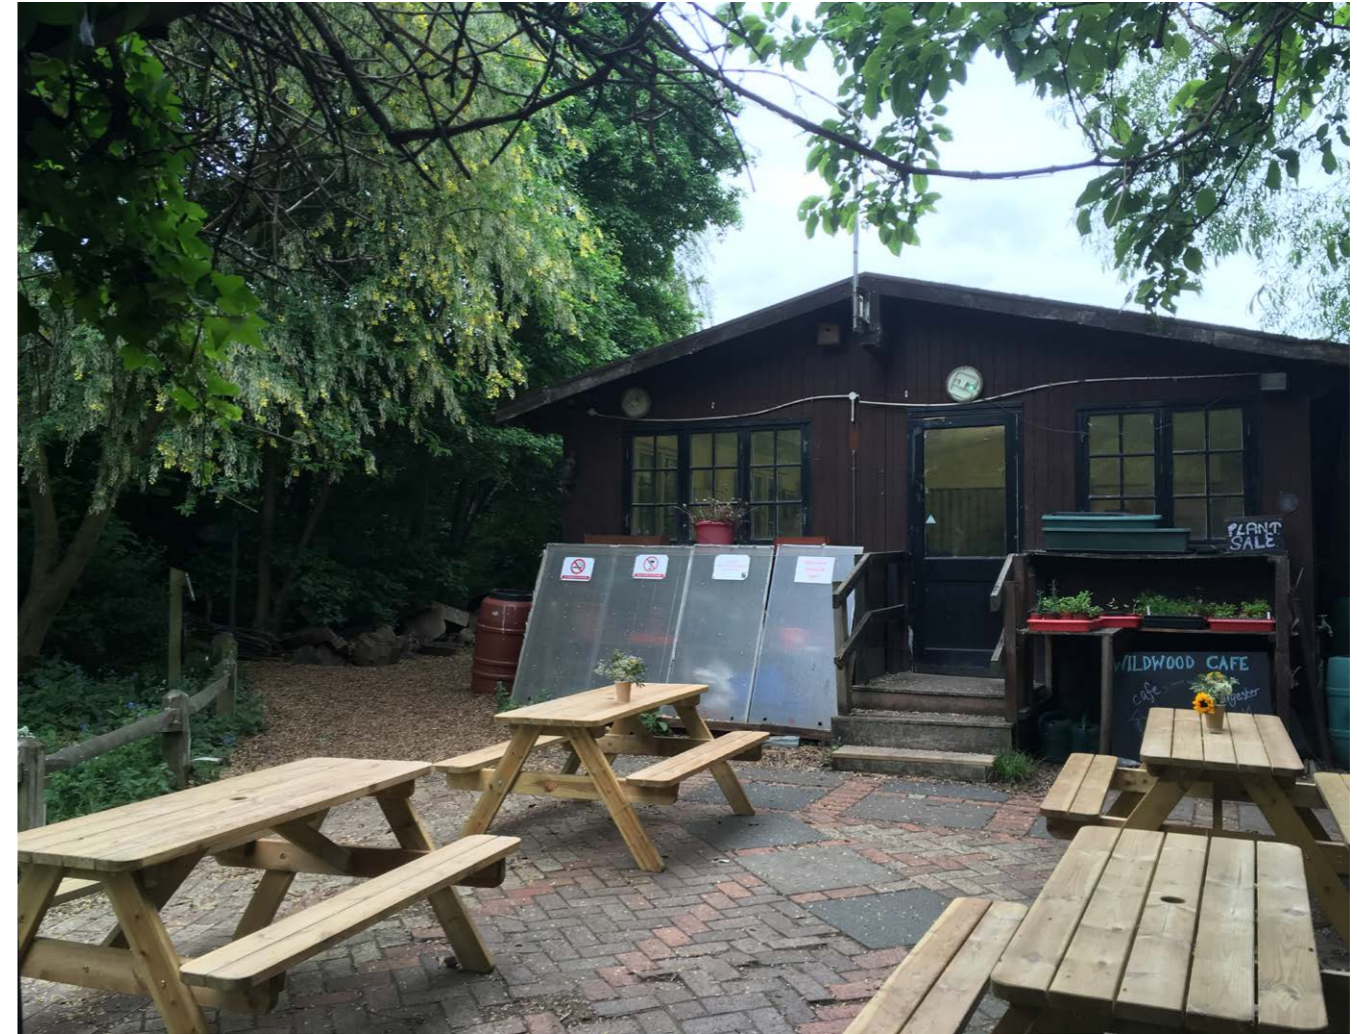
① view of Southern edge of existing building (learning space) and brick paving to be demolished

There are 2 no. existing single storey buildings located to the centre of the site. Each is a detached, light-weight timber structure on a concrete hard-standing. The buildings are independent of each other and, being located within the footprint of the proposed new building, will be demolished entirely prior to constructing the new building. The demolition works will have no impact outside the site boundary.

Demolition will be undertaken by a competent specialist demolition contractor who will plan the works to manage the typical risks associated with demolition of a single storey building. There are no unusual risks posed by these demolition works as the buildings are located away from the site boundary and therefore away from the public domain or other properties.
