# **Arboricultural impact analysis**

**The Lodge,  
North End Avenue,  
Hampstead  
London  
NW3 7HP**

job no.: 597

date: 17.10.17

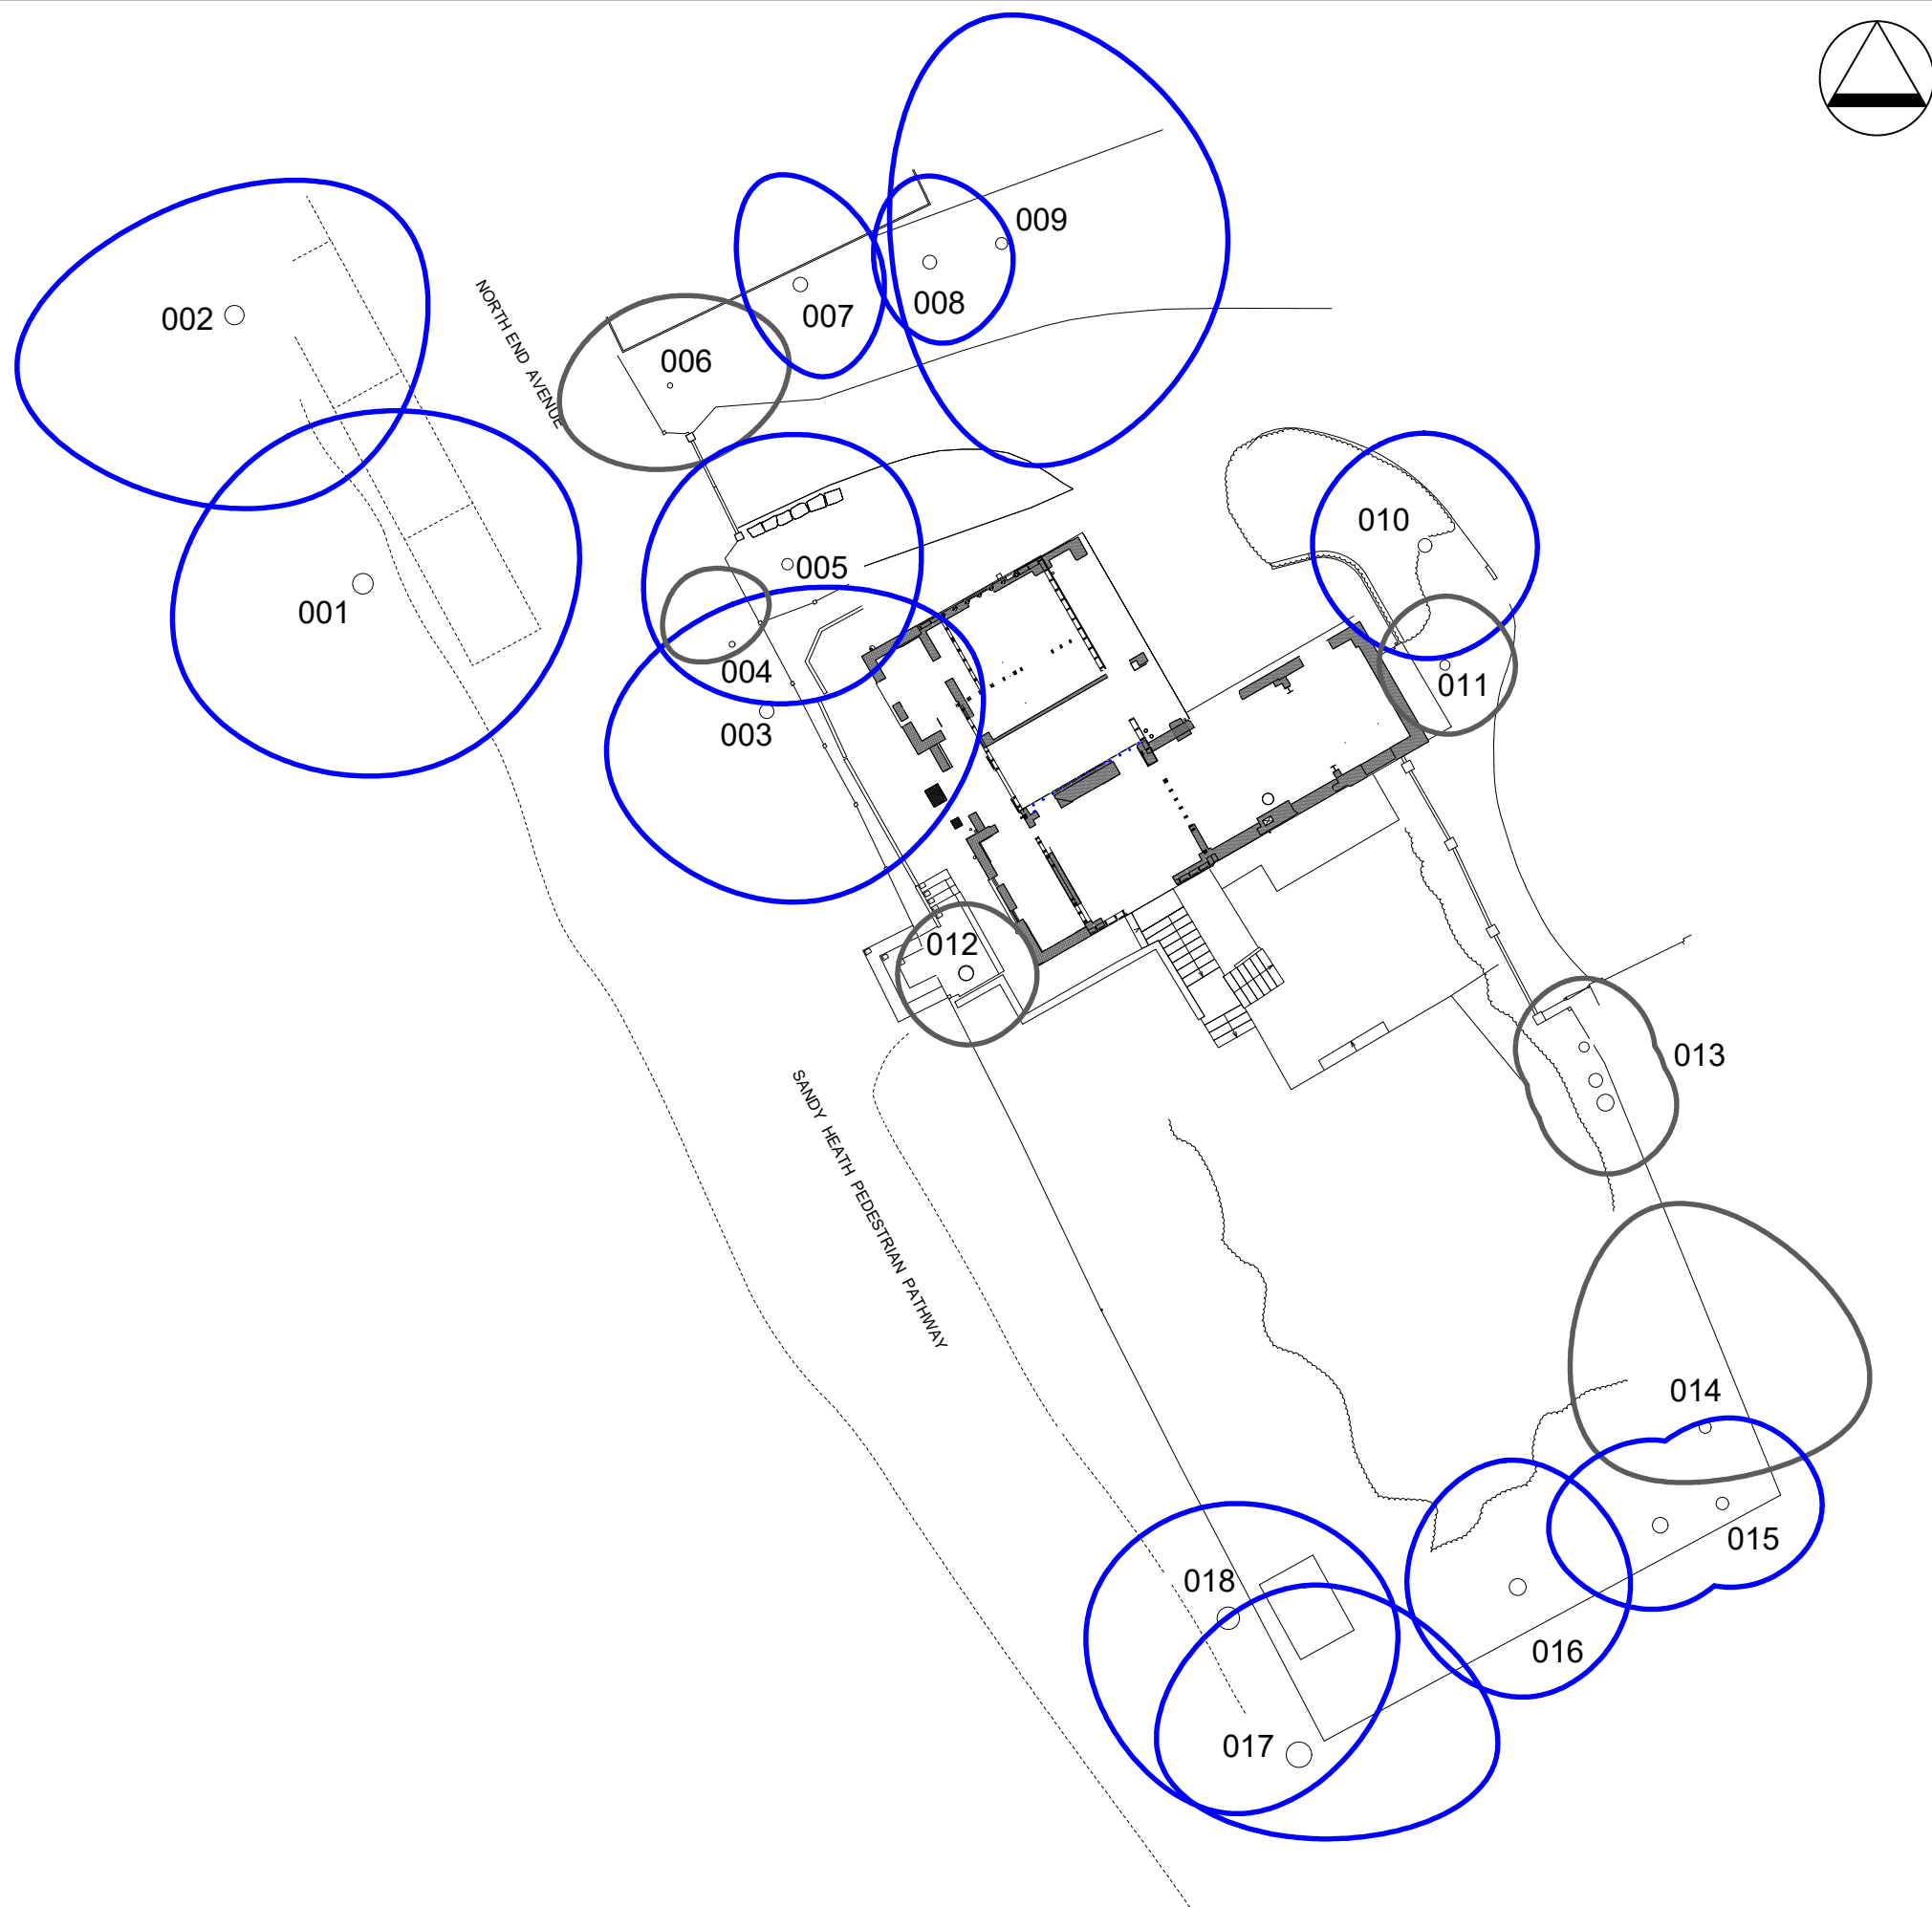
- 2.1.7 A hard surfaced courtyard immediately to the north of the dwelling is about 300mm below internal ground floor level
- 2.1.8 The **Tree survey plan** in **Appendix a** shows the existing site layout and the locations of the trees referred to in this analysis.

- 2.4.1 The trees referred to in this analysis are described in detail in the **Tree survey schedule** in **Appendix a**. Their locations are shown on the **Tree survey plan** in the same appendix.

All trees have been numbered in the survey text to correspond to the location numbers shown on the accompanying Tree survey plan. No trees have been marked on site.

**Crown spread** - radial crown spreads in metres have been recorded at four points on the circumference of the crown (north, east, south and west). The accompanying Tree survey plan shows approximate crown shapes based on these measurements

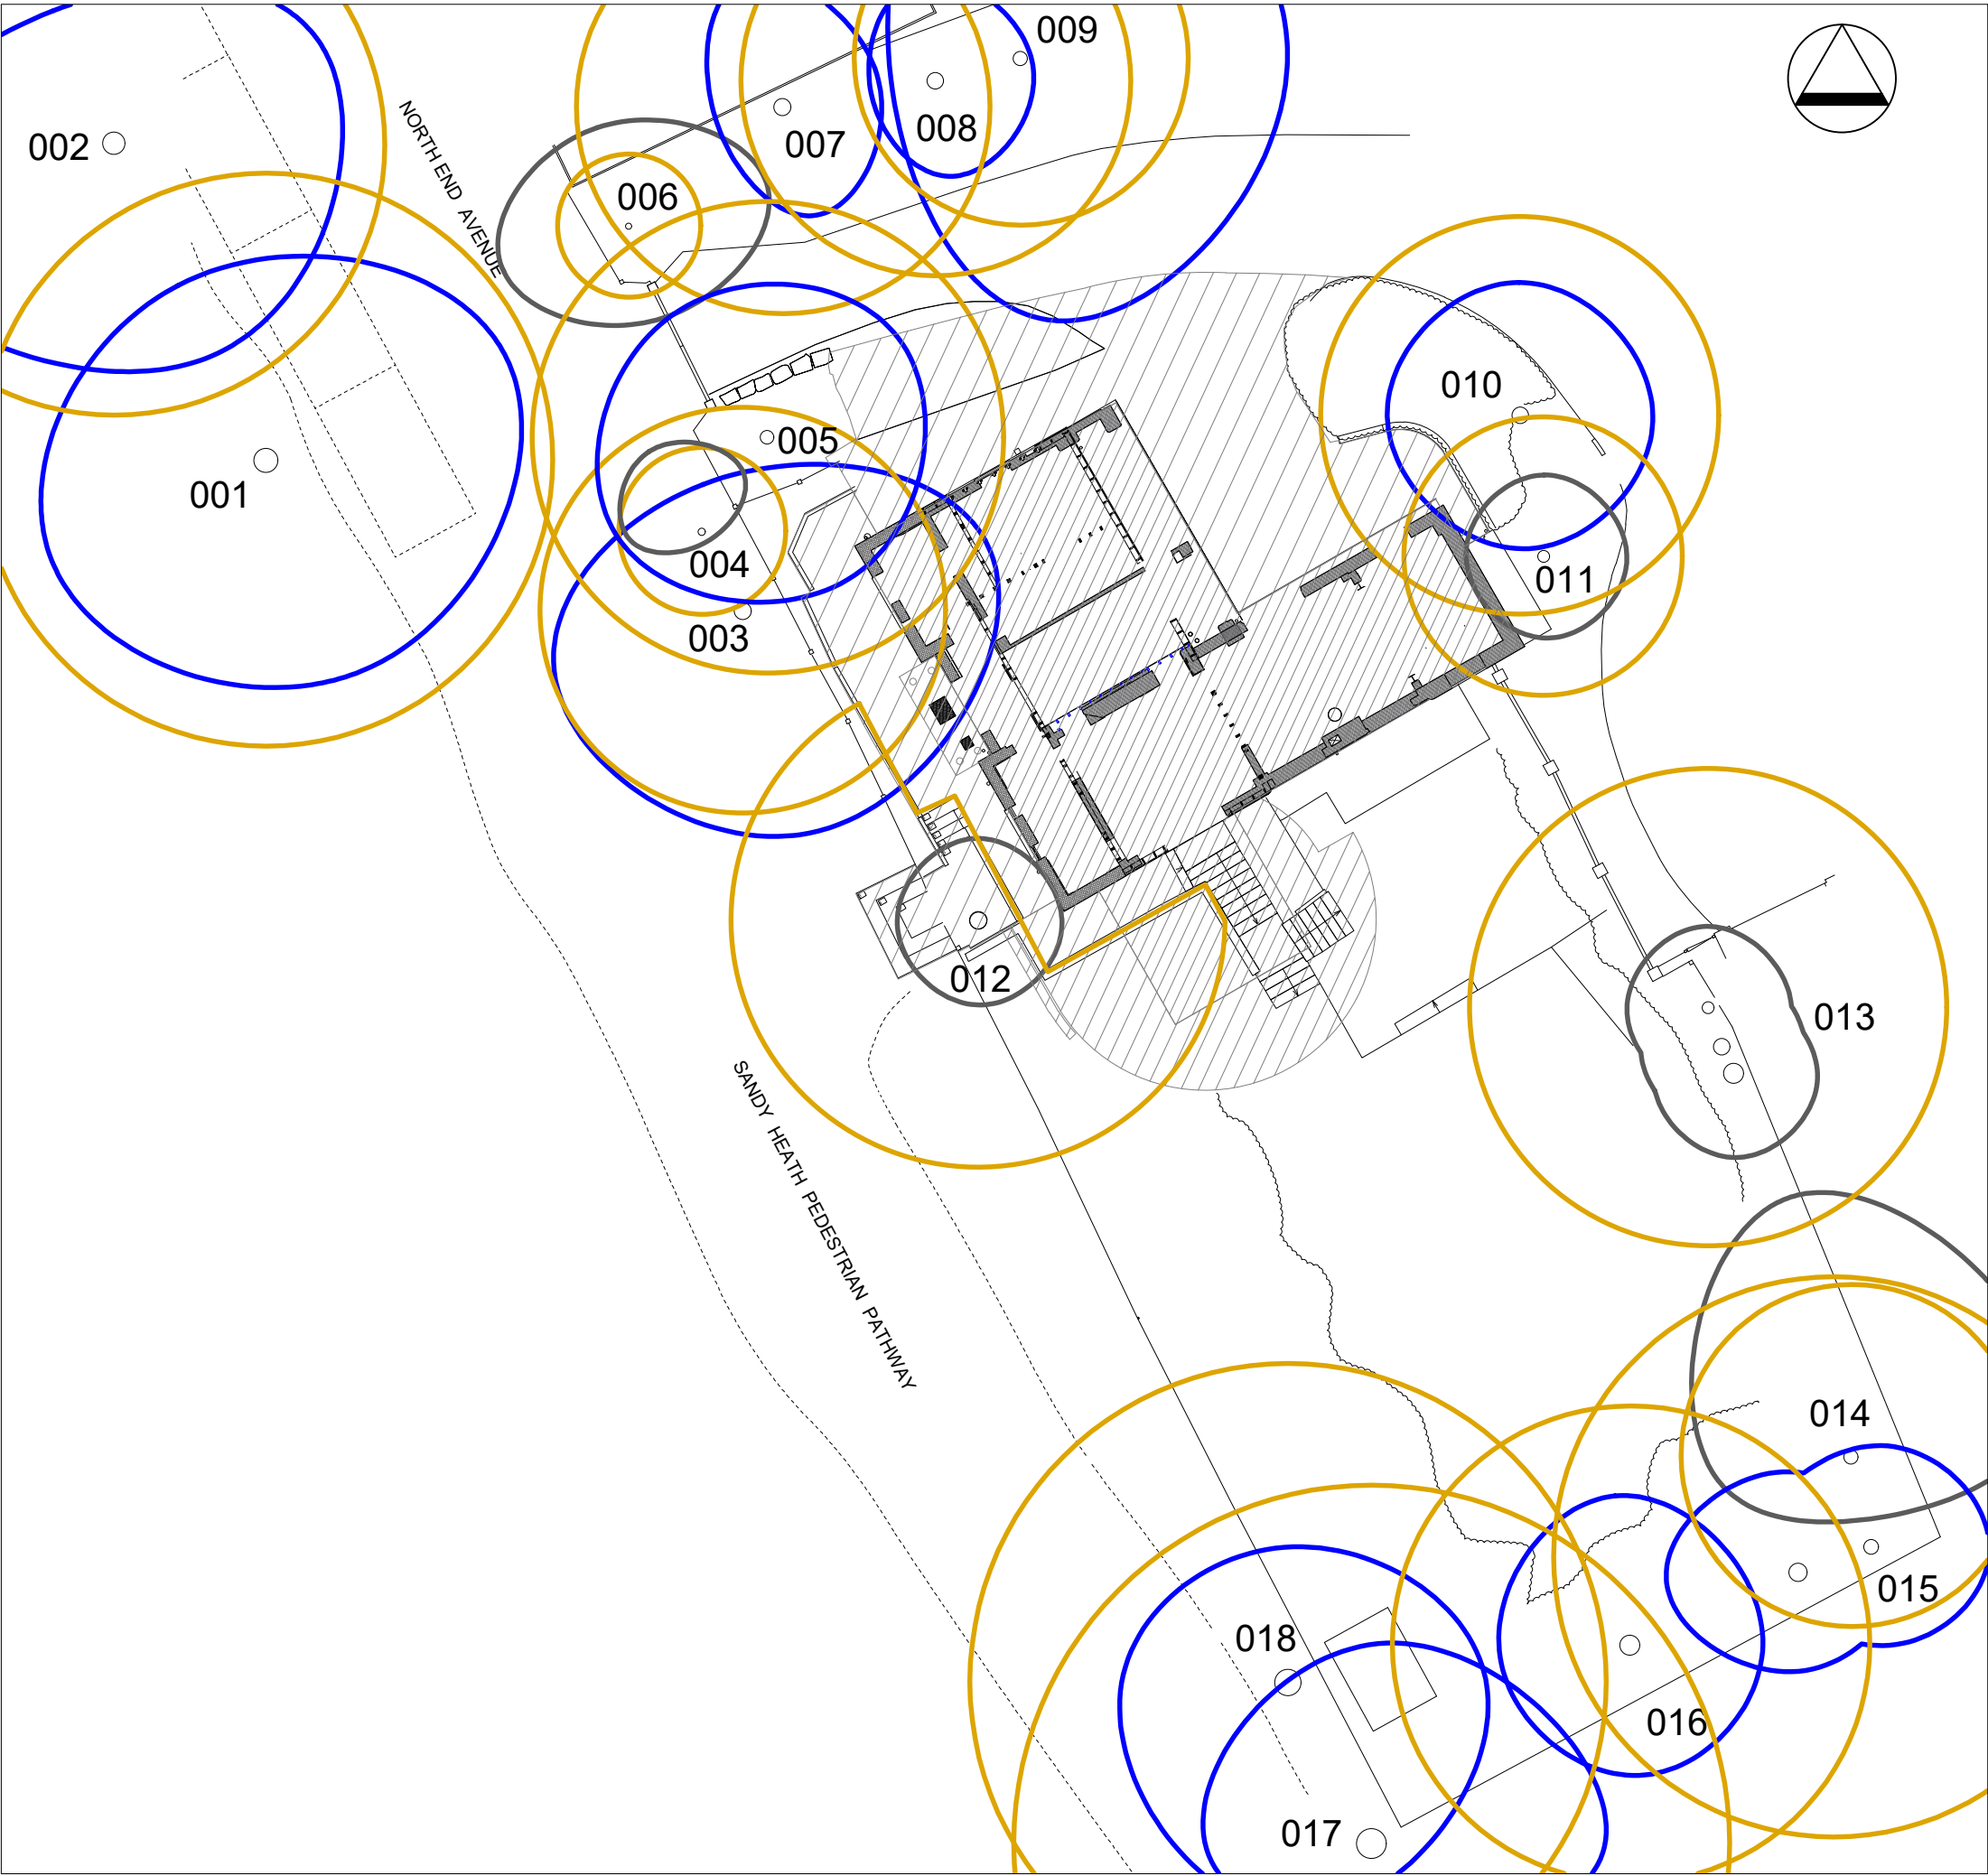
REVISION	CHK'D	APP'D	DATE
Client:			
Ms A KULTYS			
Job Title:			
THE LODGE NORTH END AVENUE LONDON NW3 7HP			
Drawing Title:			
TREE CONSTRAINTS PLAN			
Drawing Number:	Scale:		
597.02.01	1:200 (A3)		
Date:	Drawn by:		
17.10.17	RS

- 3.1.1 The **Tree constraints plan** in **Appendix a** shows the recommended Root Protection Area (RPA) for each tree arranged symmetrically around its main stem except where complete barriers to the lateral spread of root necessitate a reconfiguration.
- 3.1.2 In this respect, I have reconfigured the RPA of Leyland Cypress 012 in response to the barrier effect of the roughly 1000mm high retaining wall that separates it from the narrow building surround around the existing dwelling.
- 3.1.3 Each RPA highlights the primary potential area of conflict between proposed development and retention of existing trees, namely conflicting demands for space at and below ground level.
- 3.1.4 Where appropriate, I have considered above-ground conflicts in the analysis which follows, particularly headroom, lateral and overhead shading and perceived risk in extreme weather conditions.

- 3.3.1 The extended dwelling footprint and the increase in the size of the building surround to the south of the dwelling do not overlap the RPA of any retained tree to any greater extent than at present, except in the case of Leyland Cypress 012, where there is an additional overlap of just under 19m<sup>2</sup> (16% of total), as drawn.

- 3.3.2 It is likely in my view that the degree of overlap shown is overstated, because the section of retaining wall that runs immediately to the south of the main stem will present an obstacle to direct root spread into the overlap area.

- 3.3.3 There is also a considerable area of undeveloped open ground contiguous with the RPA to the west and north.
- 3.3.4 Give these mitigating factors, I do not consider that the degree of overlap between the proposed development and this tree's root system will have a significant adverse impact.

- 4.4 Care will also be needed – in the form of a small non-destructive root investigation at the start of the construction programme with subsequent design modifications if needed – to ensure that the proposed car parking bay adjacent to Yew 005 does not damage (25mm or greater) large diameter roots

- 4.5 These are matters that should be addressed in an **Arboricultural Method Statement (AMS)**. The draft AMS (to be finalised after consent has been granted, to coincide with the main contractor's construction method statement and programme) accompanying this analysis sets out tree protection measures and appropriate working practices to ensure successful tree retention.
