Ground Investigations Report (RSK)

**Project No.:** 371475-01 (05)

*“Demolition of 65 Bayham Place, 1 Bayham Street (retention of façade) and rebuilding to provide private members club (sui generis) with extension to the rear and basement; retention and refurbishment of the ground floor of the Hope & Anchor Public House (Use Class A4) with 1st/2nd floor internal demolition and replacement to provide restaurant and bar, minor reconfiguration to circulation space within KOKO. Use of the Flytower by the private members club with retention of original theatre equipment. Installation of fourth floor extension to provide amenity space with terrace restaurant and bar. The proposals also include for the conversion of the KOKO dome to a private bar and general refurbishment and restoration to the building, along with the installation of new plant”.*

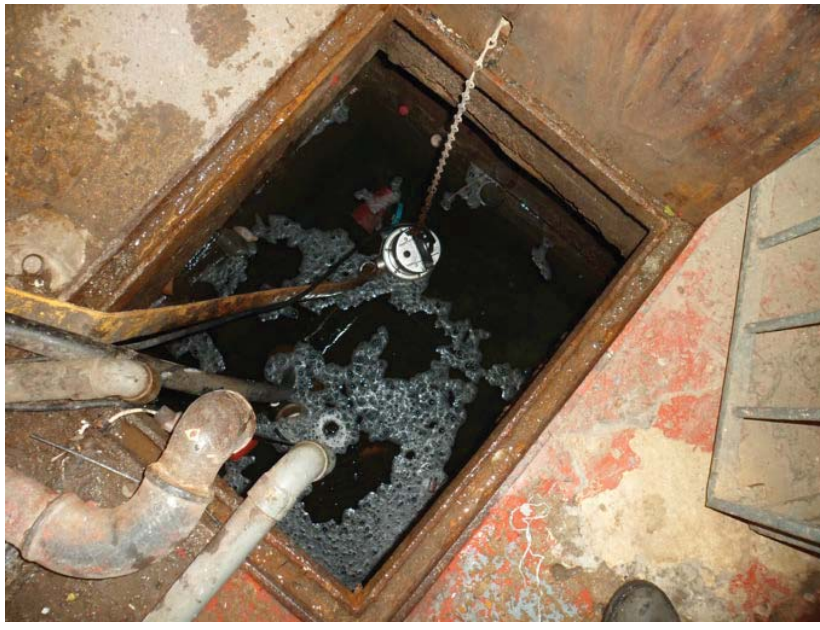
<b>Photo No.</b> 9	<b>Date:</b> 22.4.16

<b>Direction Photo Taken:</b>		
<b>Description:</b> Sump chamber in Koko basement

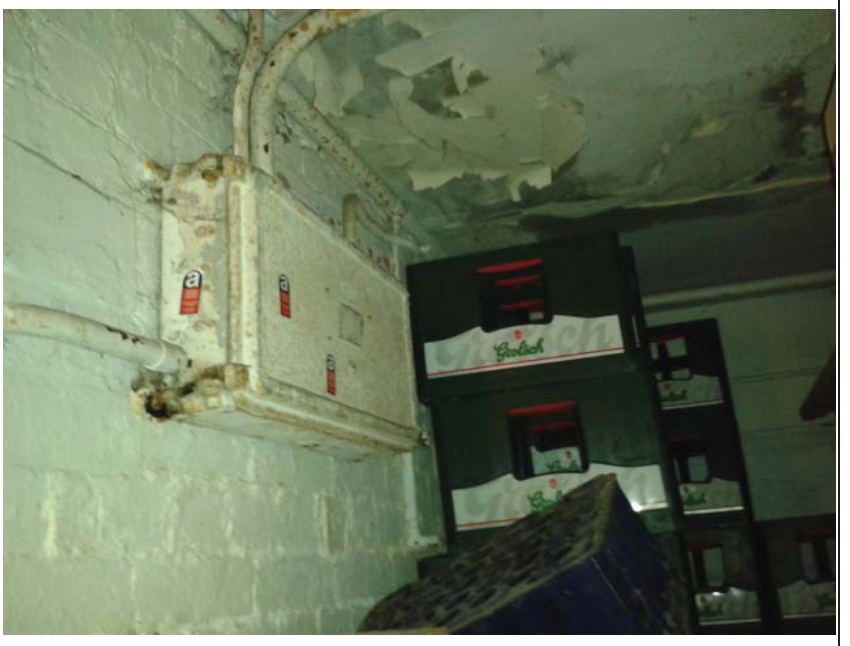
<b>Photo No.</b> 11	<b>Date:</b> 11.7.16

<b>Direction Photo Taken:</b>		
<b>Description:</b> ACM flash guard in Koko basement

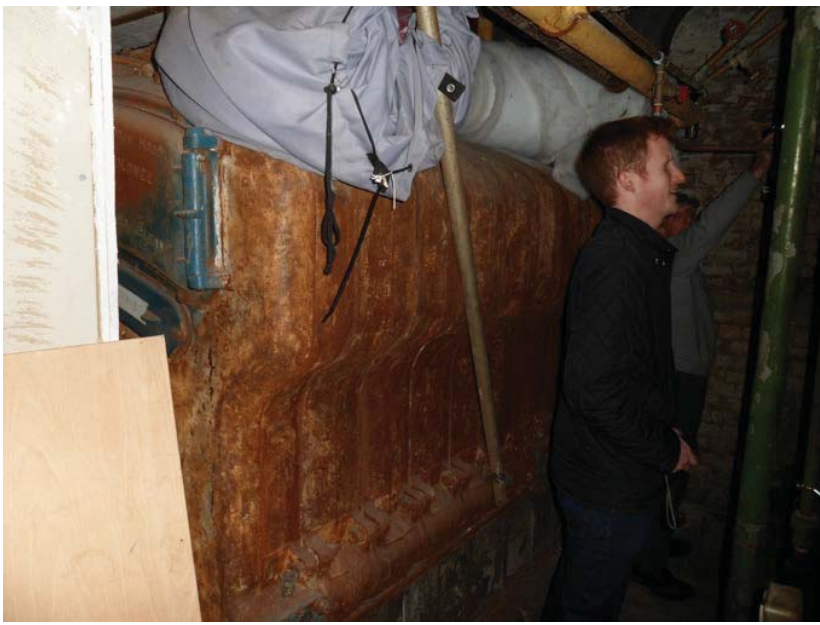
<b>Photo No.</b> 10	<b>Date:</b> 22.4.16

<b>Direction Photo Taken:</b>		
<b>Description:</b> Old boiler in Koko boiler room at lower ground floor level
