Client					
THE HOPE LEASE LTD					
Project Title					
THE HOPE PROJECT					
Drawing Title					
TRIAL PIT 1					
Drawn	Date	Checked	Date	Approved	Date
ASC	13.07.16	CS	13.07.16	CS	13.07.16
Scale		Orig Size		Dimensions	
AS SHOWN		A3		m	
Project No.			Drawing File		
371475 - R01 (00)			371475 (R01-00) TP.dwg		
Drawing No.					Rev.
TP1					P1

Client  
**THE HOPE LEASE LTD**

Project Title  
**THE HOPE PROJECT**

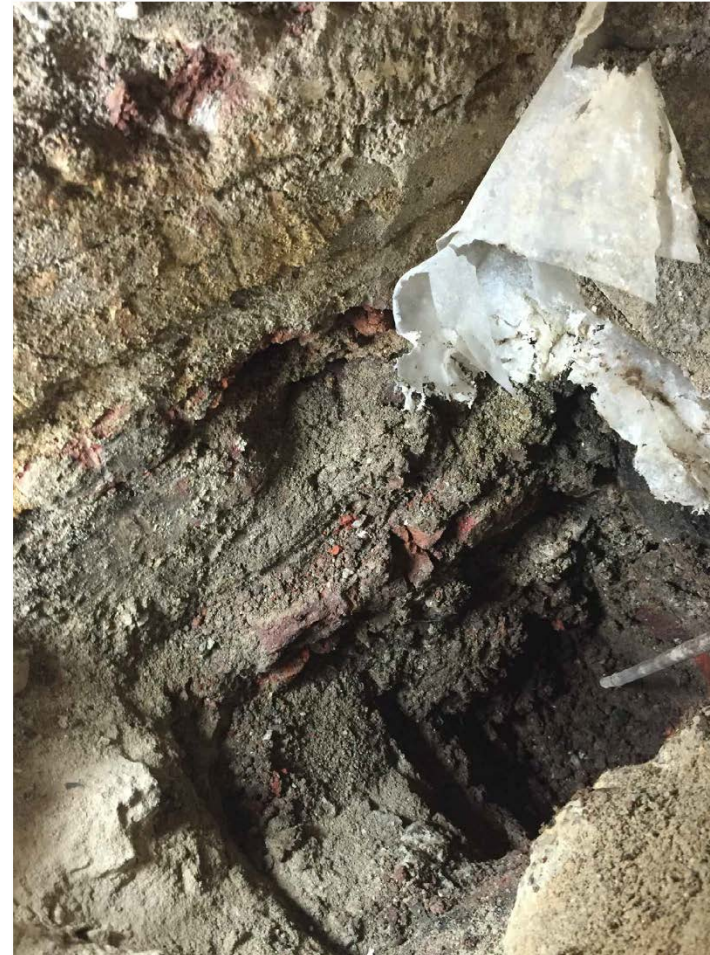
- Section Line
- ① Concrete with damp proof sheet at 0.08m and 0.31m.
- ② MADE GROUND: Dark red brown and brown silty very gravelly SAND with clasts of sandy gravelly CLAY. Sand is fine to medium. Gravel is sub-angular to sub-rounded fine to coarse brick, concrete, occasional clinker, ash and rare slate.

Section A-A':  
(1:10)

Section B-B':  
(1:10)

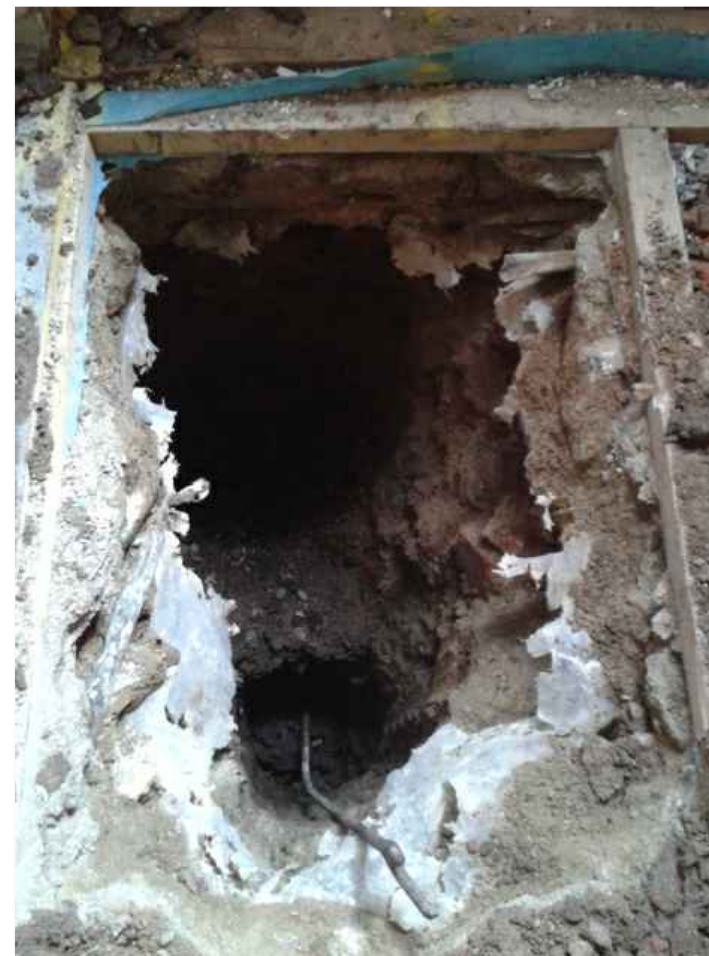
**Section A-A':  
(1:15)**

- Section Line
- ① MADE GROUND: Brown slightly sandy gravelly CLAY. Gravel is very angular to subangular fine to coarse flint, brick, concrete, ash, clinker. Occasional pockets of black carbonaceous matter and occasional pockets of light brown clay.
- ② Damp, recovered as soft, dark brown slightly sandy silty CLAY (on end of road pin)

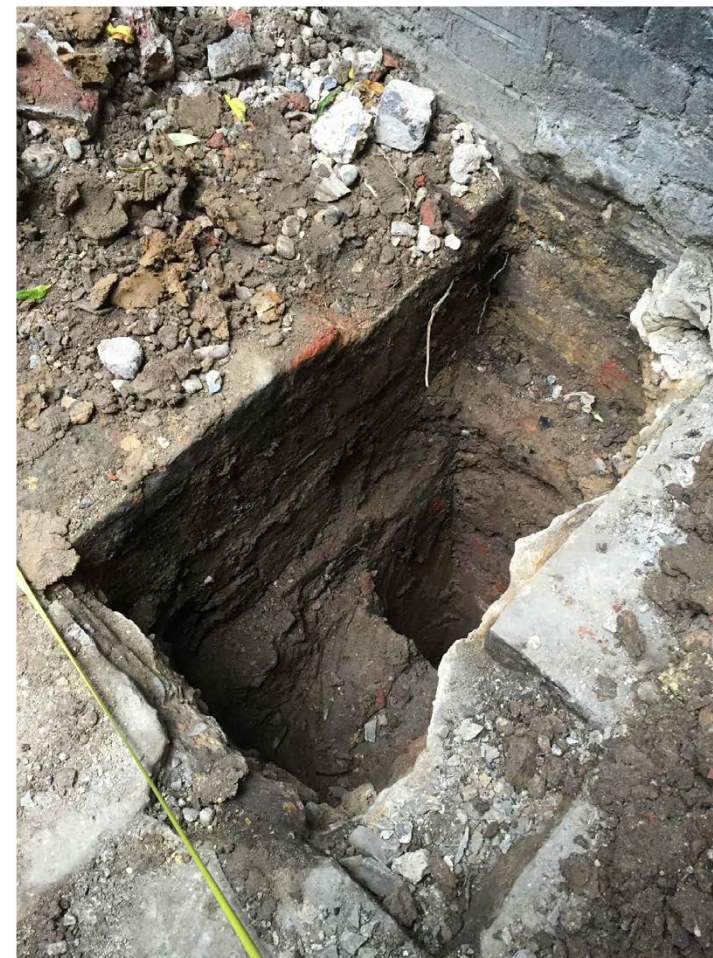
**Section A-A':**  
(1:15)

- Section Line
- ① MADE GROUND: Brown slightly gravelly sandy CLAY. Gravel is angular to sub-angular fine to coarse of brick, flint, concrete and ash.  
At top: 50mm layer of black sandy clay
- ② Firm fissured brown and grey mottled silty CLAY with occasional pockets of light brown silt and occasional mica.

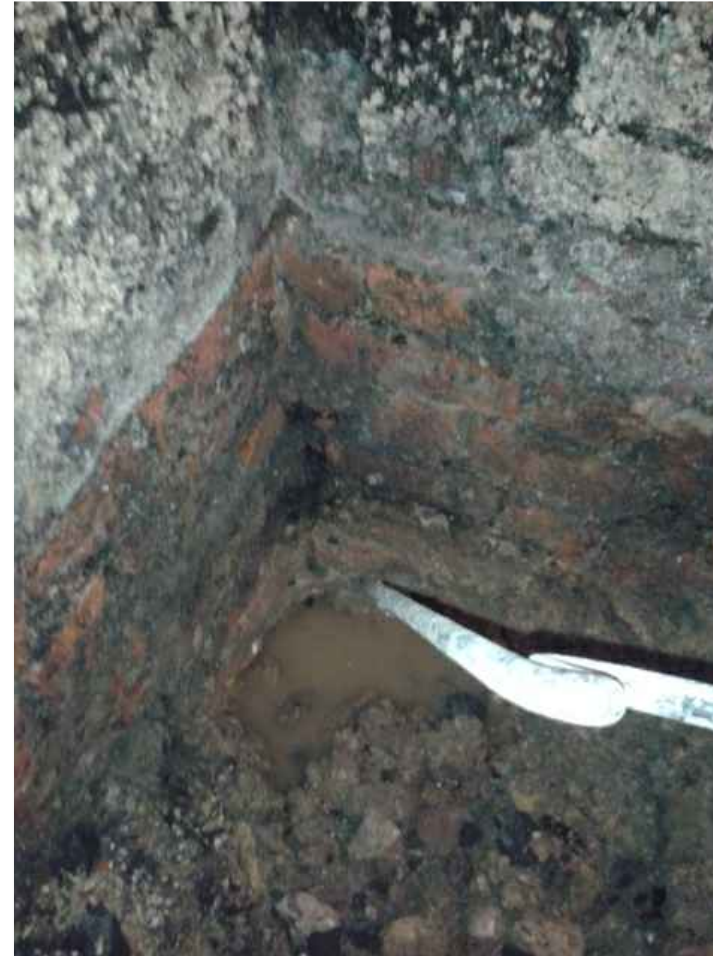
Plan View:  
(1:10)

- Section Line
- ① MADE GROUND: Black ash GRAVEL.  
MADE GROUND: Brown slightly sandy gravelly CLAY. Gravel is angular to sub-angular fine to coarse of brick, ash, concrete and clinker.
- ② Firm fissured brown and grey mottled silty CLAY with occasional mica and occasional grey gleying on fissures.
- ③

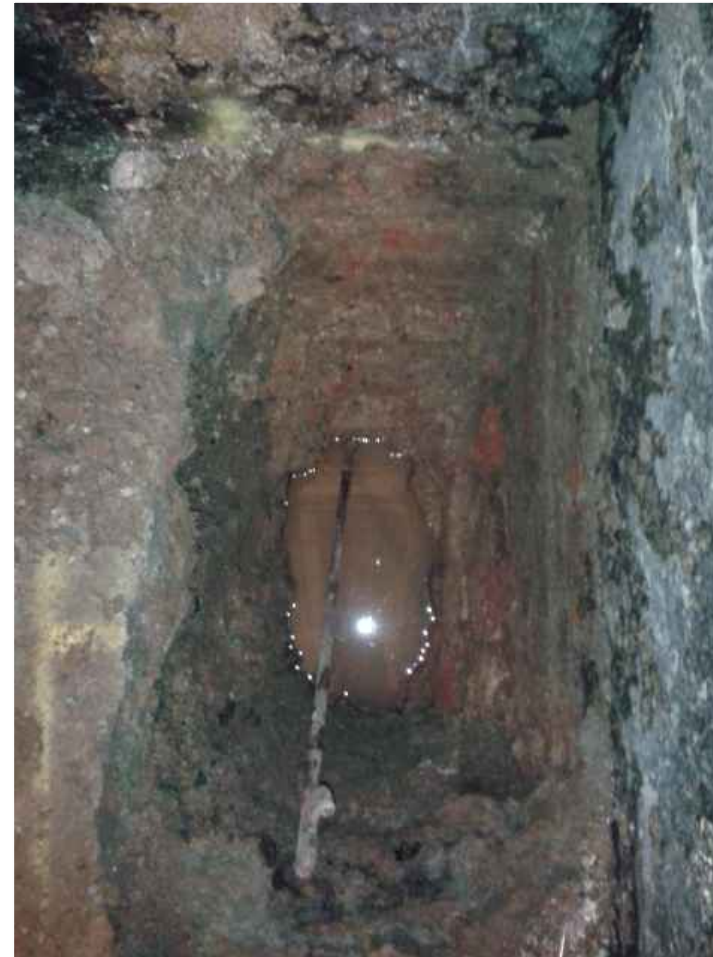
Plan View:  
(1:10)

- Section Line
- MADE GROUND: Brown sandy slightly gravelly CLAY. Gravel is angular to sub-angular fine to coarse of brick, flint, ash and clinker. Occasional pockets of brown and grey mottled clay.
- ① Firm fissured brown mottled grey CLAY with occasional mica.

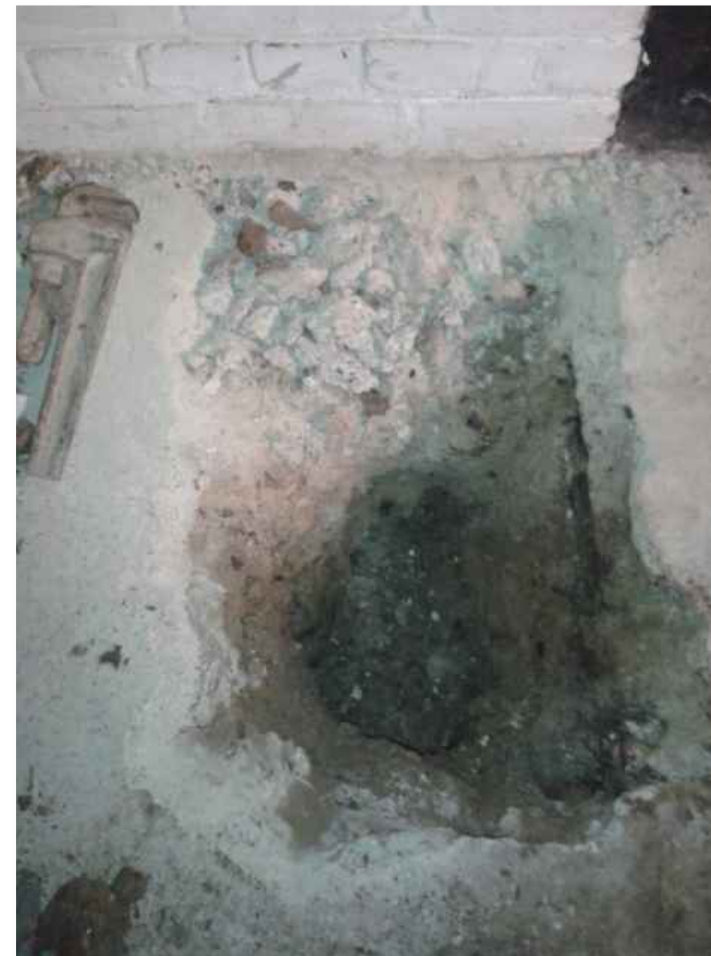
**Section A-A':**  
(1:15)

- Section Line
- ① MADE GROUND: Brown slightly silty sandy GRAVEL. Gravel is very angular to angular fine to coarse flint, brick and tile.
- ② MADE GROUND: Brown slightly sandy gravelly CLAY. Gravel is angular to sub-rounded fine to coarse flint and brick with occasional pockets of firm clay. Recovered as soft and saturated.

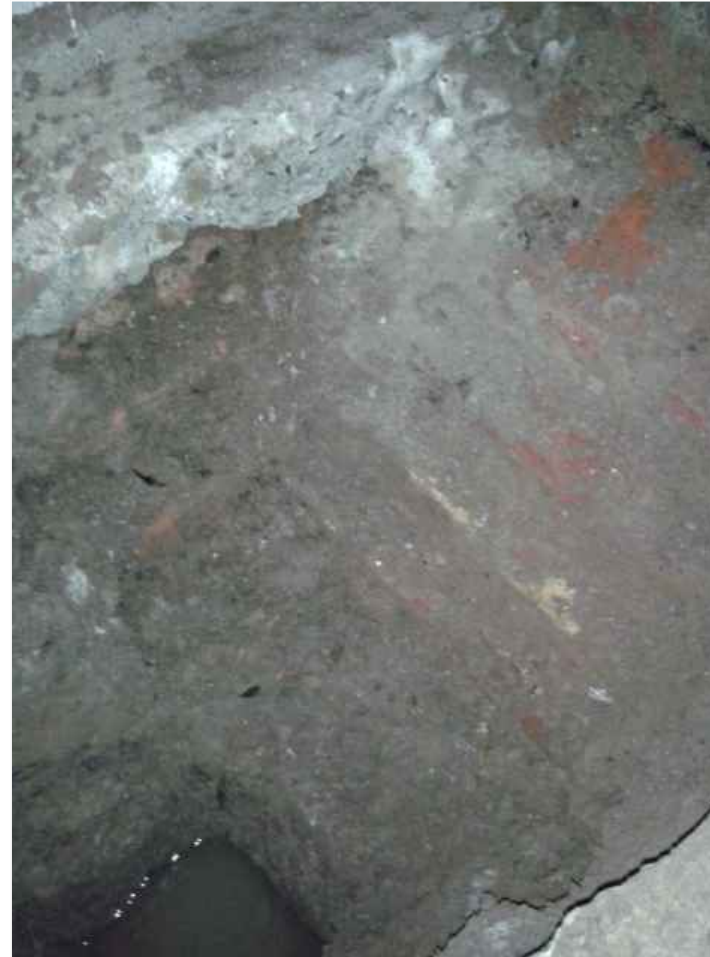
Plan View:  
(1:10)

- Section Line
- ① MADE GROUND: Brown slightly silty sandy GRAVEL. Gravel is very angular to angular fine to coarse flint, concrete, brick and tile.
- ② Firm to stiff brown mottled grey CLAY with occasional orange silt pockets.
