10 GREAT ORMOND STREET, ENTRANCE HALL PANELLING

ARCHITECTURAL PAINT RESEARCH REPORT

March 2017

Compiled by Michael Correia & Rosie Shaw, Hare & Humphreys Ltd.

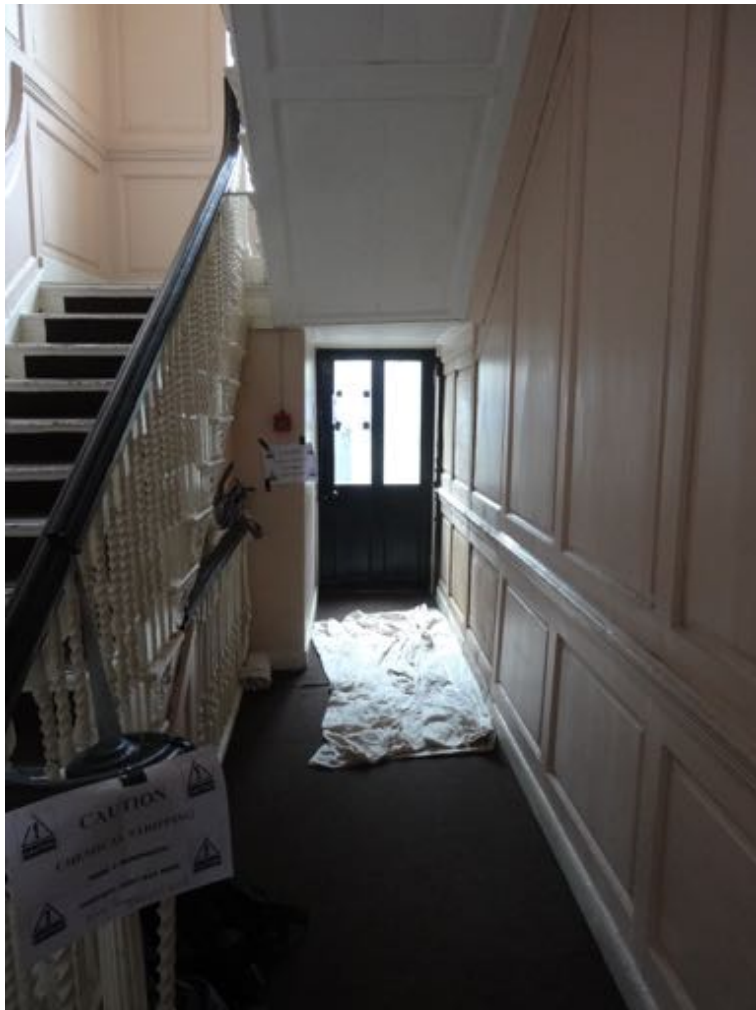
Figure 2: View of the ground floor corridor looking north, showing original panelling on the walls and the staircase with carved balusters and tread ends, March 2017.

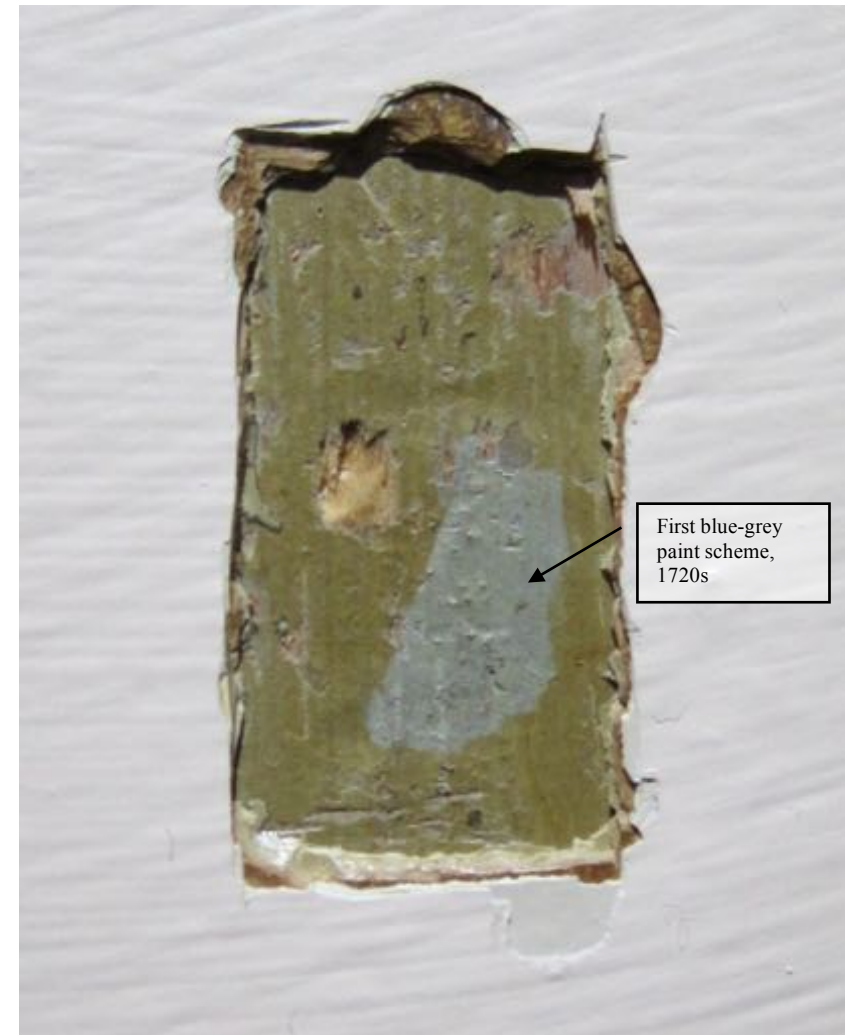
Figure 4: Uncovering on the west wall panelling, revealing the first blue-grey oil paint scheme below numerous layers of later paint. (Newly-exposed areas of original paint have a greenish appearance due to pronounced yellowing of the oil binder when not exposed to sunlight.) Uncovering ~10mm wide.

Prior to the systematic sampling of the painted features, several exploratory small uncoverings were made in selected areas of to gain a visual overview of the successive paint schemes. Uncoverings on the wall panelling revealed the first scheme, applied to the wood surface, to feature a blue-grey paint (Figure 4). This was succeeded by a second scheme with a dark, olive green paint (Figure 6). Numerous further paint schemes, of lesser historical interest, generally consist of off-white or pale colours.

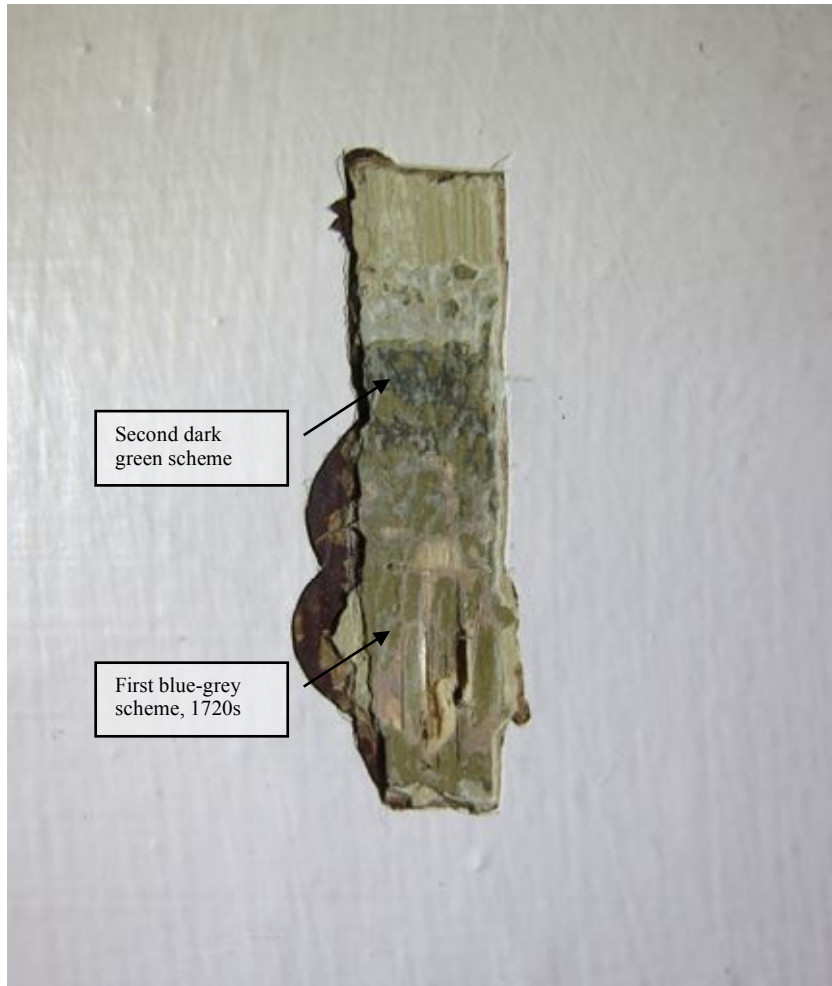
Figure 5: Uncovering showing the first, light grey-blue scheme at bottom (much of which is discoloured to a yellowish-green), fragments of the second dark green scheme at centre, and later paint schemes at the top. Uncovering ~10mm wide.

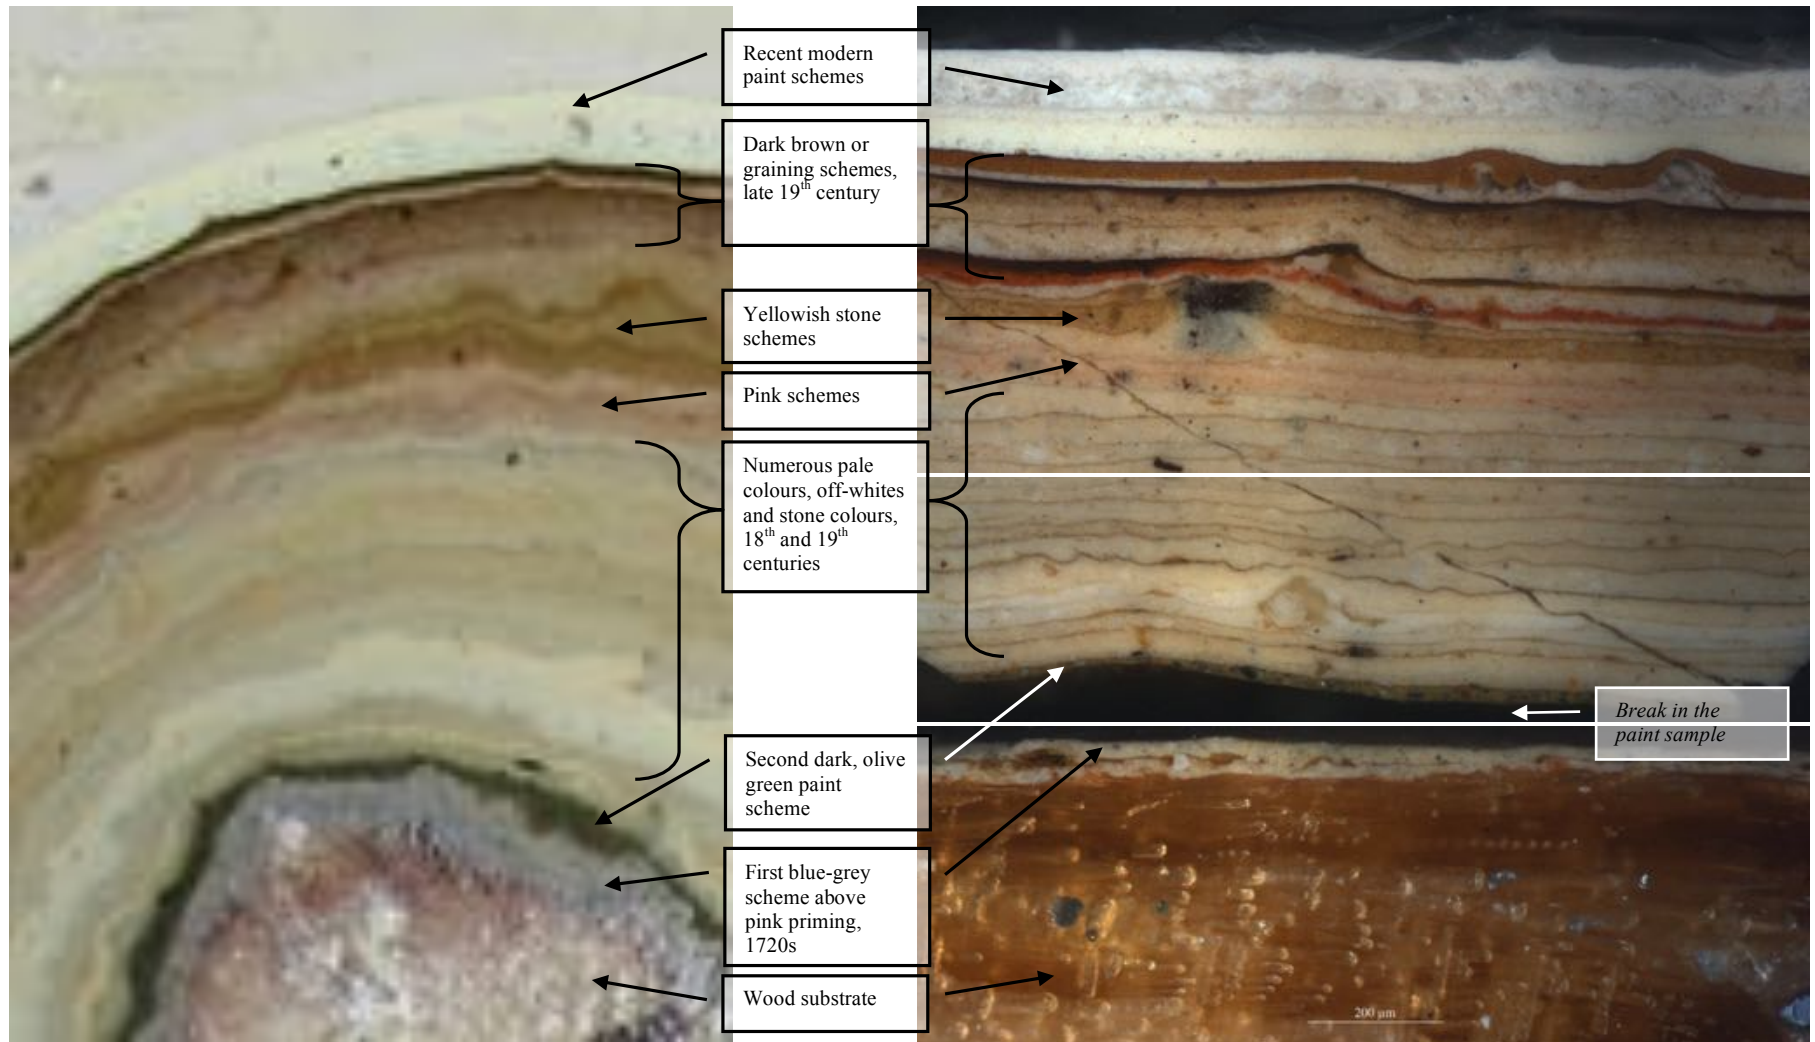
Figure 7: Detail of paint uncovering showing all layers from original blue-grey to modern white paint.

Figure 8: The full sequence of paint layers in cross-section, photographed from Sample 19 taken from the east wall pilaster capital. Most paint layers are delineated by thin, dark surface dirt layers. There is a break in the sample near the bottom where the second green paint scheme has separated from the underlying first blue-grey paint scheme.

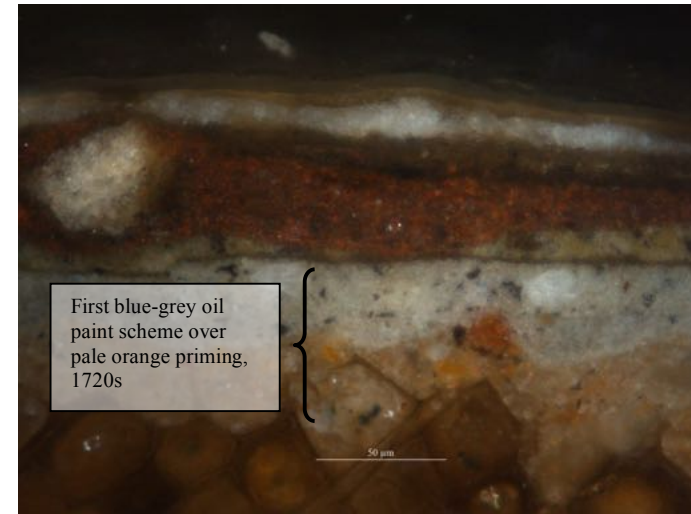
Figure 9: Lower layers of Sample 2, from the skirting of the east wall panelling. The original blue-grey scheme is here applied above a pale orange priming layer.

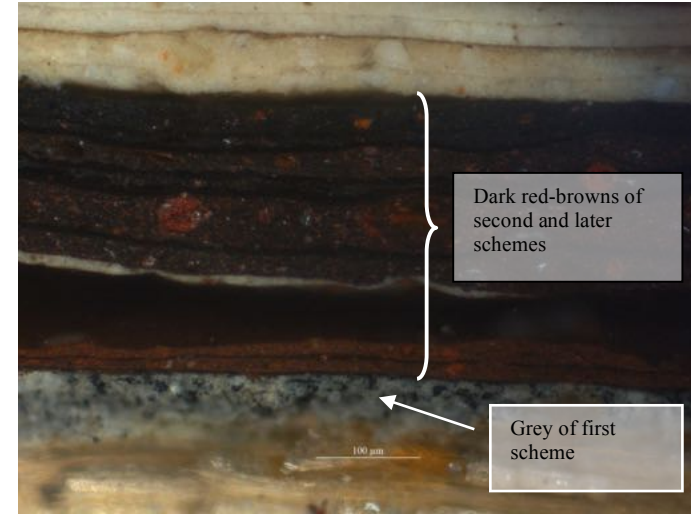
Figure 13: View of early layers in Sample 32B, from skirting on the stairway. The grey of the first scheme is followed by red-brown in the second scheme. Several later schemes employ dark browns.

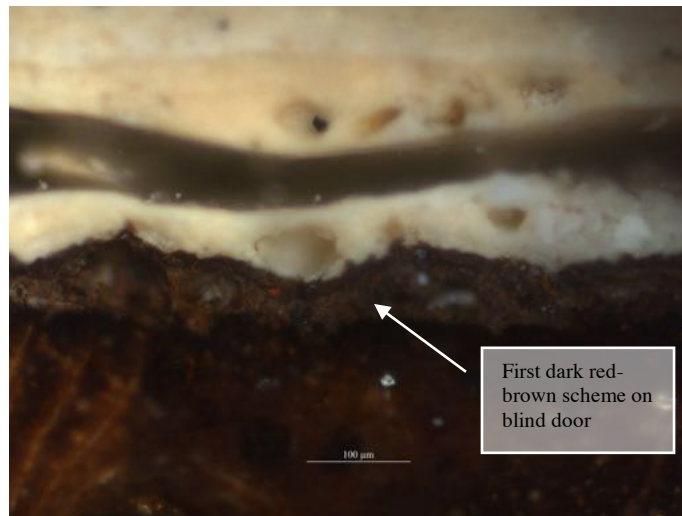
Figure 15: Lower paint layers from Sample 36, on the blind door on the west side, showing the dark brown first scheme applied to the wood surface.

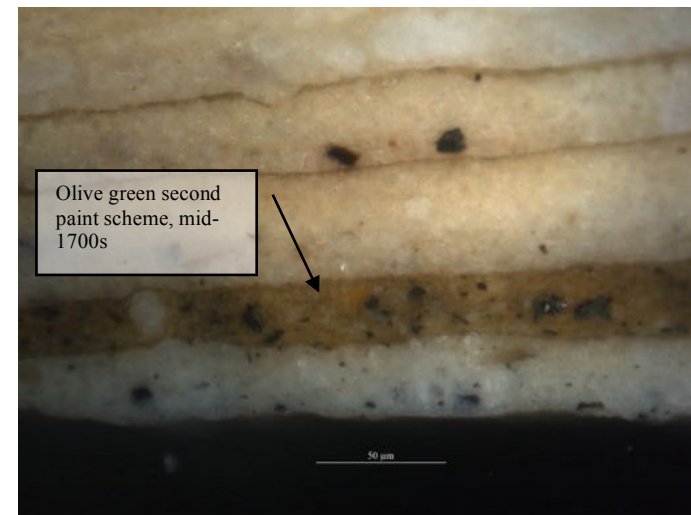
Figure 17: Lower layers of Sample 21 from east wall pilaster capital clearly showing the mixture of white, black and yellow pigments that make up the olive green paint of the second scheme.

The second decorative scheme applied to this interior is characterised by a distinctive dark, olive green oil paint containing a mixture of yellow ochre, lead white and black pigments (Figure 17). Such a mixture of relatively inexpensive pigments was frequently utilised to create a tertiary green colour without the requirement of the more expensive, brighter green pigments such as verdigris or verditer. This paint is found on the wall panelling, cornice, pilasters, architrave and stairwell, and is likely to date from the mid-1700s.

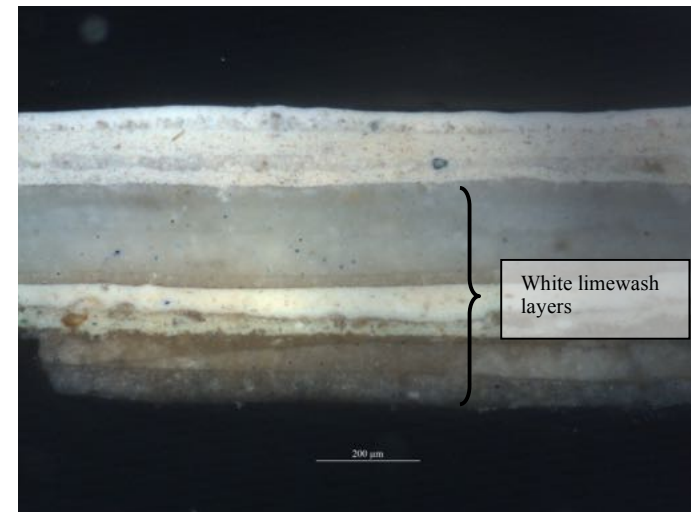
Figure 19: Upper layers of Sample 13 from the cornice, showing a series of limewash layers from the late 19th and early 20th century schemes beneath the modern paints.

The numerous pale schemes are followed by a series of several brown paint schemes, imitating dark wood, which certainly date to the late 19th and early 20th centuries (Figure 18: Upper layers of Sample 16 from the cornice, showing the later 19th century dark brown / graining schemes applied over earlier yellowish stone colours. Here the entirety of the wall panelling, pilasters and skirting were painted brown, probably with imitation graining, while the cornice and the architrave were painted with white limewash (Figure 19).

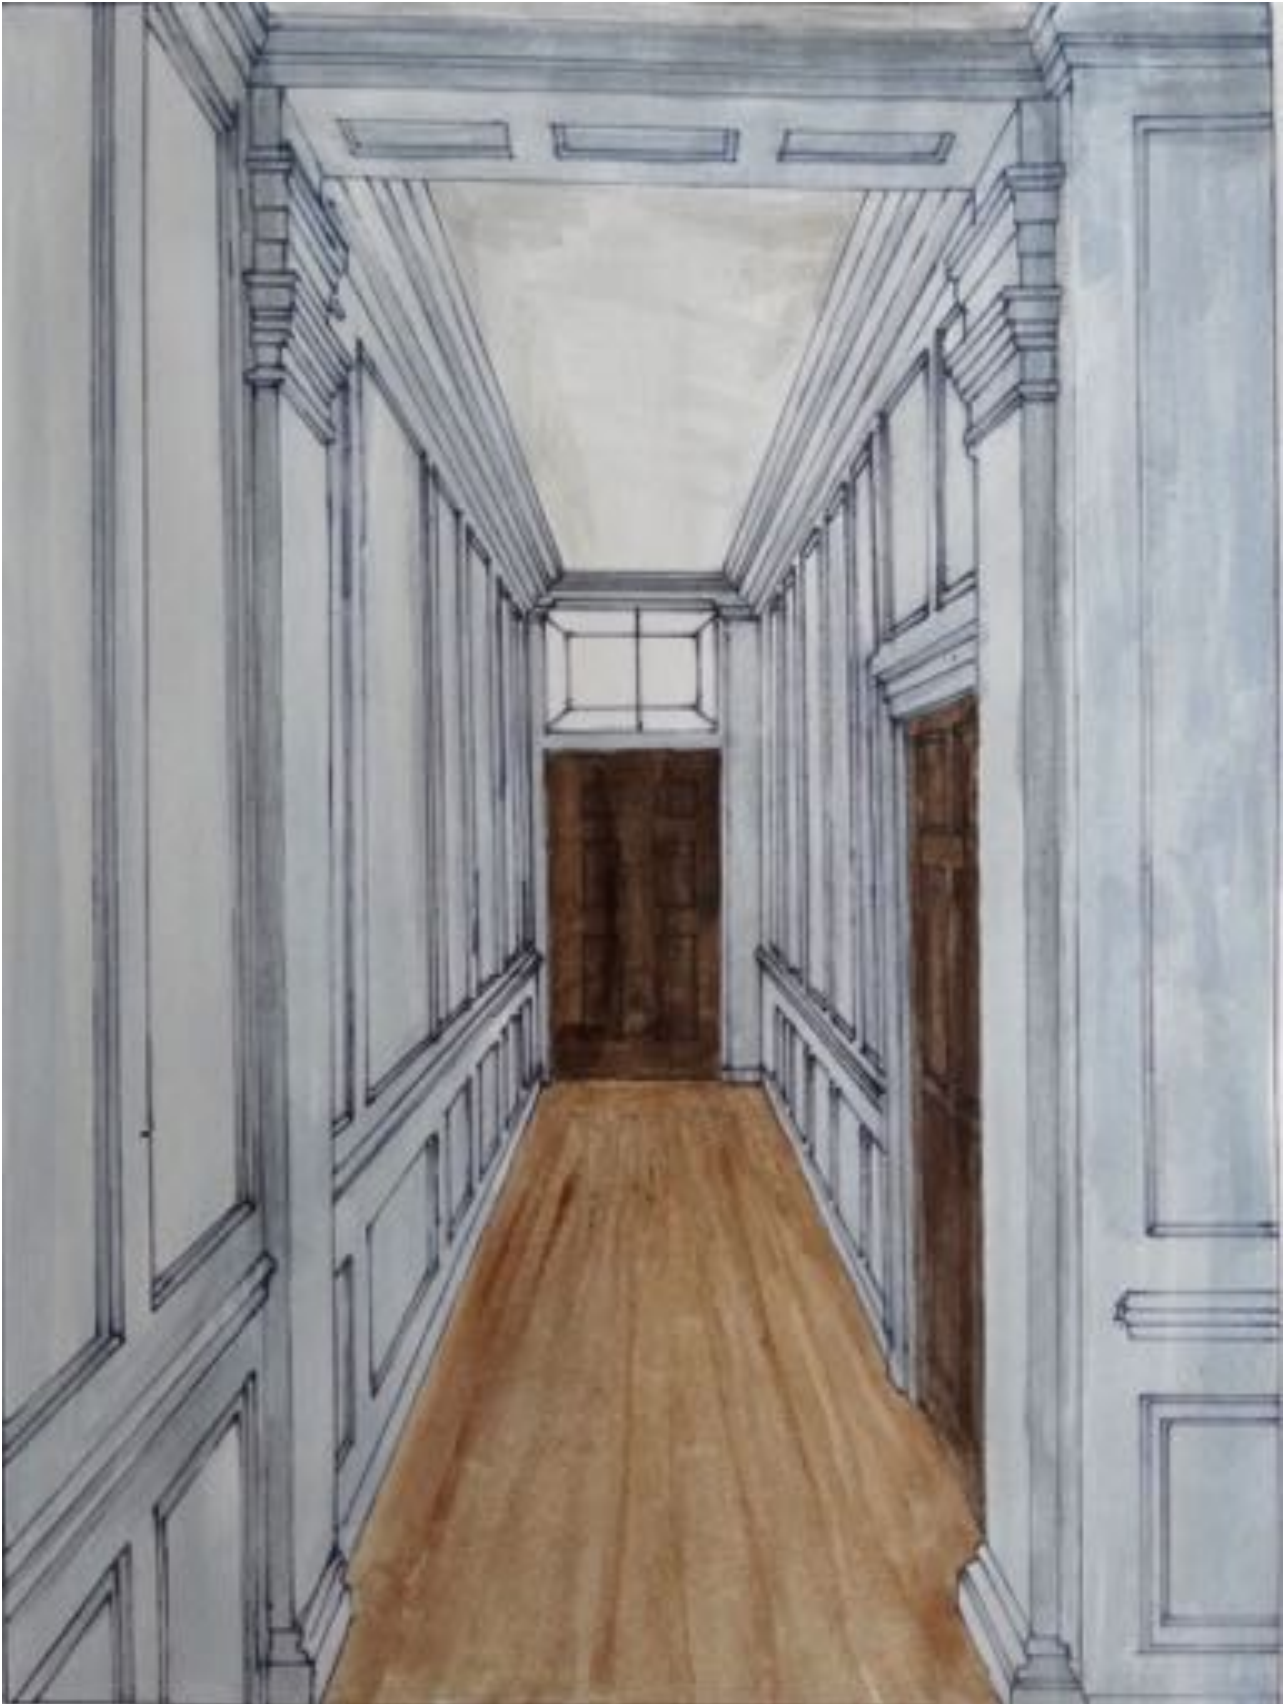
Figure 20: Reconstruction of original scheme of entrance hall. *(This image is intended to illustrate the first scheme as indicated by the results of analysis and is not intended to provide an accurate colour match.)*

As shown in the Table of Results above, the original decorative scheme of the early 1720s was found to consist chiefly of a pale, blue-grey oil paint. This was applied to all of the panelled joinery surfaces on the walls, including the skirting boards and cornice, and to the two pilasters and the architrave spanning between them. The panelling of the stairwell and the window joinery on the north wall were also treated with this same paint.
