128-130 GRAFTON ROAD, LONDON, NW5 4BA
Phase 1 Desk Study: Preliminary Risk Assessment

September 2017

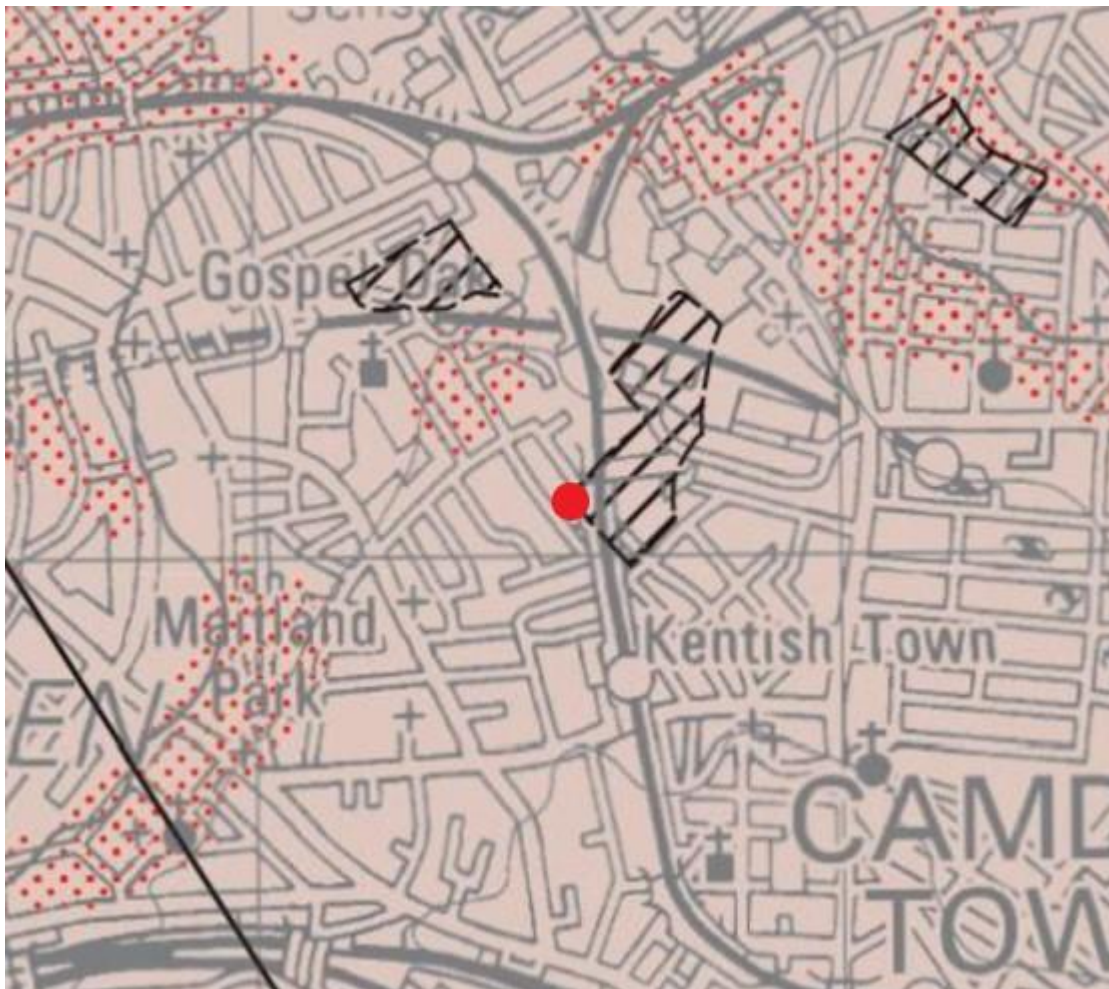
Figure 2: Geology

The available geological mapping (Ref 1.) indicates that the site lies on London Clay. London Clay typically comprises a stiff grey fissured clay, weathering to brown near surface. Concretions of argillaceous limestone in nodular form (Claystones) occur throughout the formation. The base of the London Clay is likely to occur at significant depth below the property. An area of worked ground (the hatched area) is indicated close by to the East and North. An area of potential Head Deposit is shown around 300m to the Northwest. See Figure 2 below.
