DESK STUDY, GROUND INVESTIGATION & BASEMENT IMPACT ASSESSMENT REPORT

35 TEMPLEWOOD AVENUE
LONDON
NW3 7UY

Report Title: Geotechnical Desk Study, Ground Investigation & Basement Impact Assessment for 35 Templewood Avenue, London, NW3 7UY

Job No: P1019J1129

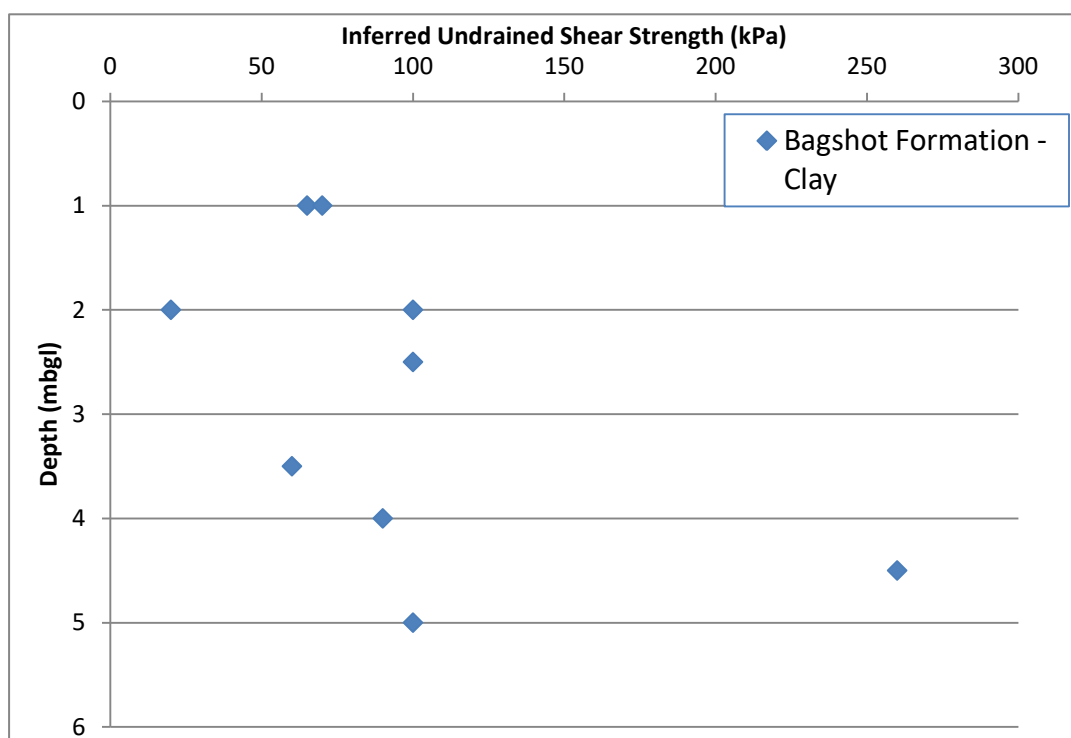
Figure 14.1: Inferred Undrained Shear Strength vs Depth

14.3.4 An SPT 'N' value of 22 was reported for the layer of Bagshot Formation - Sand at 3.50mbgl. This is slightly higher than the values recorded in the clay at around the same depth.
