**Part Dismantling and Rebuilding of Front Facade: Further Justification Statement
for Camden Planning Department's Conservation Officers**

125 Clerkenwell Road, London EC1R 5DB

October 2017

Monahan Blythen Hopkins Architects

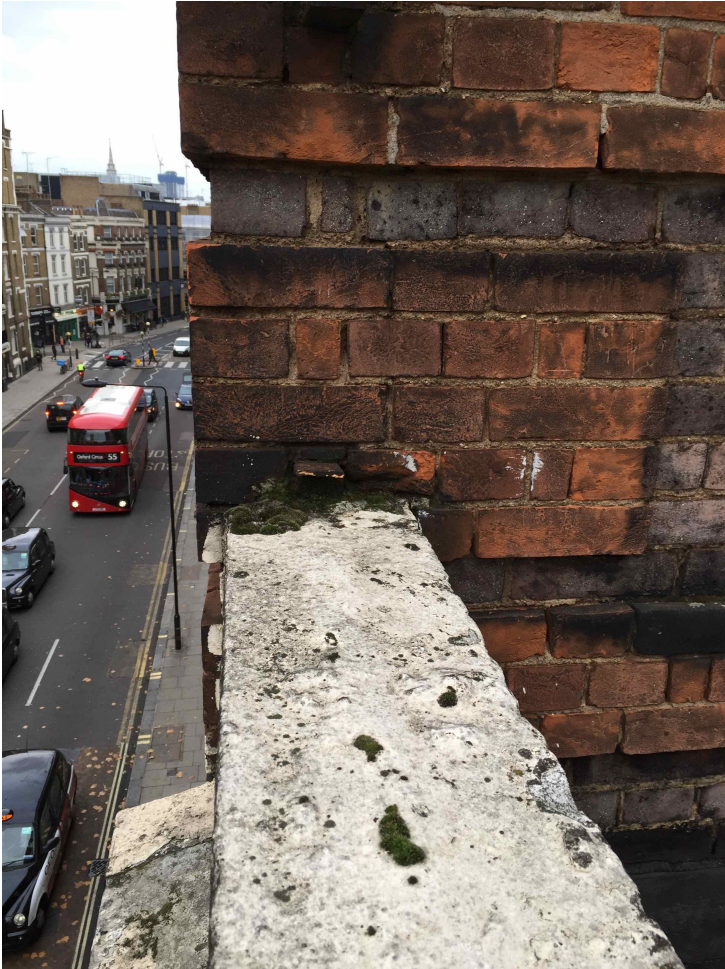
Photographs 1 and 2 show the top of the parapet wall to the infill section of 125 Clerkenwell Road and how it runs into the flank wall of 123 Clerkenwell Road. Note how there is return parapet wall to the property on the No. 125 side against the flank wall. Note also the fixing cleat for railings (no longer present) have been built into the flank wall, and how Quoins to the wall have been cut to allow the front parallel wall to abut tight against the flank wall.

The attached photographs illustrate the infill front parapet wall running into the flank wall of 123 Clerkenwell Road (see Photos 1 and 2) and how the quoining to the corner of the wall has been cut around the parapet wall at this junction. Photos 3 and 4 shows the rear parapet wall of the infill section at the junction with the flank wall of 123 Clerkenwell Road

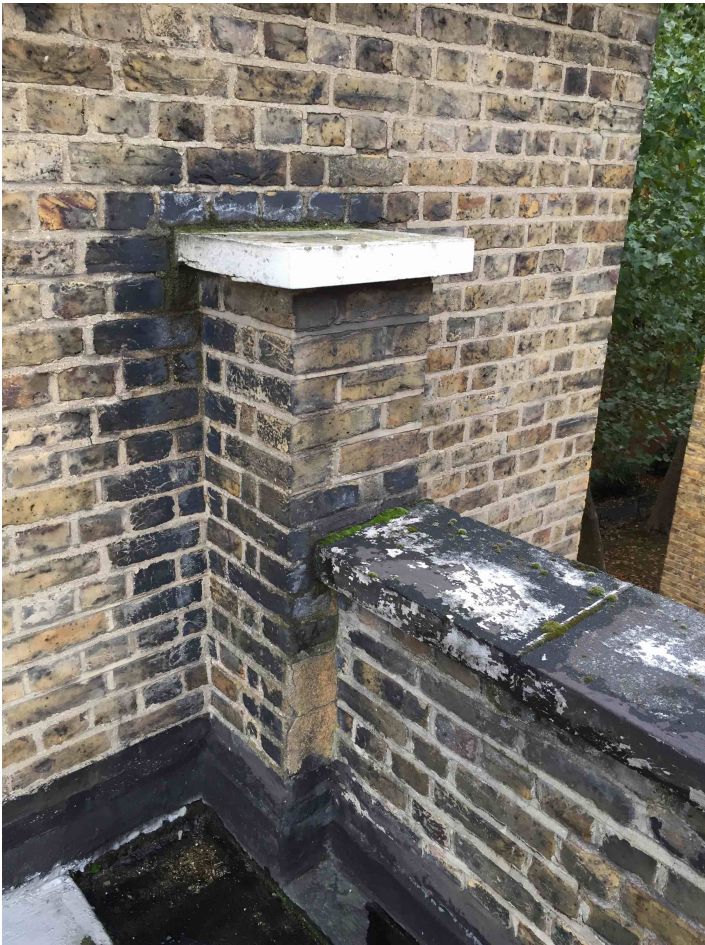
Photos 3 and 4 shows the parapet wall and pier to the rear (south) wall to the infill section (which already has permission to be demolished under application Ref. 2015/6751/P except the front wall to Clerkenwell Road). Note how the pier has been built into the wall, the bricks are the same type (London Yellow Stocks) and how the brick coursing also matches illustrating how both the infill section and No.123 would have been constructed at the same time.

(permission for the demolition of the infill building except the front facade was previously granted under application ref. 2015/6751/P); note the pier at this location and how the brickwork matches the bricks to the flank wall at this location not just in terms of the yellow stock bricks it is constructed from but also how the courses line through to both properties. The pier itself has also been built into the brickwork of the flank wall.

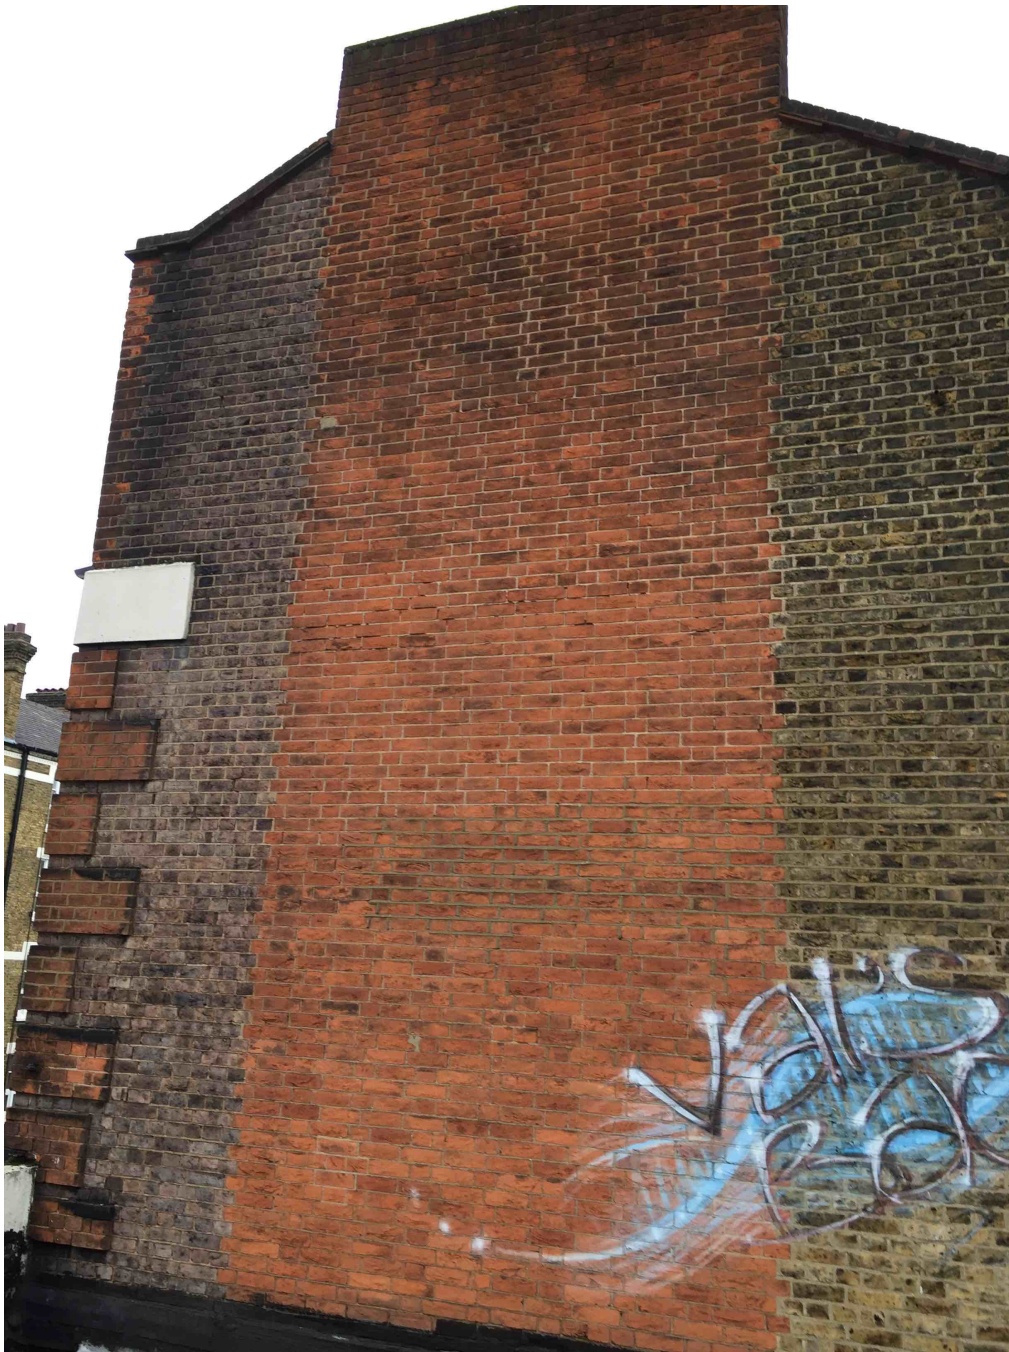
Photo of the flank wall of 123 Clerkenwell Road illustrating the three distinctive zones of brick types used to construct it including Brindle bricks to the street end of the wall (at left), London Red Stocks to the width of the large chimney stack and London Yellow stocks to the southern section of wall (at right) furthest away from the street. Note the graduation of the quality of pointing as the brickwork progresses away from Clerkenwell Road to the rear, with the best quality pointing being to the street side at left.

The bricks shown here above roof level is not visible internally where the brickwork has been exposed indicating that poorer quality Fletton brickwork was used where it was not going to be visible internally to the infill section of No. 125 when it was constructed.

Photographs taken at roof level demonstrate the higher quality of the brickwork and greater care in the pointing where the flank wall is visible above the roof level of the infill section of 123 Clerkenwell Road (refer to Photo 5 and the accompanying notes).

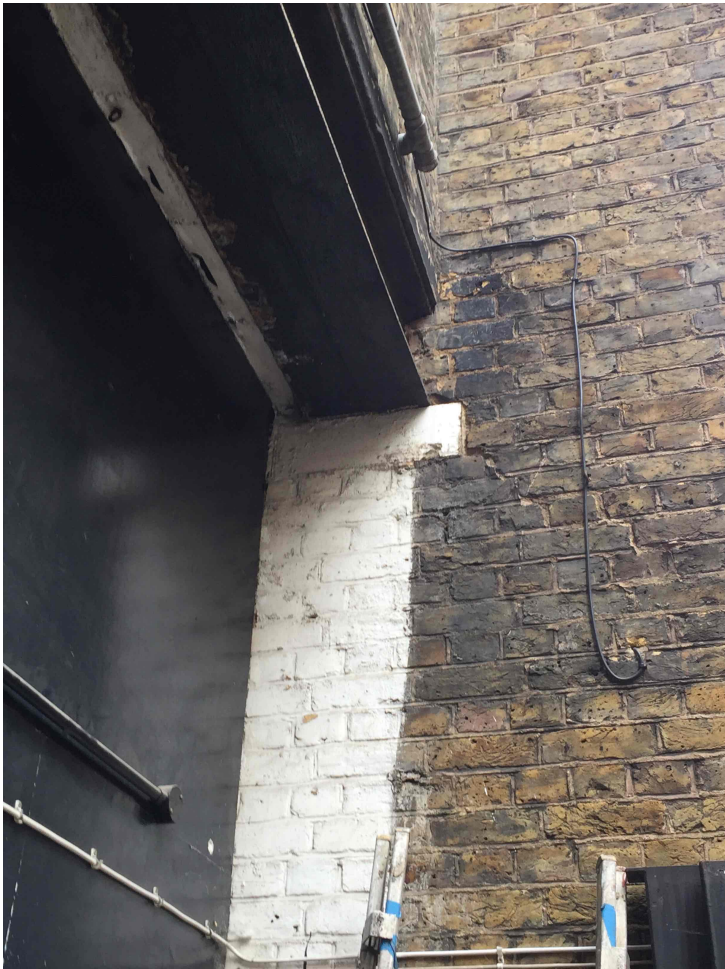
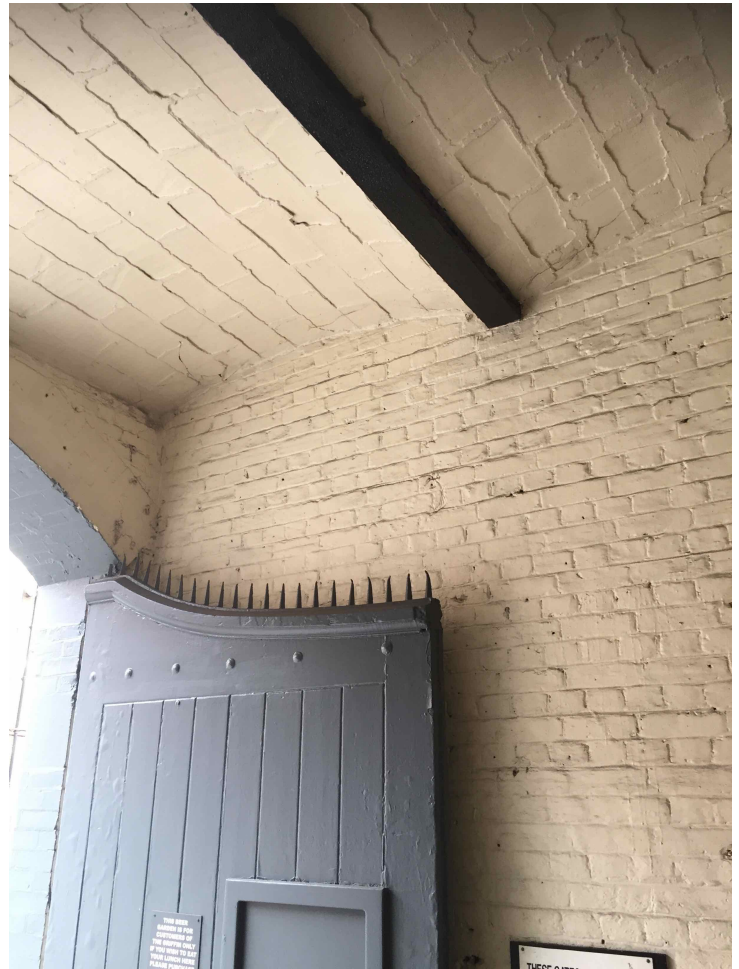
Photographs showing the flank wall of 123 Clerkenwell Road showing how structure from the infill section of No.125 has been built into the wall. Photo 6 shows a close up of the steel beam built into the flank wall (note the built-in pad stone) and Photo 7 shows how the beams to the vaulted ceiling are also built into the wall.

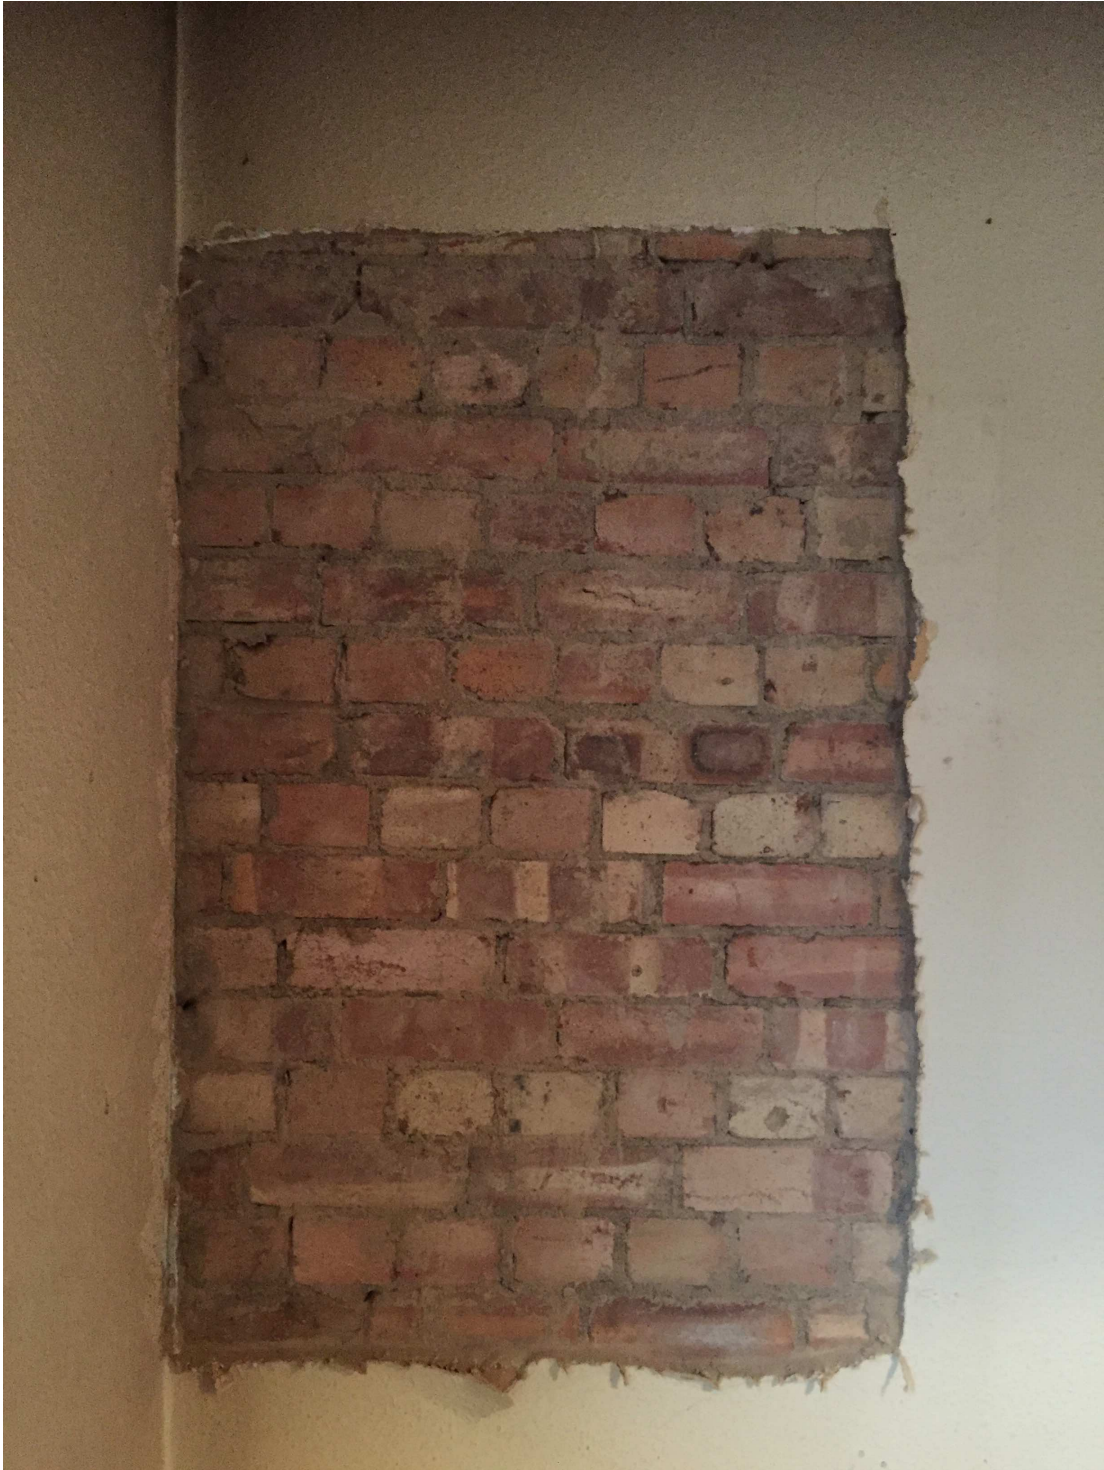
Photo 8

Photograph of investigation opening up to the front wall to the second floor of the infill section of 125 Clerkenwell Road, revealing the common Fletton bricks and poor quality pointing used where the brickwork was plastered internally consistent with the builders constructing the infill section at the same time as No. 123.

Because this section of the flank wall was not intended to be seen it was built with Fletton bricks. It is also worth noting that Fletton bricks were not widely used until the early 20th Century around the time they would have been used here.

At first floor level, finishes have been removed to the flank wall at the junction with the front facade wall as indicated in red on the floor plan included in this statement to expose the brickwork of the flank wall internally. This has revealed Fletton brickwork up to roof level to the flank wall where the brickwork and mortar is of poor quality indicating that it was intended not to be seen.

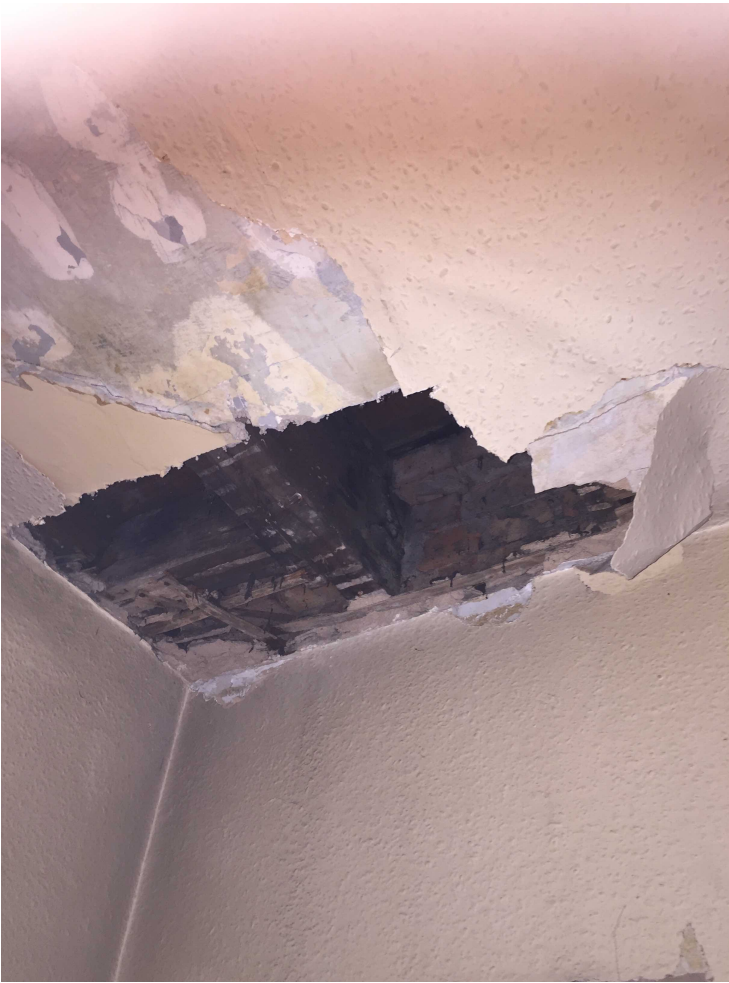
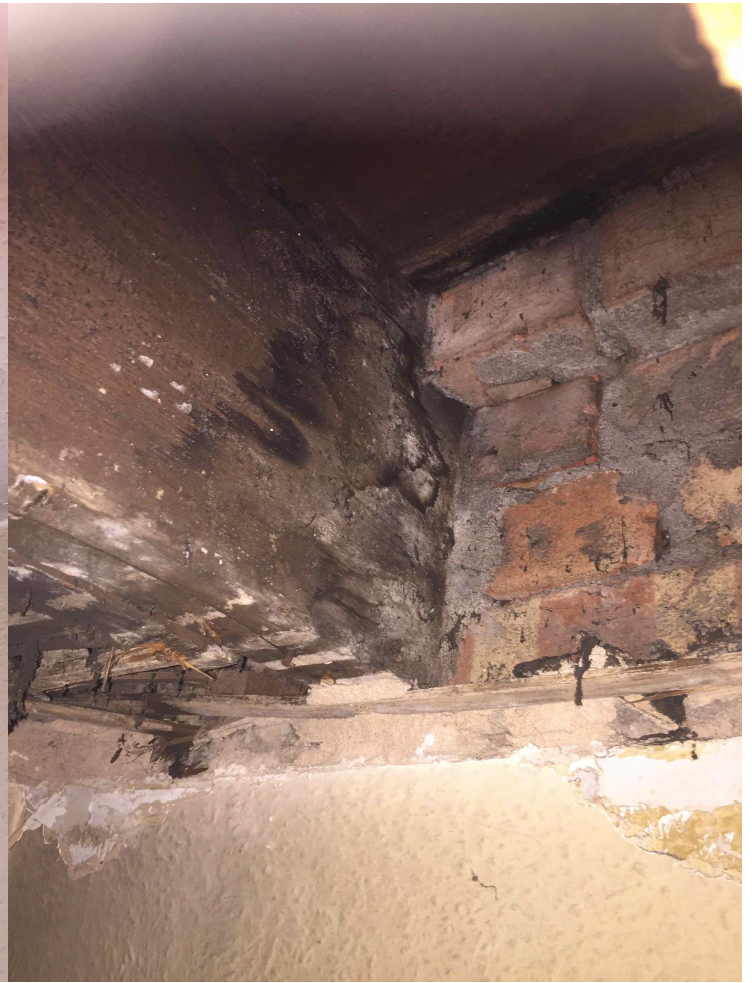
Photographs 9 and 10 show the exploratory works to the ceiling of the second floor front bedroom showing the roof construction of the infill section and how it relates to the flank wall of 123 Clerkenwell Road.

Note how the original timber roof joists are built into the brickwork of the flank wall and how the brickwork to the flank wall has been corbelled to support the roof finishes over where they have been dressed up and into the wall to waterproof it. This in our view gives further evidence that the infill section was built at the same time as 123 Clerkenwell Road.
