GARDEN ELEVATION - WEST

REAR ELEVATION - SOUTH

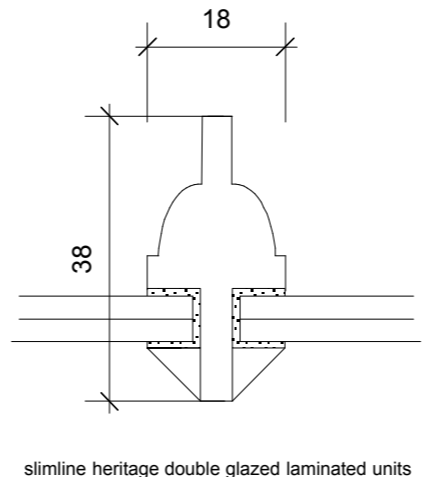
**A**  
GLAZING BAR  
ALL WINDOWS  
DETAIL 1:1

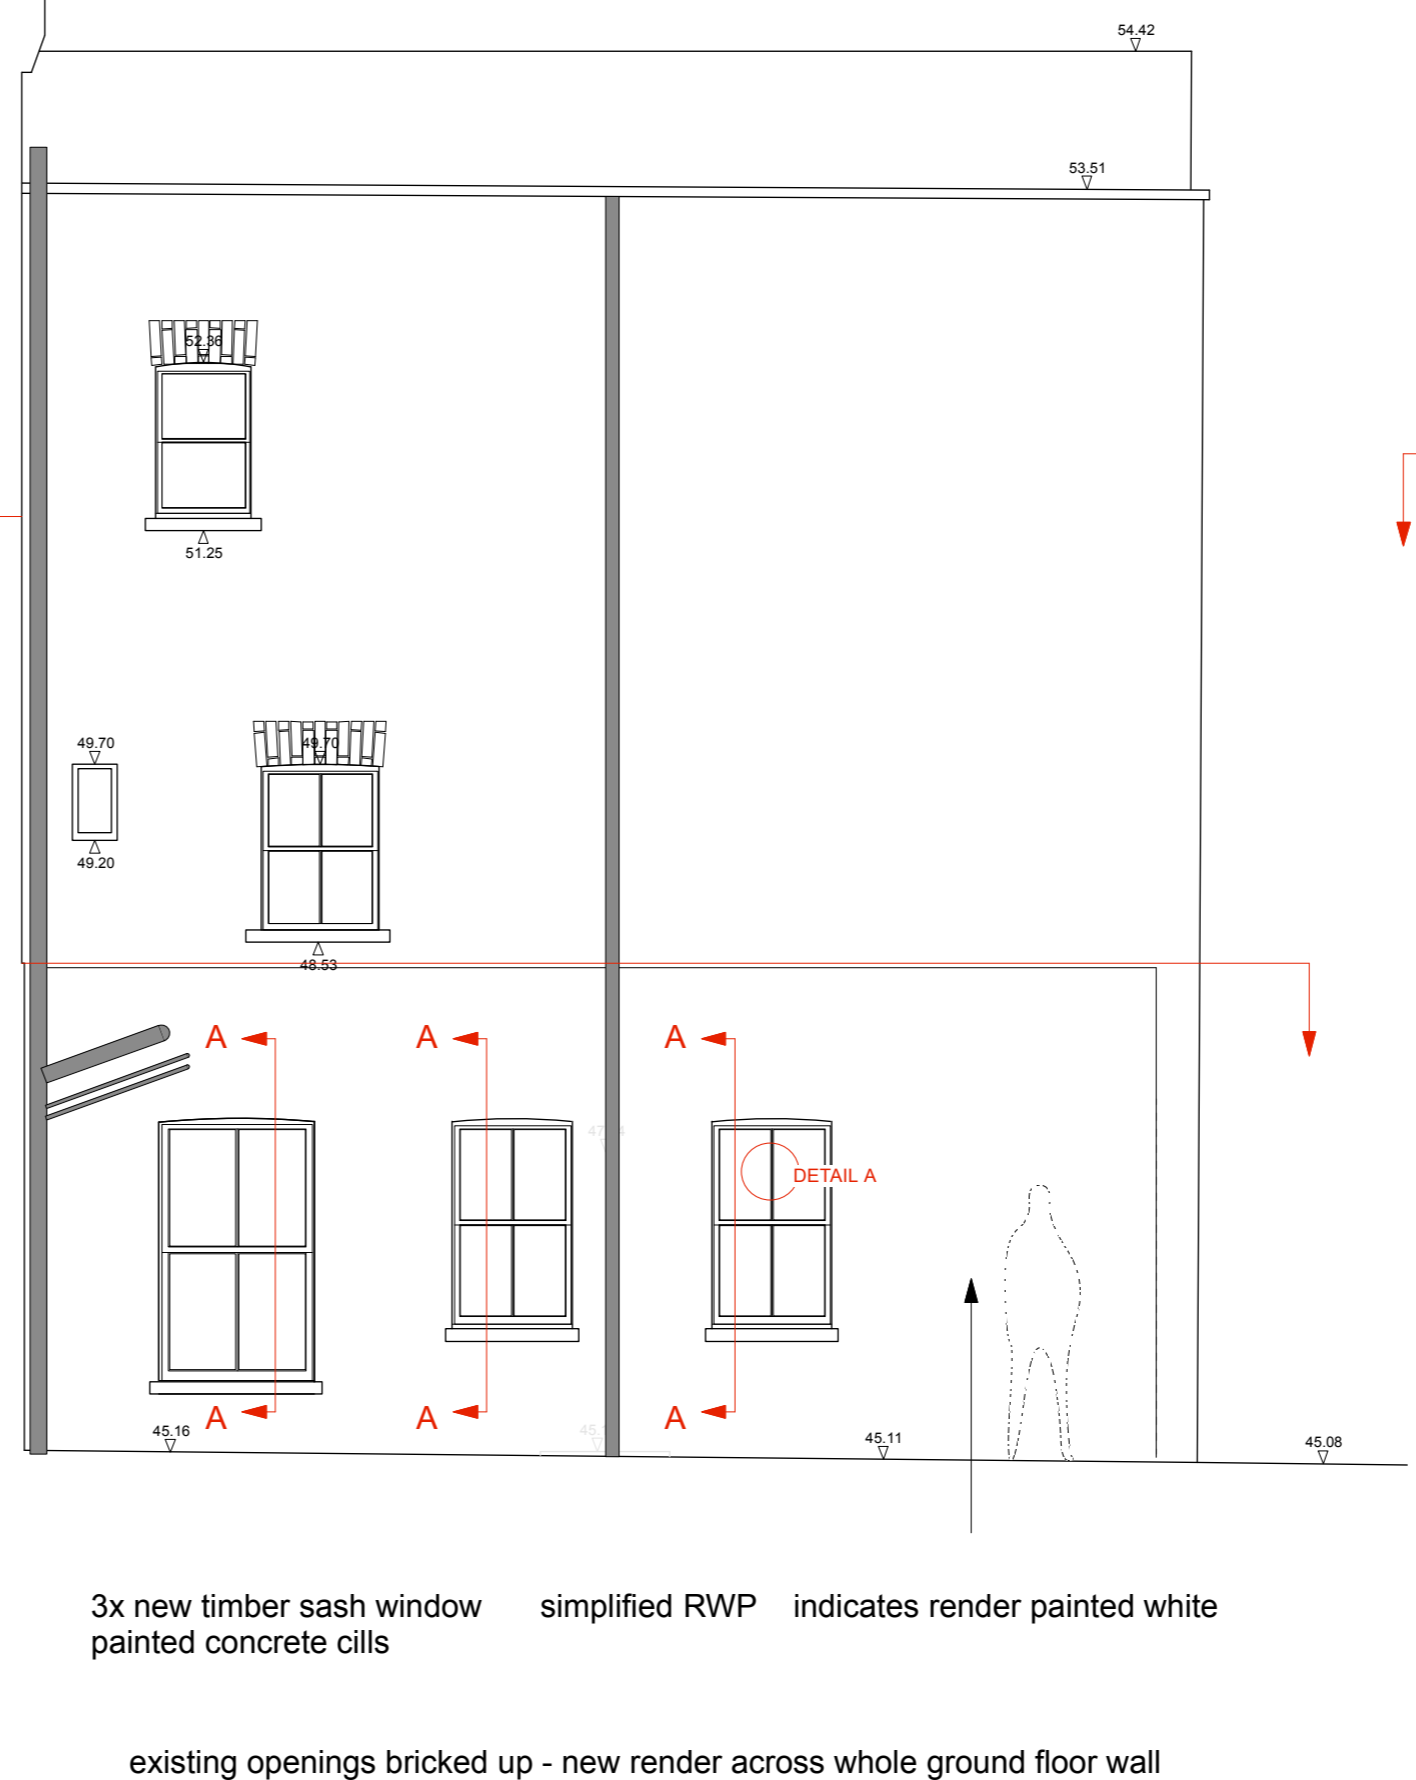
existing openings bricked up - new render across whole ground floor wall
