# **Factual Report**

Site 13a Pond Street

# **FACTUAL REPORT CONTENT**

# Laboratory Report

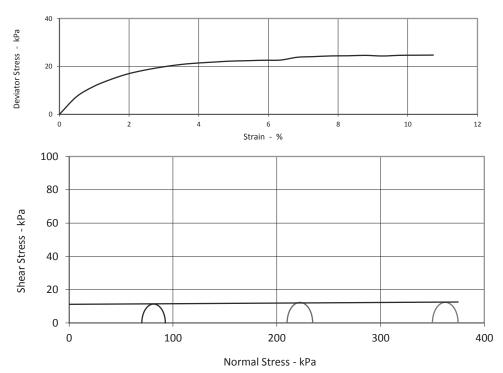
Sample Details						
Description	V	ery soft yello	wish brown §	grey veined silty (	CLAY.	
Sample Condition	ι	Indisturbed				
Height	mm	205.0				
Diameter	mm	104.0				
Moisture Content	%	34				
Bulk Density	Mg/m³	1.88				
Dry Density	Mg/m³	1.41				
Test Details	Stage	1	2	3		
Membrane Thickness	mm	0.26	0.26	0.26		
Membrane Correction	kPa	0.39	0.51	0.60		
Rate of Axial Displacement	%/min	1.76	1.76	1.76		
Cell Pressure	kPa	70	210	350		
Strain at Failure	%	6.3	8.8	10.7	Shear S	Strength
Maximum Deviator Stress	kPa	23	25	25	Paramo	eters
Shear Strength	kPa	11	12	12	С	11 kPa
Mode of Failure				Intermediate	Phi	0.2 °

Unconsolidated Undrained Shear Strength Tested in Accordance with BS 1377: Part 7: 1990

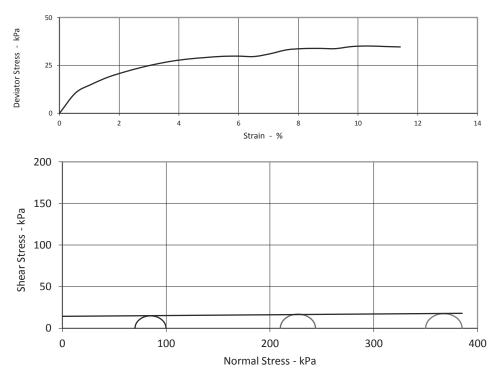
Sample Details						
Description	St	tiff to firm Bro	own SILTY Cla	ау		
Sample Condition	ι	Jndisturbed				
Height	mm	184.0				
Diameter	mm	103.0				
Moisture Content	%	28				
Bulk Density	Mg/m³	1.97				
Dry Density	Mg/m³	1.54				
Test Details	Stage	1	2	3		
Membrane Thickness	mm	0.27	0.27	0.27		
Membrane Correction	kPa	0.39	0.53	0.61		
Rate of Axial Displacement	%/min	1.96	1.96	1.96		
Cell Pressure	kPa	70	210	350		
Strain at Failure	%	6.0	8.7	10.3	Shear S	Strength
Maximum Deviator Stress	kPa	30	34	35	Paramo	eters
Shear Strength	kPa	15	17	18	С	14 kPa
Mode of Failure				Intermediate	Phi	0.5 °

Unconsolidated Undrained Shear Strength Tested in Accordance with BS 1377: Part 7: 1990

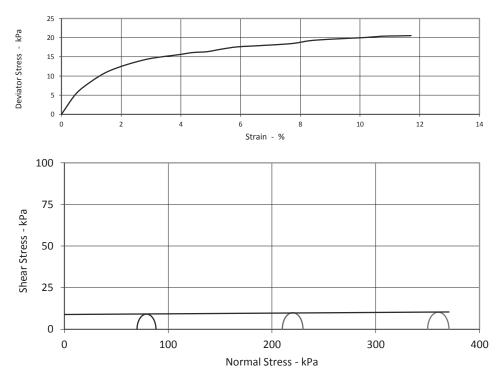
Sample Details						
Description	FI	RM YELLOWI	SH Brown Cla	ay		
Sample Condition	ι	Indisturbed				
Height	mm	205.0				
Diameter	mm	104.0				
Moisture Content	%	20				
Bulk Density	Mg/m³	1.86				
Dry Density	Mg/m³	1.55				
Test Details	Stage	1	2	3		
Membrane Thickness	mm	0.19	0.19	0.19		
Membrane Correction	kPa	0.32	0.41	0.47		
Rate of Axial Displacement	%/min	1.76	1.76	1.76		
Cell Pressure	kPa	70	210	350		
Strain at Failure	%	7.3	9.8	11.7	Shear S	Strength
Maximum Deviator Stress	kPa	18	20	21	Param	eters
Shear Strength	kPa	9	10	10	С	9 kPa
Mode of Failure				Intermediate	Phi	0.2 °

Unconsolidated Undrained Shear Strength Tested in Accordance with BS 1377: Part 7: 1990

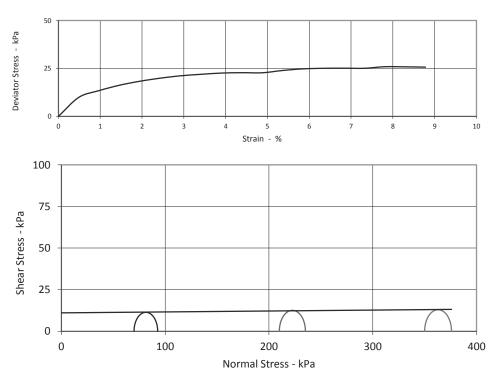
Sample Details						
Description	Fi	rm yellowish	brown grey	veined silty CLAY		
Sample Condition	ι	Indisturbed				
Height	mm	205.0				
Diameter	mm	104.0				
Moisture Content	%	32				
Bulk Density	Mg/m³	1.88				
Dry Density	Mg/m³	1.43				
Test Details	Stage	1	2	3		
Membrane Thickness	mm	0.27	0.27	0.27		
Membrane Correction	kPa	0.30	0.44	0.48		
Rate of Axial Displacement	%/min	1.76	1.76	1.76		
Cell Pressure	kPa	70	210	350		
Strain at Failure	%	4.4	6.8	7.8	Shear S	Strength
Maximum Deviator Stress	kPa	23	25	26	Parame	eters
Shear Strength	kPa	11	13	13	С	11 kPa
Mode of Failure				Intermediate	Phi	0.3 °

Unconsolidated Undrained Shear Strength Tested in Accordance with BS 1377: Part 7: 1990

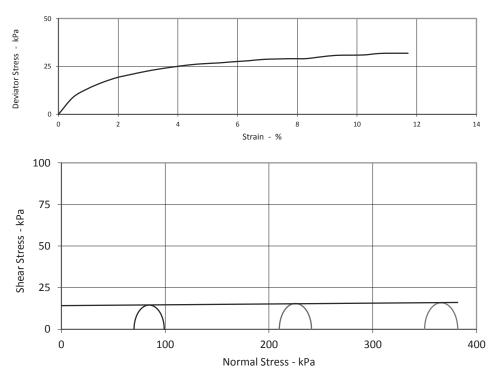
Sample Details						
Description	St	iff brown silt	y CLAY			
Sample Condition	ι	Indisturbed				
Height	mm	205.0				
Diameter	mm	104.0				
Moisture Content	%	32				
Bulk Density	Mg/m³	1.88				
Dry Density	Mg/m³	1.43				
Test Details	Stage	1	2	3		
Membrane Thickness	mm	0.27	0.27	0.27		
Membrane Correction	kPa	0.51	0.60	0.66		
Rate of Axial Displacement	%/min	1.76	1.76	1.76		
Cell Pressure	kPa	70	210	350		
Strain at Failure	%	8.3	10.2	11.7	Shear S	Strength
Maximum Deviator Stress	kPa	29	31	32	Param	eters
Shear Strength	kPa	15	15	16	С	14 kPa
Mode of Failure				Intermediate	Phi	0.3 °

Unconsolidated Undrained Shear Strength Tested in Accordance with BS 1377: Part 7: 1990
