# **Arboricultural impact assessment**

## **5 Rudgwick Terrace, Avenue Road**

## **London NW**

# Arboricultural impact assessment of proposed development at 5 Rudgwick Terrace, Avenue Road London NW8 6BR

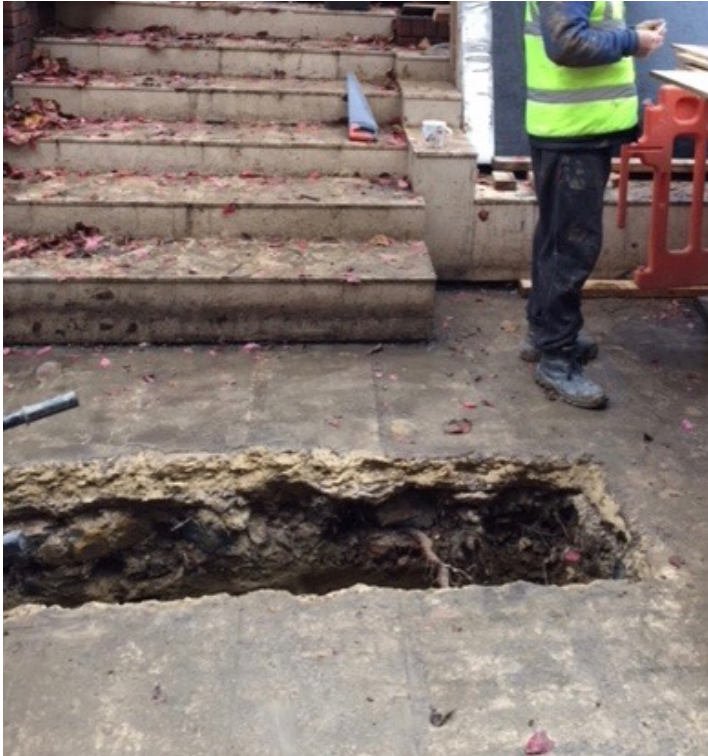
- 4.8 The trench was along the line of the north wall of the proposed extension, about 4.5m long and about 0.5m wide. A thick concrete slab was uncovered below the patio paving.
- 4.9 Only a few individual hair roots and a single root of less than 25mm diameter (probably from the lime T3) were discovered – please see the photographs overleaf.
- 4.10 While the loss of any tree root should ideally be avoided, the loss of some fine individual roots and a single small-diameter root would not cause any significant short-term or long-term harm to the tree.

PHOTO 1: position of trial trench and single root

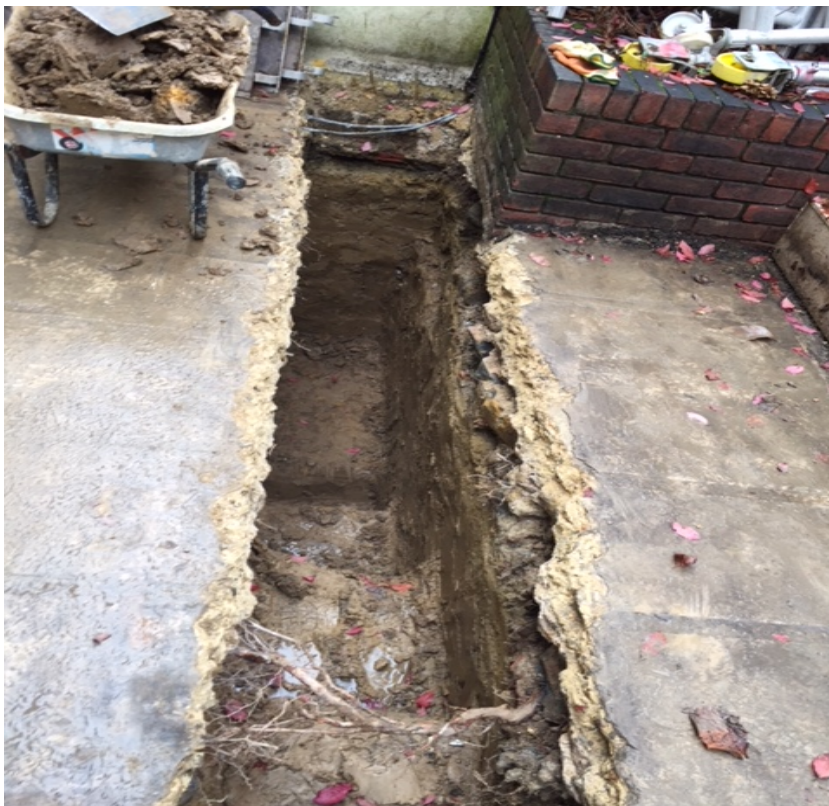
PHOTO 2: the single root of less than 25mm diameter in the trial trench

- 5.3 A trial trench showed only one root of any size (but under 25mm diameter) to be present under the site of the proposed rear extension. Its loss would not have a harmful long-term impact.
