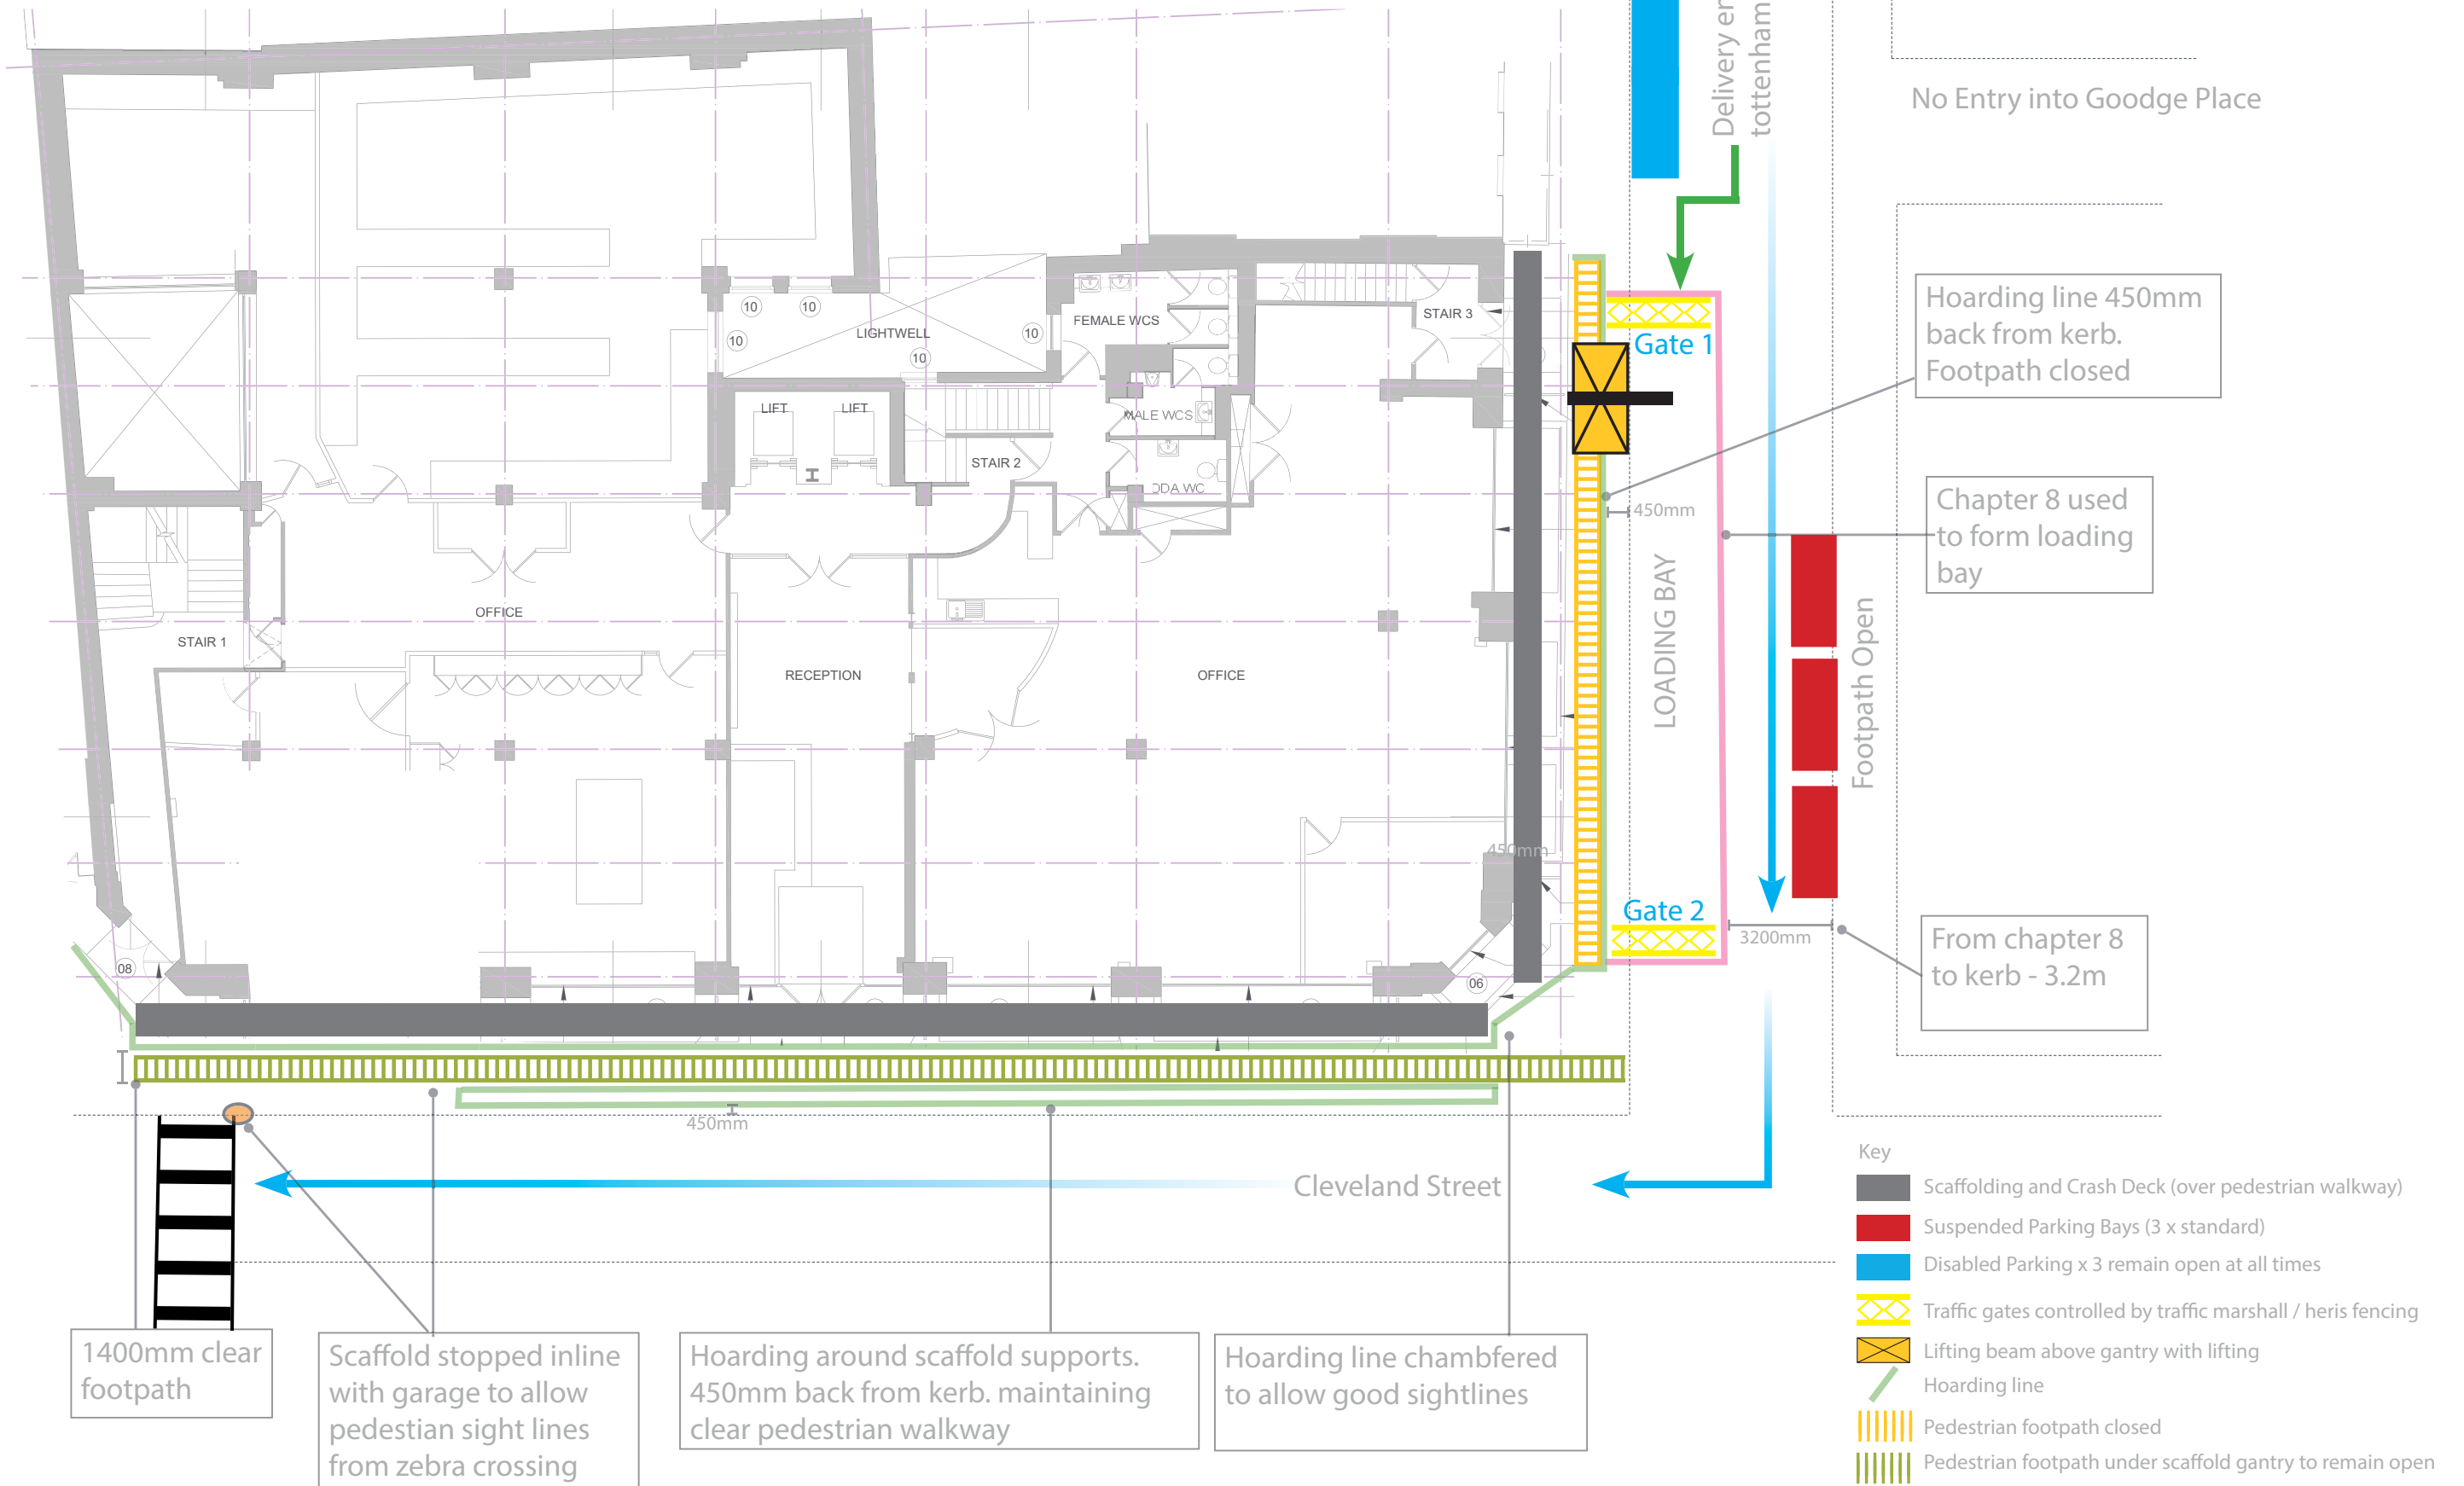
Hoarding line 450mm back from kerb. Footpath closed

Chapter 8 used to form loading bay

From chapter 8 to kerb - 3.2m

1400mm clear footpath

Scaffold stopped inline with garage to allow pedestrian sight lines from zebra crossing

Hoarding around scaffold supports. 450mm back from kerb. maintaining clear pedestrian walkway

Hoarding line chamfered to allow good sightlines
