135-149
Shaftesbury
Avenue
London
WC2H 8AH

Preliminary Ecological Appraisal

November
2017

Ref: 17-3621

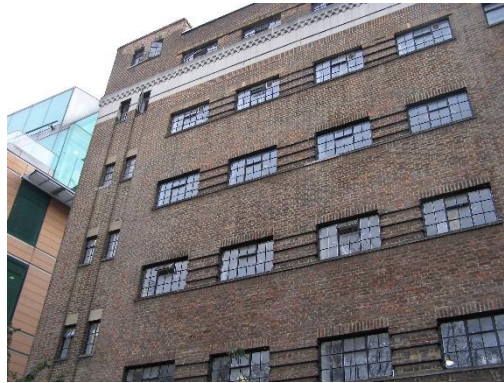
The buildings metal doors, glass doors and windows were all intact and tight within their frames. No gaps, holes, cracks or missing sections were noted along the doors or windows. The brick walls were in a good state of repair with no holes, gaps, cracks or missing bricks. The stone facades were tight against the bricks and noted no holes, gaps, crack or missing sections.

Rear of building

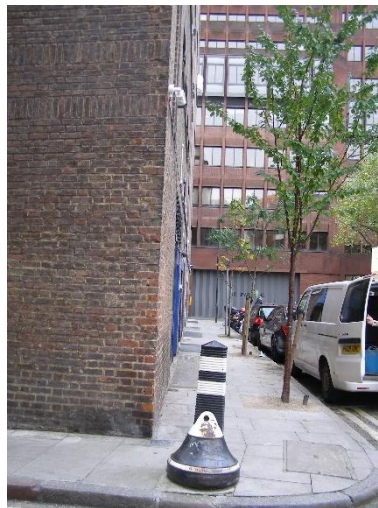
The building sits within hard standing with no emerging vegetation. To the northern offsite boundary are immature Cherry, Rowan and London Plane trees set within hard standing path. Directly north of the site is Phoenix Gardens, an area with a mixture of mature trees, semi-mature trees, and areas of ornamental planting including shrubs, flowers and grasses.

Trees within offsite northern boundary

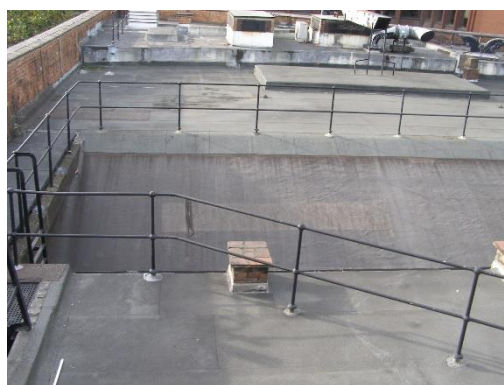
The inspection of the roof space noted tar and asphalt lined flat roofs with areas of brick, metal and asphalt edging. The raised stores and stairwell areas meet the roof space with no holes, gaps or missing sections. The store and stairwell buildings consisted of brick, cement and pebble dash with flat asphalt roofs. The buildings had no missing sections, cracks, gaps or holes within the walls or roof space.

Lined roof space

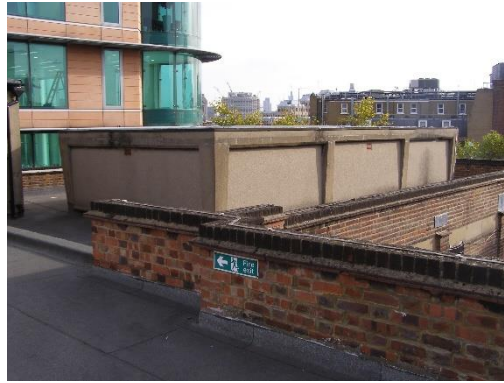
In summary, the upper roof stores and stairwells were flat roofs with no loft spaces. The stores consist of brick walls, cement and exposed roof spaces consisting of cement and plywood. The spaces lacked suitable crevice roosting spaces or potential access points. No signs of bats in the form of droppings, debris, marks or stains were noted. No signs of remnant or active nesting birds were noted.

Stores on roof space

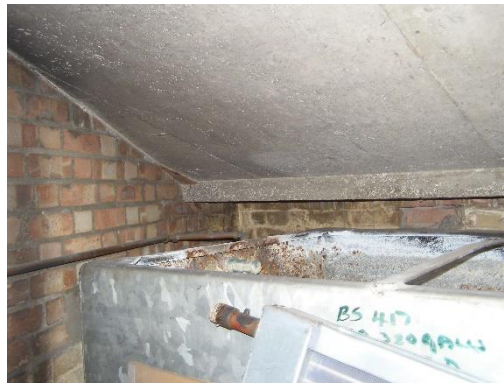
Internal water tank store

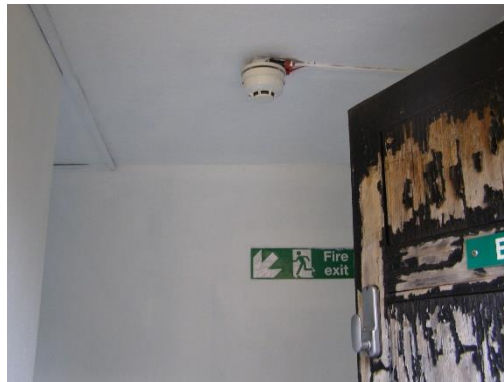
The stairwells consisted of plasterboard and cement walls with plasterboard roof spaces. No areas of visible light were noted during the survey. The stairwell areas lacked suitable crevice spaces or access points. No signs of bats in the form of droppings, debris, marks or stains were noted. No signs of remnant or active nesting birds were noted.

Internal stairwell
