59 St Giles High Street

Investigative Strip Out & Proposed Works

The following document acts as a visual representation of the found condition, the extent of proposed investigative strip out works, and proposed works to No. 59 St Giles High Street following site visits dated 14th September 2017, 11th October 2017 & 19th October 2017 by Ian Chalk Architects.

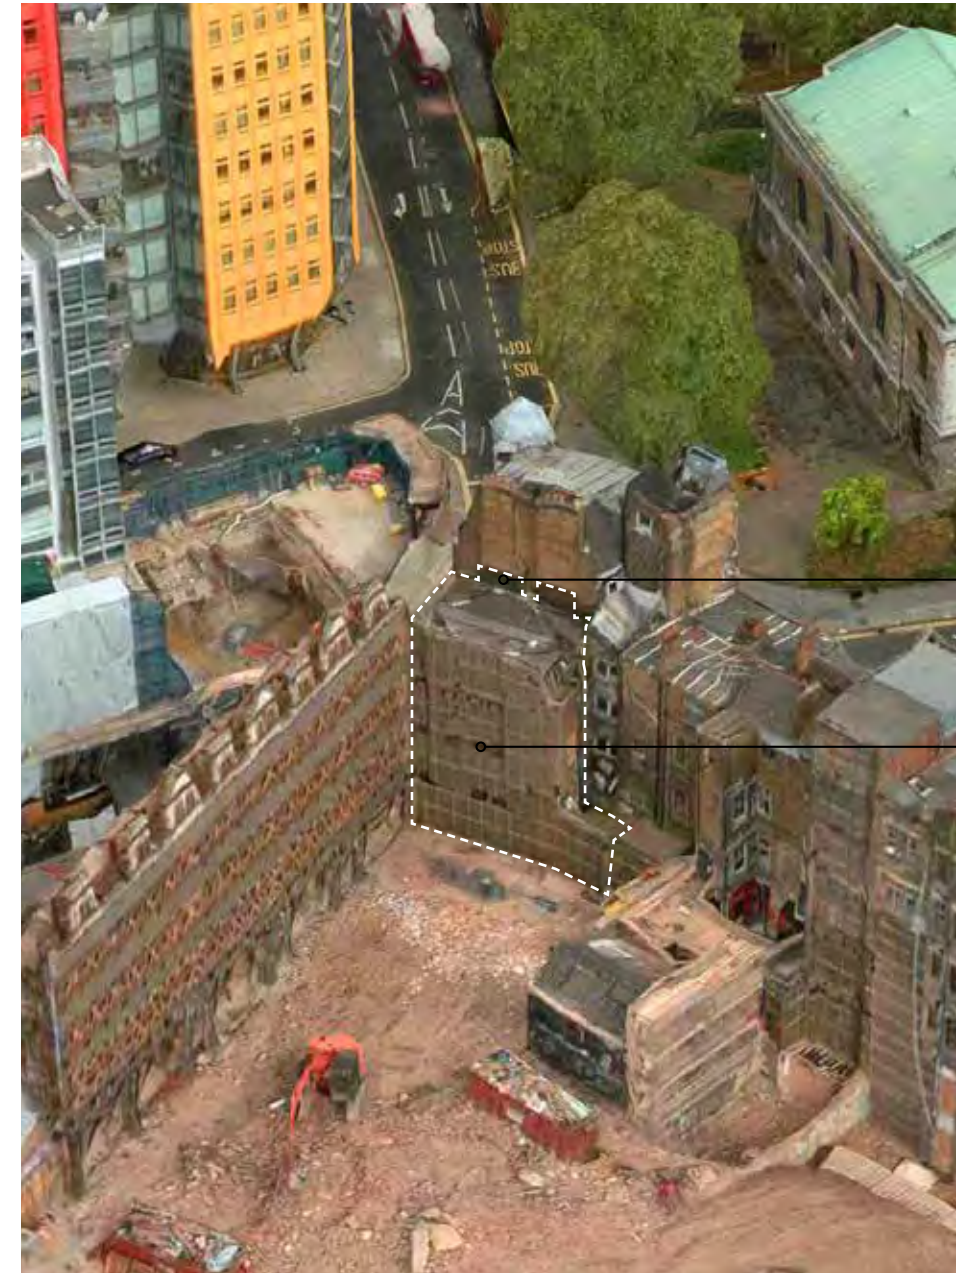
59 St Giles High Street  
Aerial image looking south east

Original chimney stacks extended  
for nos 28 Denmark Street

Wall ties put in by others  
supporting exposed party wall

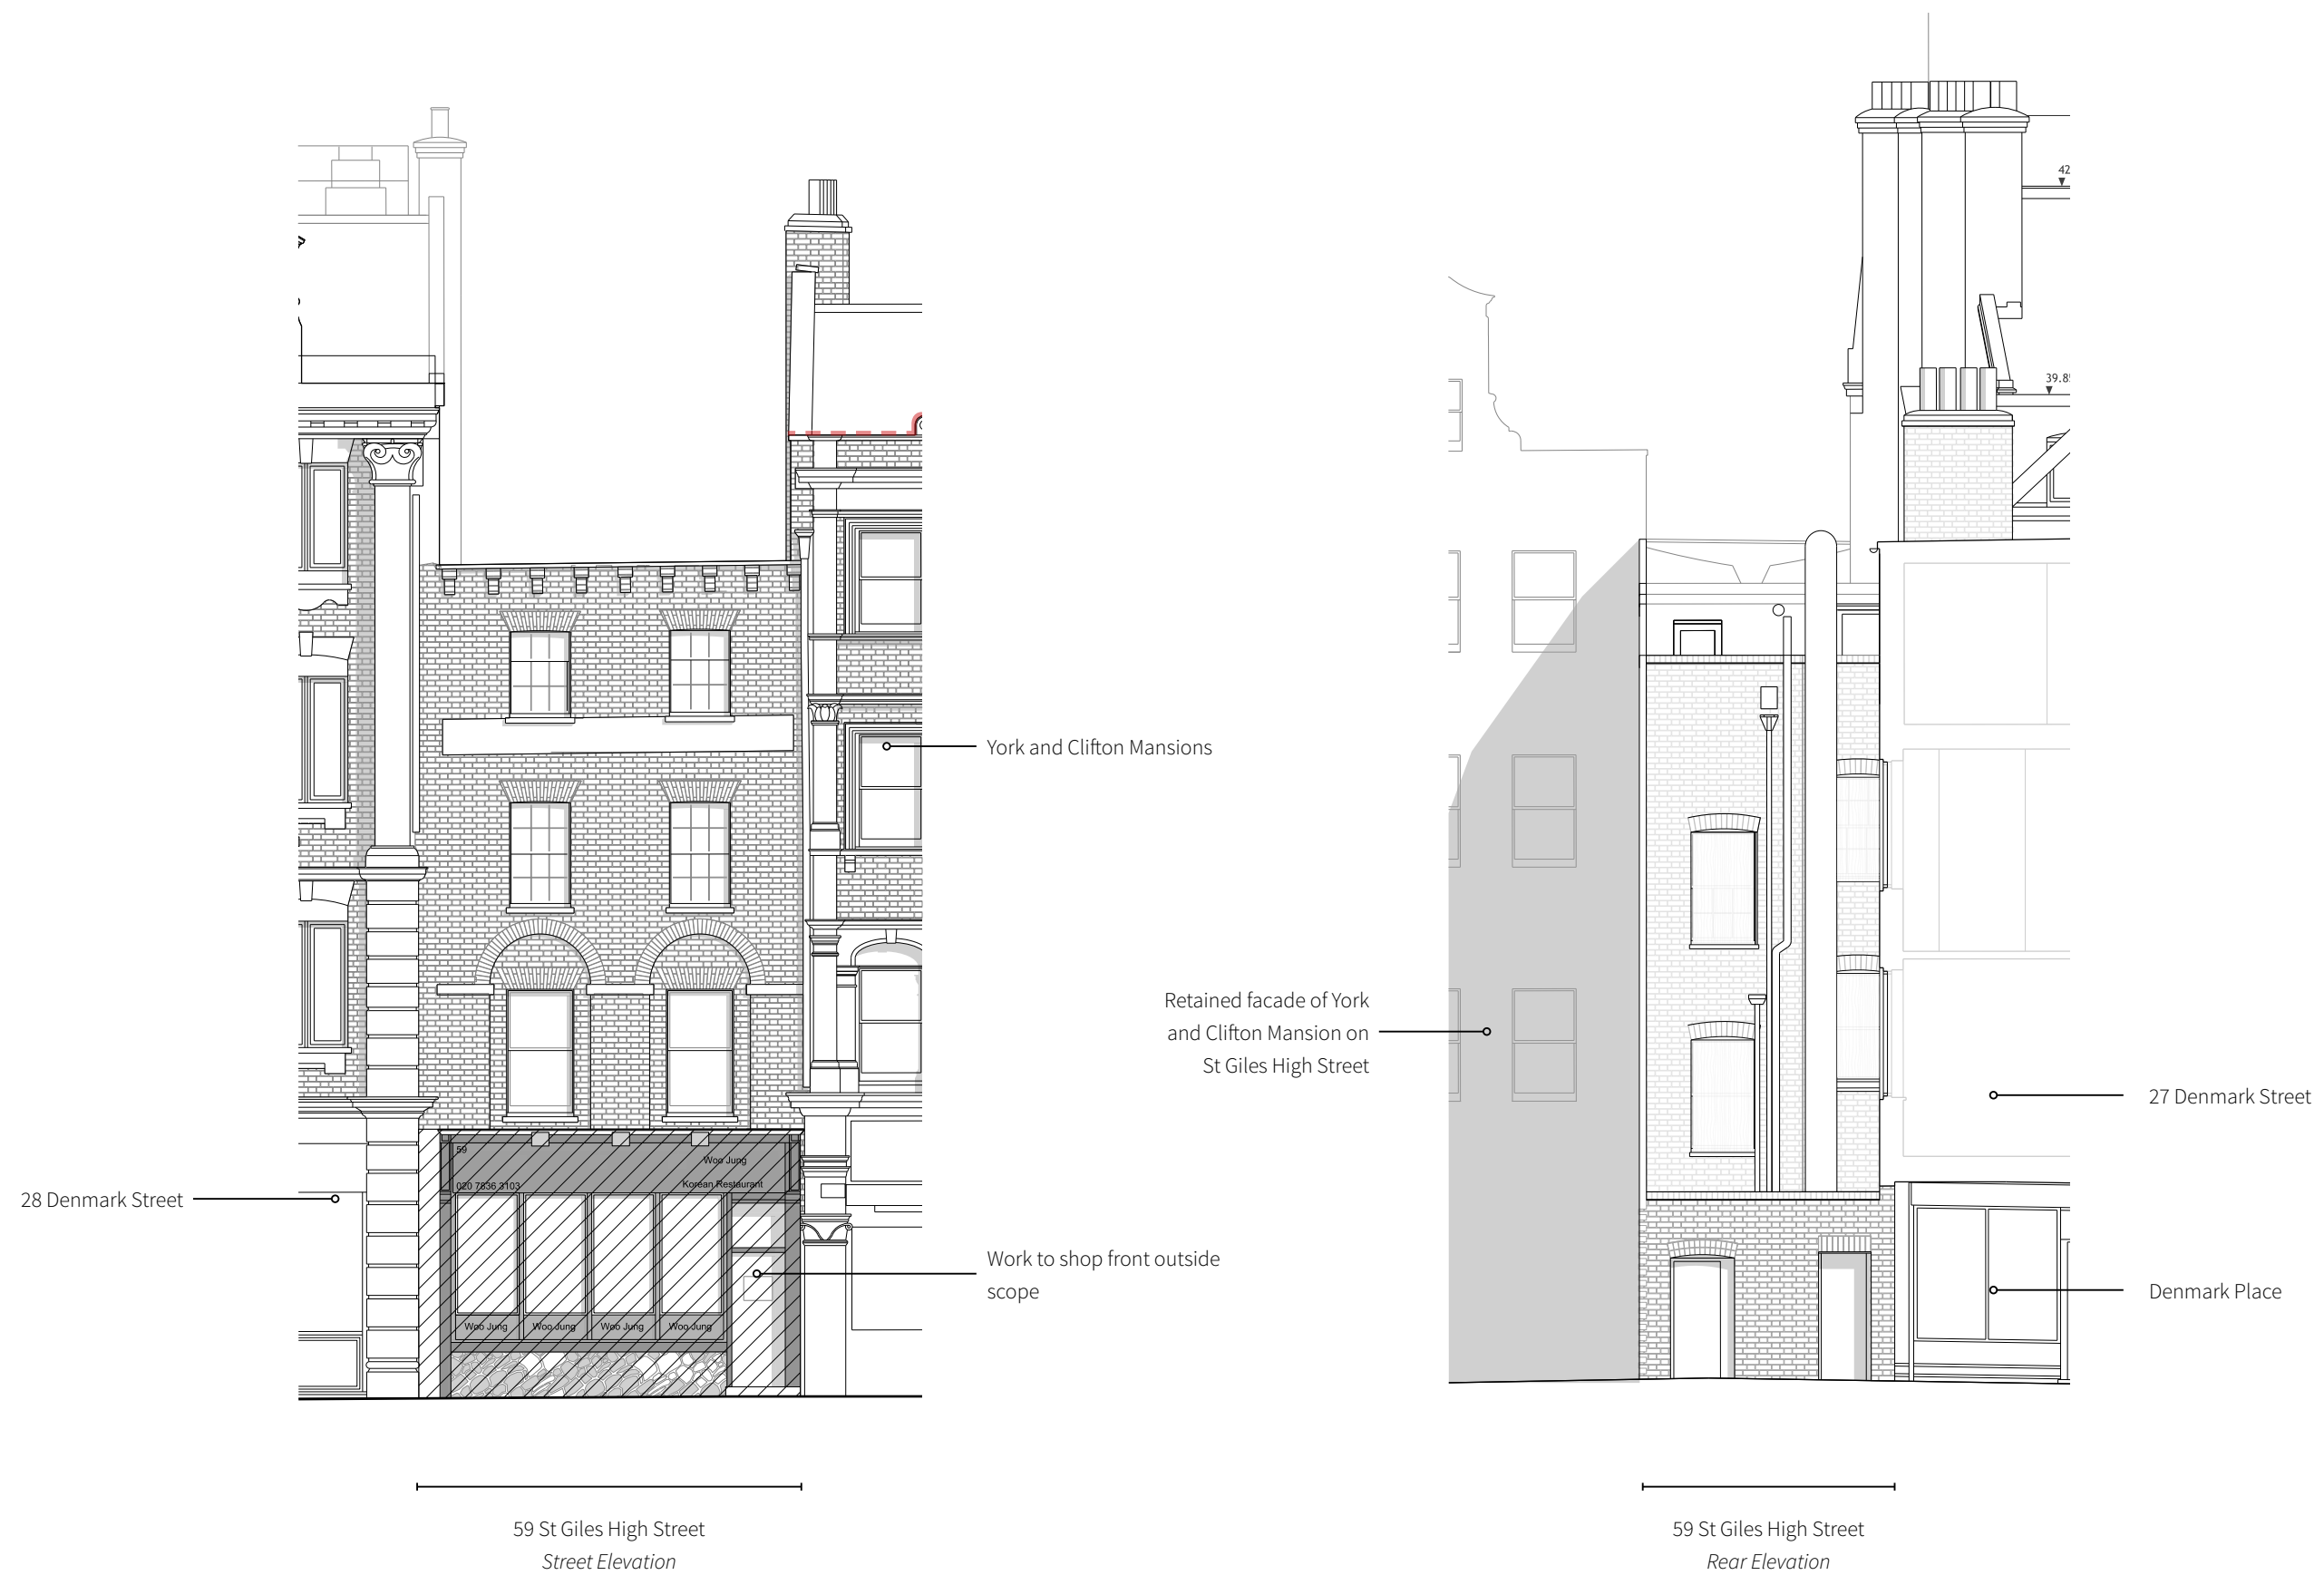
59 St Giles High Street  
Front Elevation

Heavily stained render panel to be carefully cleaned to reveal possible original signage

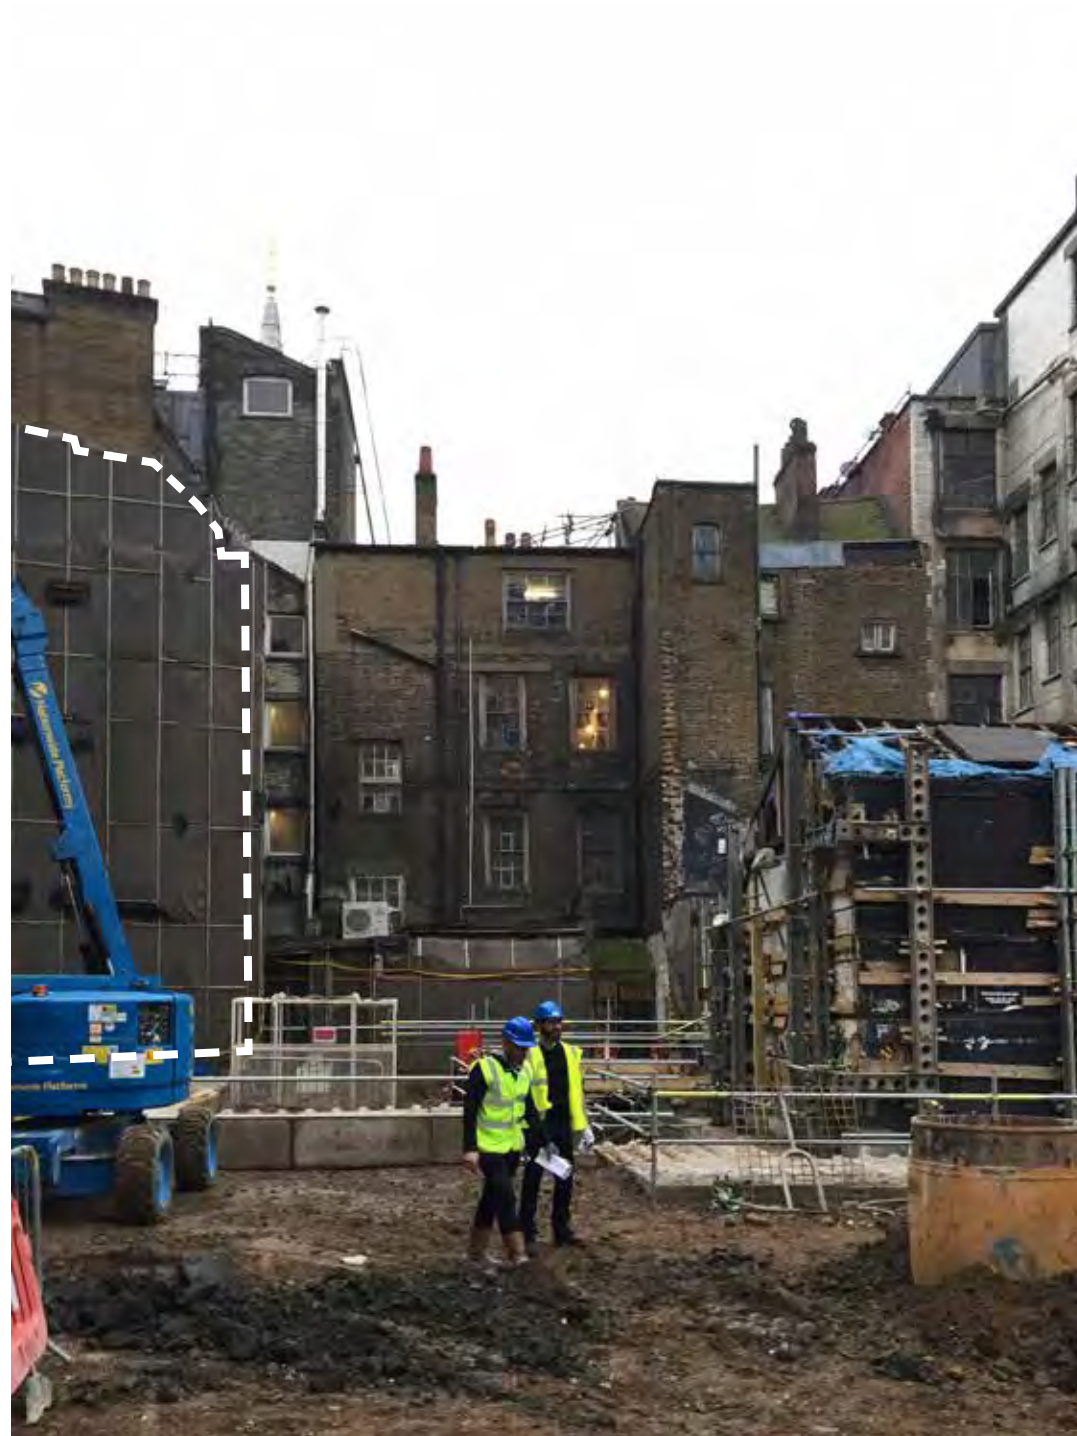
Image showing the exposed party wall of 59 St Giles High Street, with strengthening straps, weather protection and battening visible

Party wall exposed as a result of demolition works adjacent - temporary weather protection , and battening carried out by others

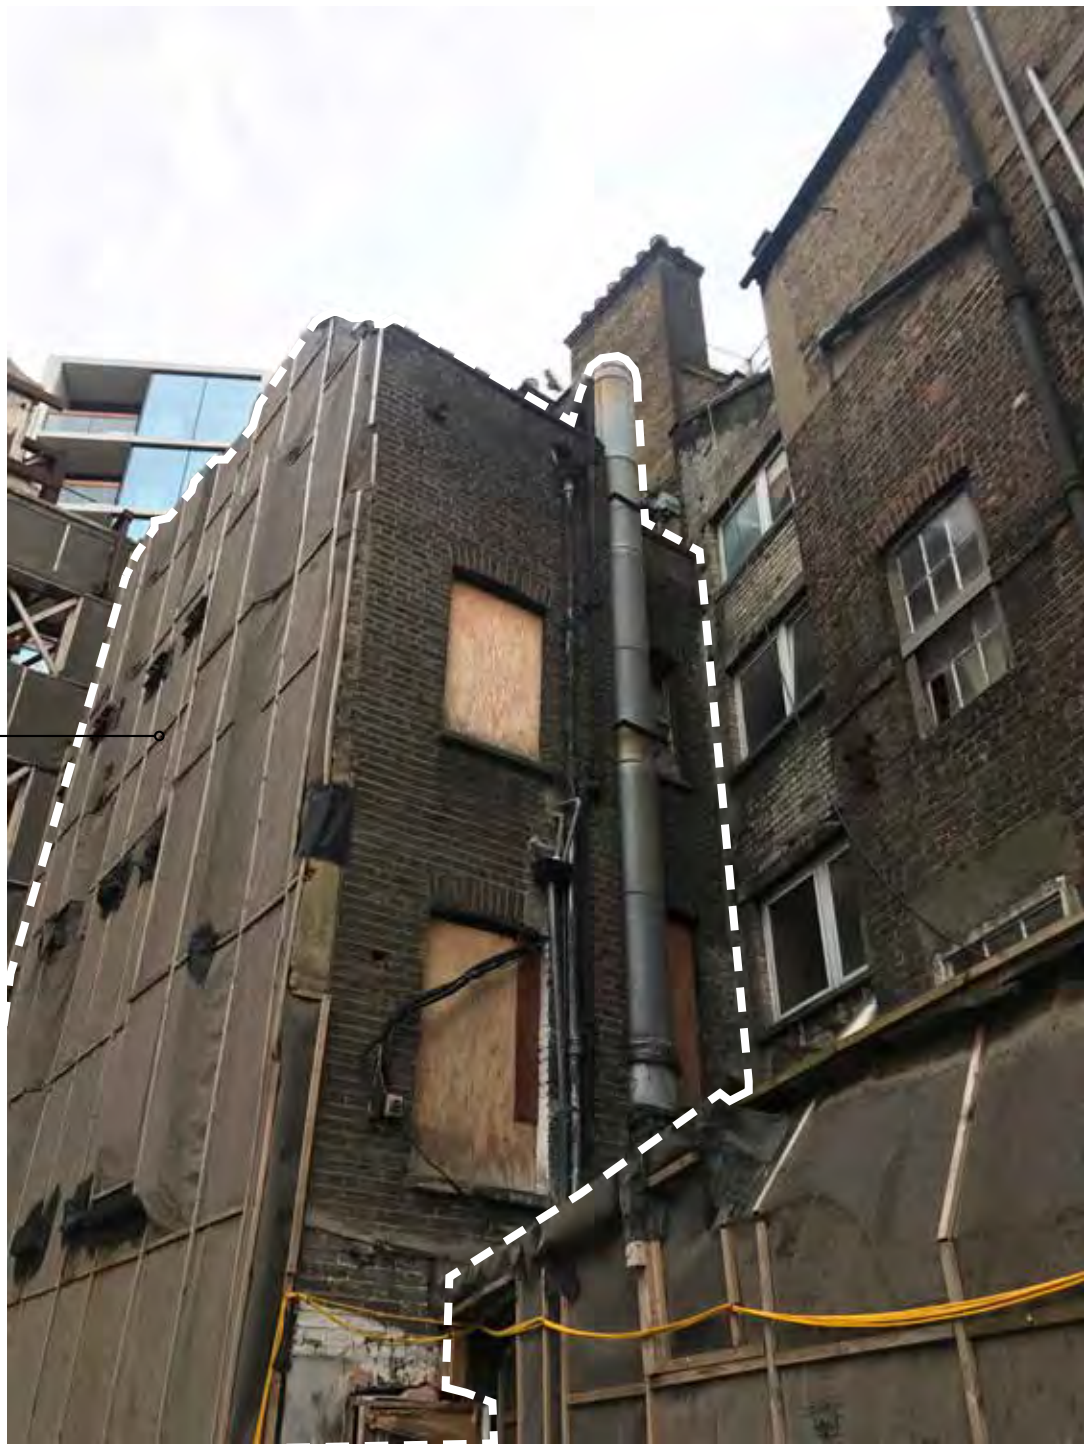
Image showing the rear elevation of 59 St Giles High Street, with windows boarded up. Large extract duct from ground floor to roof visible.

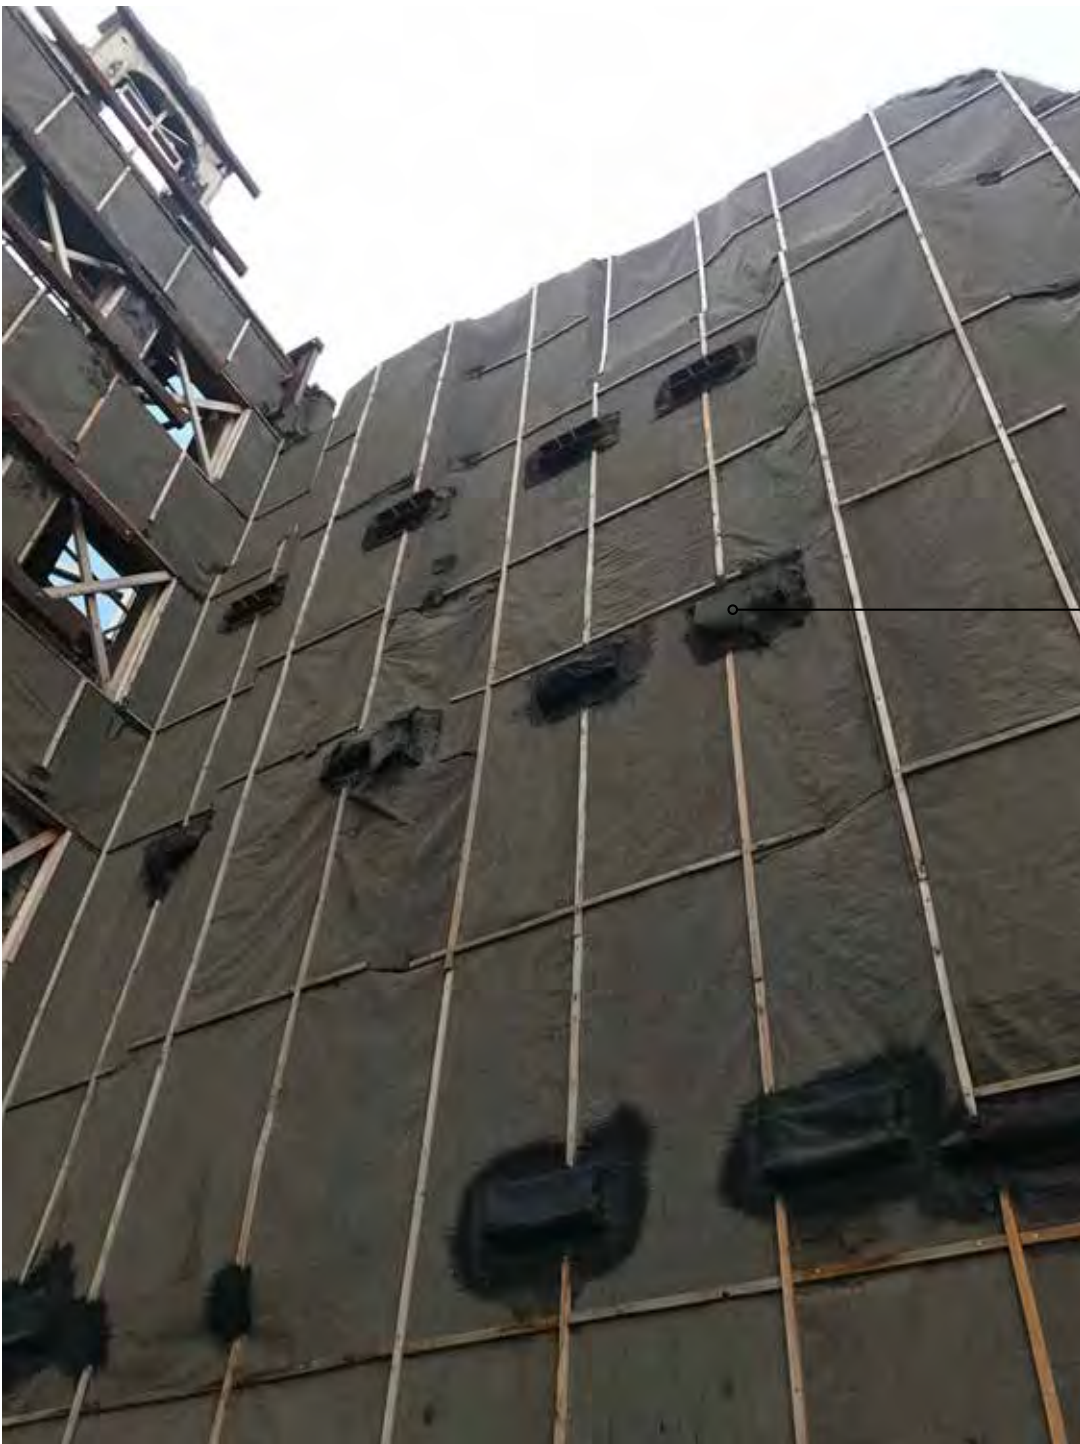
Temporary straps installed as part of demolition works of York and Clifton mansions - works carried out by others

Image showing the exposed party wall of 59 St Giles High Street, with strengthening strapping visible
