## THE STUDIO HOUSE

1 HAMPSTEAD HILL GARDENS, LONDON NW3 2PH

## BASEMENT IMPACT ASSESSMENT

**Our Ref:** HLEI50381/002R

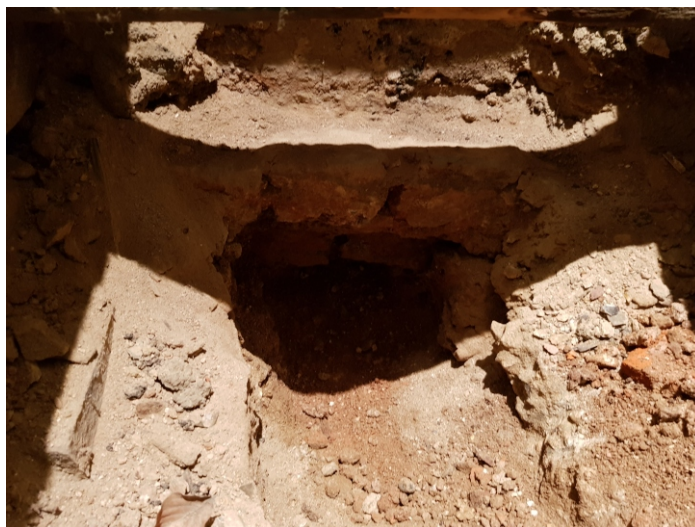
Soil Profile:

Depth(m bgl):	Description of Strata
0.0 - 0.05	Floor boards
0.05 - 0.27	Void
0.27 - 0.55	Reddish brown slightly clayey sandy angular to subrounded fine to coarse GRAVEL of concrete, flint and brick. Sand is fine to coarse. (MADE GROUND)
0.55 - 0.60	Brown slightly sandy slightly silty CLAY. Sand is fine. (LONDON CLAY FORMATION)
