DETAIL 1 REFERENCE IMAGE - PICTURE OF EXISTING LOW LEVEL RAILING TO WINDOW APRONS

PROPOSED NEW BRICK
65MM METRIC BRICK FITZJOHNS NOBLE
PICTURE OF SAMPLE PANEL FOR APPROVAL

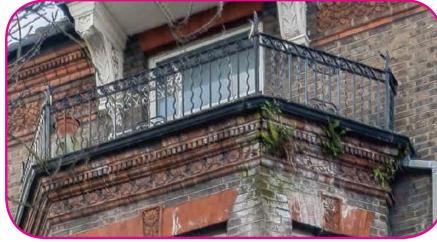
DETAIL 2 REFERENCE IMAGE - PICTURE OF EXISTING RAILING TO FRONT BALCONY

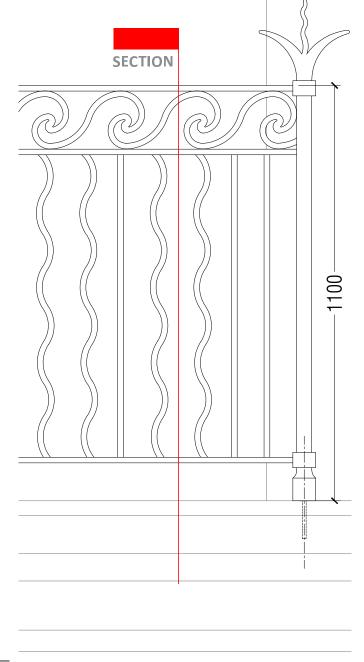
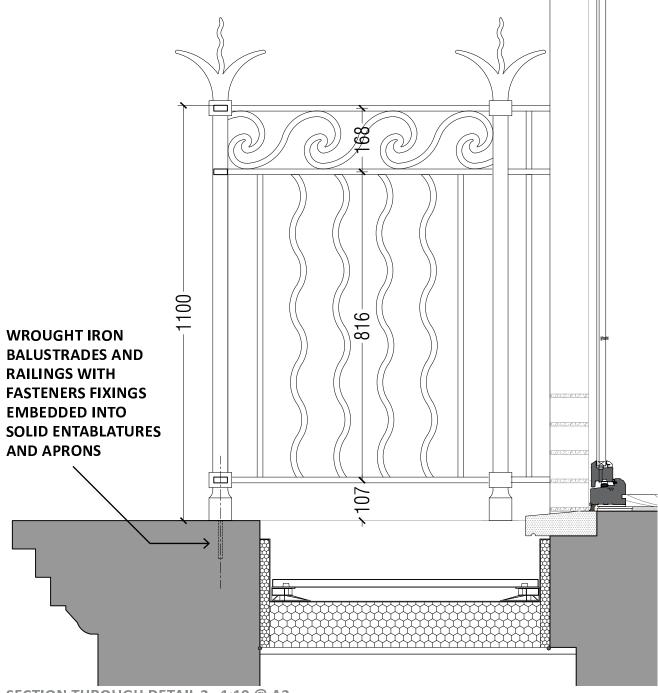
SECTION THROUGH DETAIL 2 - 1:10 @ A3

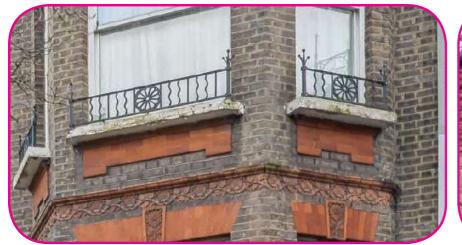
DETAIL 1 REFERENCE IMAGE - PICTURE OF EXISTING LOW LEVEL RAILING TO WINDOW APRONS

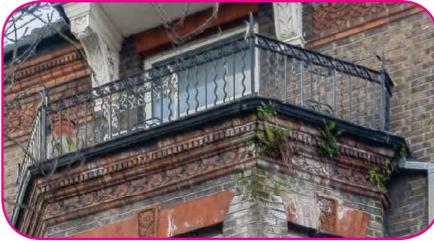
DETAIL 2 REFERENCE IMAGE - PICTURE OF EXISTING RAILING TO FRONT BALCONY

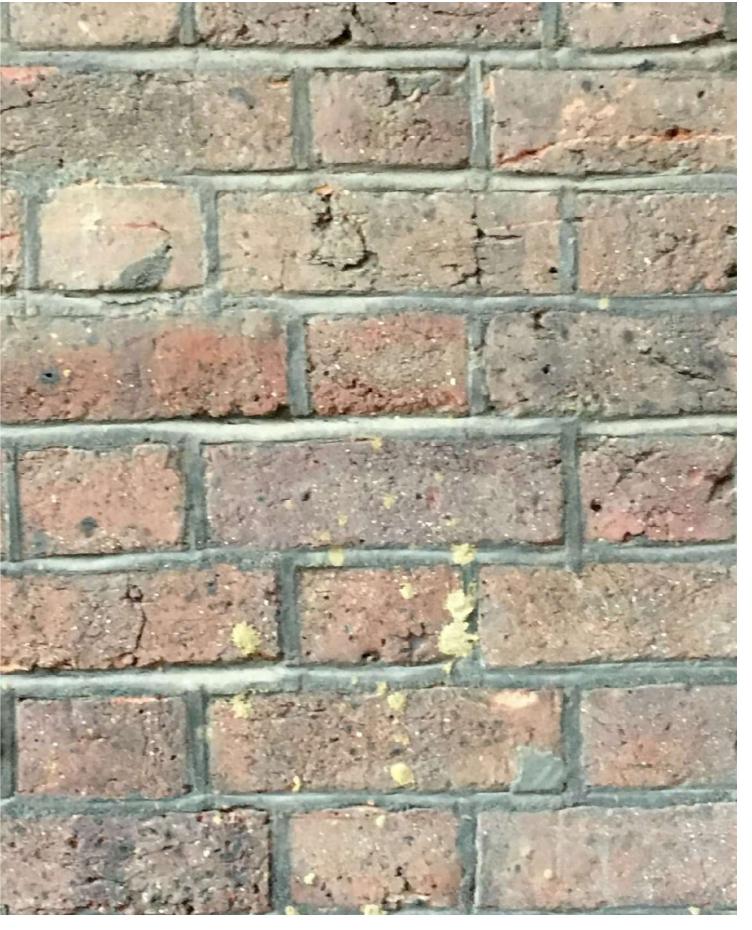
EXISTING BRICK TO BE CLEANED AND RETAINED

NOTE: PICTURE SHOWS UNCLEANED BRICKWORK AND MORTAR JOINTS

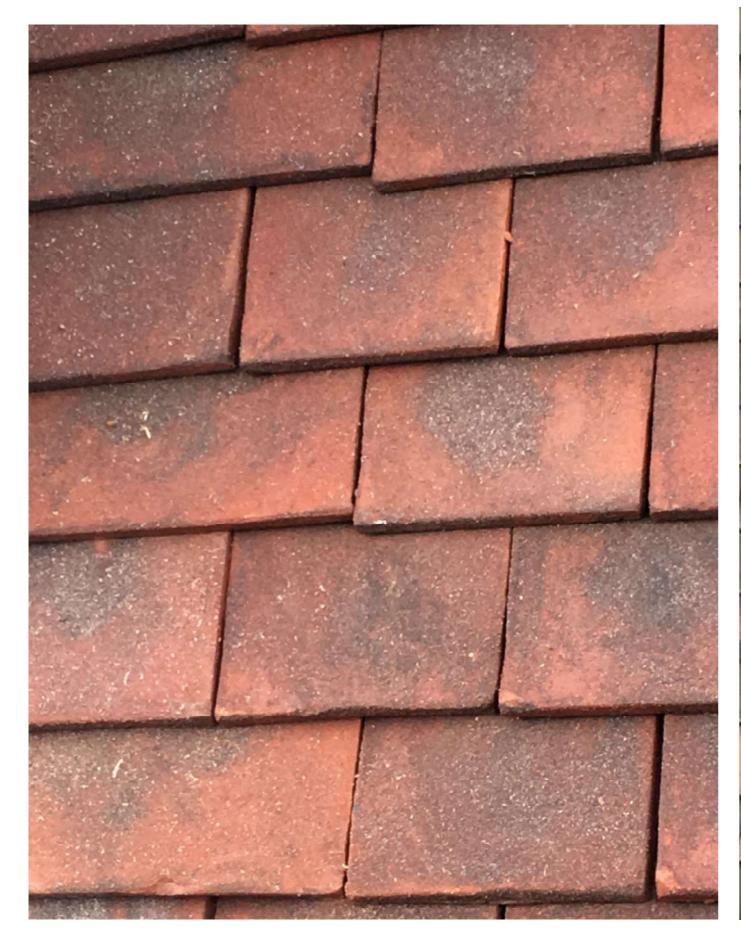
PROPOSED NEW ROOF TILES
HERITAGE CLAY TILES
PICTURE OF SAMPLE PANEL FOR APPROVAL

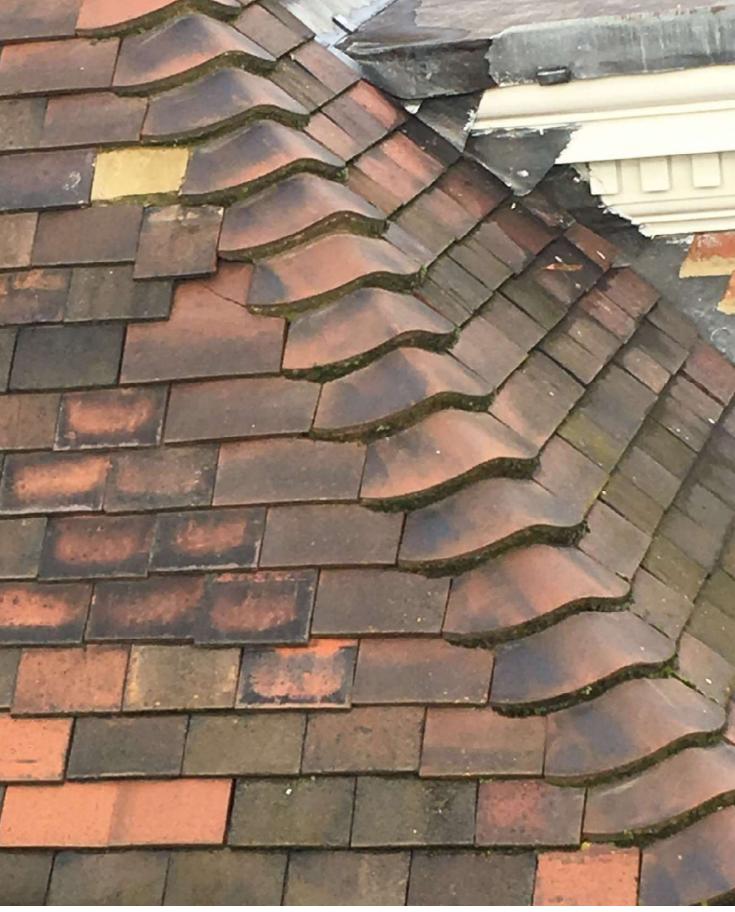
EXISTING CLAY TILES TO THE ROOF OF NUMBER 13 FITZJOHNS AVENUE
NOTE: PICTURE SHOWN FOR REFERENCE ONLY. PICTURE SHOWS FULLY WEATHERED CLAY TILES
