SOAS, University of London

Main Building Reception Alterations

Heritage, Design and Access Statement

22nd January 2018

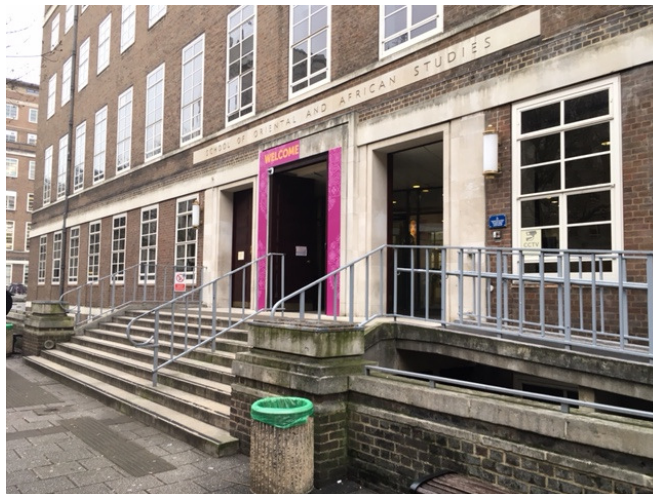
Fig. 01 – Present Day, SOAS College Building, Southern and Western Elevations, Author's own.

Externals: The Holden Building was designed and built by architect Charles Holden in the period of 1939 – 1945. Its architectural style and construction is typical of Holden as it champions simplified architectural forms and is free of what he considered unnecessary decorative detailing. The semi-detached building connects via a link bridge to the Philips Building (a later SOAS University building), which can be found to the north-west of the Holden Building. The Holden Building was commissioned and constructed as a purpose-built University building.

The building plan was an inverted L-shape in design, pointing in a north-easterly direction, with a curved end bay at the east end and rectangular built projections on both the north and east facades. The building has five storeys including a lower ground, ground, first, second and third floor with a sixth-floor lift room. The main entrance to the building is located on the east façade where a set of Portland stone steps project from the ground level up to the ground floor level of the building. The east elevation is deemed the principle elevation when viewed from Thornhaugh Street.

The walls are constructed in handmade brick, laid in English bond and built around a concrete encased steel frame. Portland stone string courses have been put in across the façade to define between various floor arrangements. This includes a substantial deep string course between the lower ground floor and ground floor, a broken string course (consisting of one lower large and smaller higher string) between the ground floor and the first floor and a deep string between the third floor and fourth floor. The Portland stone string courses have a vertical tooled finish which is visible on the front face of the stone. The façade construction to the east and south facades remain un-broken until a stepped bay projects out slightly either side of the curved north easterly façade. At parapet level a Portland stone capping is continuous around the building.

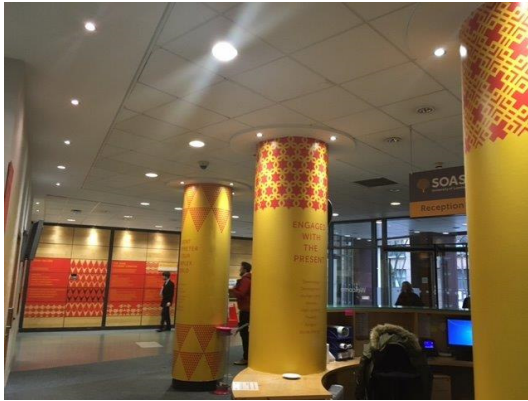
Fig. 07 - Existing ceiling finishes and cladding to columns.

<p>Replacement of the existing ceiling tiles, ceiling grid to be retained.</p> <p>Existing MF ceiling to be removed and replaced at height to match existing.</p>	<p>The existing suspended ceiling grid is to be retained, existing ceiling tiles are to be removed and replaced with white acoustic rated ceiling tiles. Existing surface mounted services such as CCTV, lights and ventilation grilles are to remain in existing locations and be fitted into replacement ceiling tiles.</p> <p>The MF ceiling section to the lobby area is to be carefully removed to enable the installation of the new glazed lobby door system. A replacement MF ceiling will then be installed to match the same height as existing. Where possible existing fixing points used to secure the MF ceiling will be re-used to mechanically fix to the structural ceiling.</p> <p>Existing perimeter margins and the new MF ceiling to the entrance glazing is to be decorated white as existing.</p>

2	Ground Floor	Reception / Front Entrance Area	Replacement of the existing ceiling tiles, ceiling grid to be retained. Existing MF ceiling to be removed and replaced at height to match existing.	NEUTRAL SIGNIFICANCE. Suspended ceiling finishes are not original and do not provide any significance to the building fabric.	NO IMPACT The adjacent corridor area has a modern suspended ceiling grid installed with fluorescent lighting, which could easily be replicated in each of the three rooms. The grid will allow for any services or conduits to be hidden from view. The grid can be removed at a later date and expose the existing ceiling above.	Refer to drawings and photographs included with the application.	N/A
3	Ground Floor	Reception / Front Entrance Area	Redecoration of wall surfaces.	NEUTRAL SIGNIFICANCE. Where finishes are currently decorated, simple decorations are in place and have no significance associated.	NO IMPACT Redecorations will freshen areas of existing decoration only and will have no impact on the significance of any fabric.	Refer to drawings and photographs included with the application.	N/A

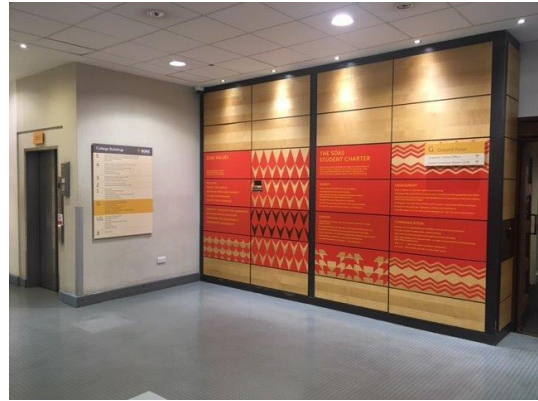
Fig. 08 - Existing cladding to cupboards.

Replacement of cladding to cupboards and internal doors.	The existing pine timber panelling to the doors is to be removed. This is to be replaced with through colour MDF Valchromat fibre board, the thickness and fenestration of the cladding is to match existing panelling.
Replacement of Venetian blinds to front facing windows	New blinds are to be installed in existing locations.
Installation of new donor plaque to the wall.	A donor plaque is to be installed wall mounted as shown on the existing drawing. This is to be screw fixed on hangars.

13	Ground Floor	Reception / Front Entrance Area	Replacement of cladding to cupboards and internal doors.	NEUTRAL SIGNIFICANCE. Existing cladding to wall areas is a modern addition, on a timber frame protecting original wall finishes.	NO IMPACT The new cladding will be installed to replace the existing, on the existing timber frame system.	Refer to drawings and photographs included with the application.	Care should be taken around original finishes at all times during the removal and replacement of cladding finishes.
14	Ground Floor	Reception / Front Entrance Area	Replacement of Venetian blinds to front facing windows	NEUTRAL SIGNIFICANCE. The blinds within the reception area are a modern installation and have no significance value.	NO IMPACT The new blinds are to be installed within existing window openings and is deemed to have no impact upon the structure or fabric.	N/A	N/A
15	Ground Floor	Reception / Front Entrance Area	Installation of new donor plaque to the wall.	LOW SIGNIFICANCE. Walls upon which the donor plaque will be mounted are plain plastered and of low significance.	LOW IMPACT A new donor plaque is to be installed with minimal disturbance to existing finishes, screw fixed onto hangers.	N/A	N/A

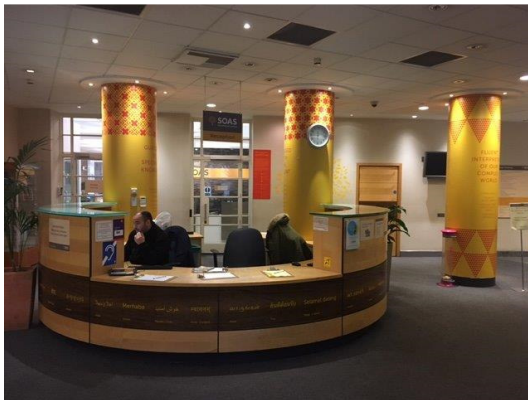
Fig. 09 - Existing reception desk and floor finishes

Replacement of carpet and vinyl floor finishes, including adapting to the matwell.	<p>The existing floor finishes are to be carefully removed. New floor finish to the main reception area is to be a Linoleum type product, Marmoleum Marbled effect sheet finish. Finish to be neutral colour.</p> <p>New matwell entrance matting will be installed to match existing, the existing matwell depth is to match existing and be adapted and made smaller to suit new entrance lobby size.</p>
Re-staining of existing external doors to match existing.	<p>No alteration works are proposed to the original doors. The existing finish is to be freshened, doors to be re-stained to match existing.</p>
Installation of overhead door heaters	<p>2nr electric overdoor heaters are to be installed above the new sliding doors. To be '<i>Windbox suspended ceiling air curtain</i>' or similar in appearance.</p> <p>These will be set flush within the MF ceiling above, coloured white to match the surrounding ceiling. To be 700mm wide and 2000mm in length. Power to this will be fed through the suspended ceiling.</p>

As part of the works the existing in-built reception desk is to be removed and replaced. The reception desk at present does not have an accessible low-level counter. The proposed changes provide an opportunity to integrate a more accessible low-level counter.

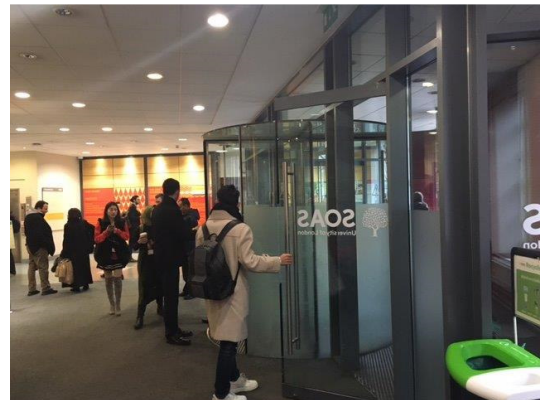
Fig. 10 - Existing revolving door and accessible door.

The existing entrance lobby system comprises a glazed curtain wall system with a centrally installed revolving door as the primary entry through the lobby. The central revolving door is flanked either side by a double door and single entrance door utilised for accessible entrance provision, deliveries and in a fire situation.

It is proposed that in order to improve accessibility into the main entrance, the secondary entrance revolving door and accessible door are replaced with 2nr double sliding glass doors. A new glazed curtain walling system is to be installed comprising of 2nr sliding doors forming a rectangular lobby. The glazing system will be installed full height from finished floor level up to a new MF ceiling section above. In addition, by removing the revolving door and simplifying the entrance area, the new lobby design compliments and reflects the original internal foyer configuration and footprint, visible in Fig. 06.

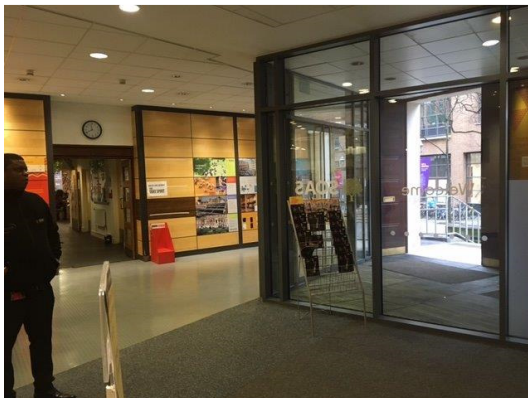
Fig. 11 - Existing glazed secondary entrance curtain walling system.

A glazed entrance lobby is set back by circa 2m from the main entrance and away from the original timber panelled entrance doors. The original entrance doors are fixed open during the day.

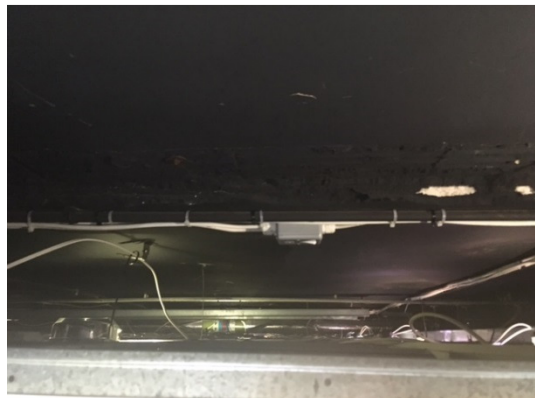
Fig. 12 - Existing concrete block and beam ceiling above suspended ceiling tiles.

The floor construction comprises of a solid concrete slab upon which there is a combination of the original parquet floor and later flooring finishes (carpet tiles, linoleum, etc.). Ceilings are formed with a mixture of powder coated metal and square fibre suspended ceiling tiles.

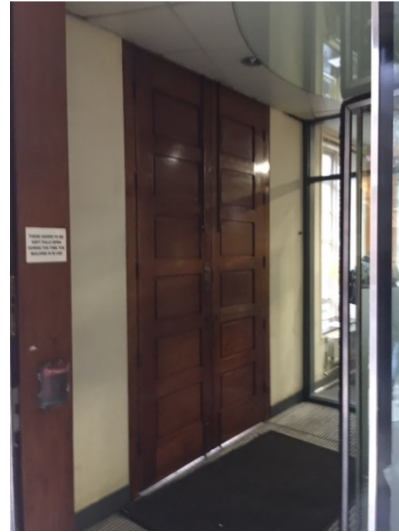
Fig. 14 - Existing main timber entrance doors.

The current main entrance to the building, which was reconfigured in the 1970's, features three Portland stone door surrounds framing the equally proportioned timber panelled entrance doors which lead into the main entrance lobby of the University. A decorative stone plaque is present above the main east façade entrance, centrally positioned between the first and second floors. The plaque is detailed with a central coat of arms, a cross and decorative floral work.

The original timber entrance doors remain fixed back and un-changed under this proposal, no change is proposed to the stairs or ramped access into the building.
