CRACK MONITORING

for Subsidence Management Services

16 Goldhurst Terrace, London, NW6 3HU

Our Ref: M9428

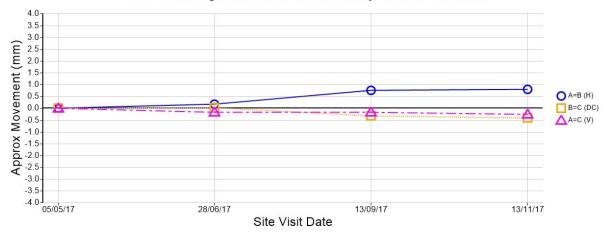
C1 - Lower ground floor bedroom by door to en-suite

The following graphs display the progressive movement that each Crack Monitoring Station recorded at each separate site visit date to give an overall look at how much the property is moving.
