# Technical Note: Response to Council's email dated 26<sup>th</sup> January 2018 regarding Service Access

**Sondheim (Ambassadors) Theatre, West Street, London**

**Technical Note: Response to Camden Council's email dated 26<sup>th</sup> January 2018  
regarding Servicing Access**

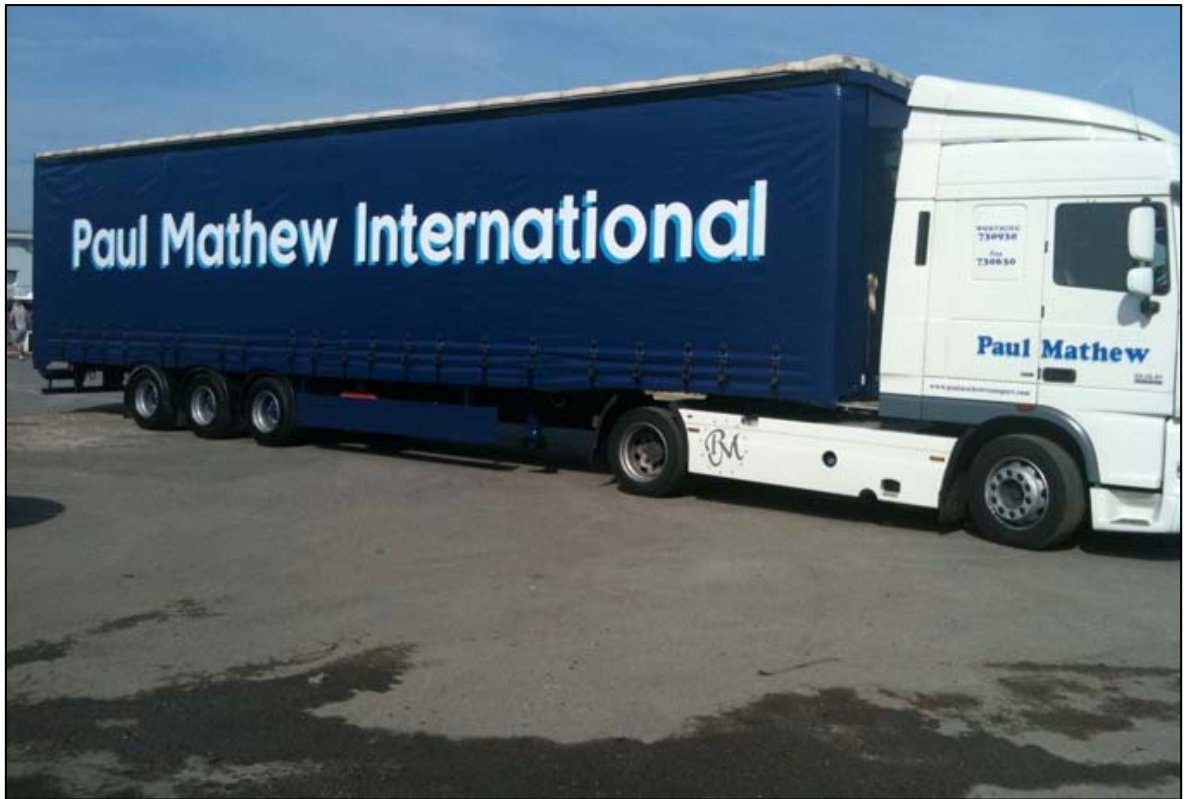
**Figure 1.1: Vehicle Used**

- 1.2 To address the concern of the council, a trial experiment where an articulated vehicle of 16.5m length was undertaken on the 8<sup>th</sup> February 2018. Note: This is the vehicle type used by the Council for its response of the 26<sup>th</sup> January 2018.
- 1.3 This Technical Note reports on the findings. The vehicle used for the experiment is shown in **Figure 1.1**.

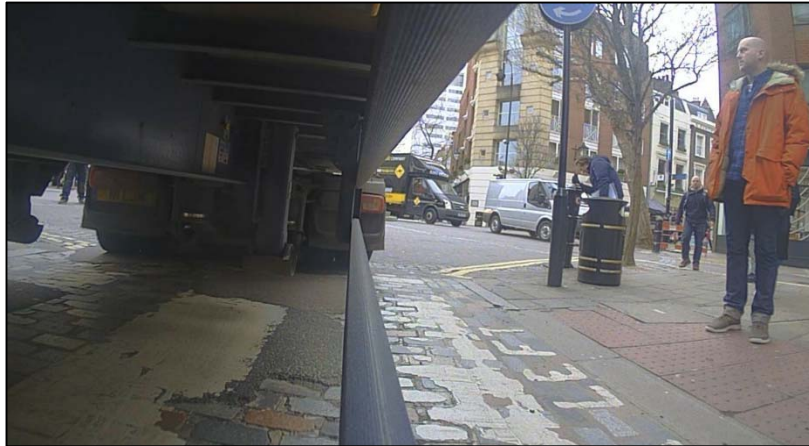
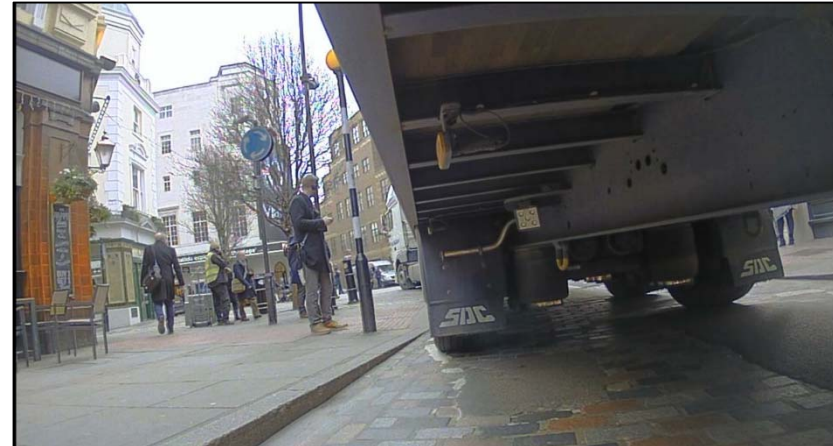
**Figure 1.2: Image 1**

- 1.4 Video records of the experiment are available upon request. **Figures 1.2 to 1.9** show screenshots of the vehicle making the manoeuvre from cameras located on both the nearside and offside of the vehicle, as well as external images of the vehicle. This demonstrates that the vehicle can make the manoeuvre without impeding on either the statue in the centre or the street furniture which surrounds the Seven Dials Roundabout.

- 1.5 **Figures 1.2 to 1.9** show clearly that a 16.5m articulated vehicle can make the route along Monmouth Street through the Seven Dials Roundabout without impeding on the roundabout and statue.
- 1.1 Notwithstanding this, Delfont Mackintosh Theatres are content to accept a condition, as set out in the '*Services and Delivery Outline Management Plan Rev a*' to monitor for a period of 2 years from first occupation to provide comfort to the Council in terms of the operation of the works. The monitoring would provide details of:
- Before and after photos of the immediate highways kerbs and street furniture shown in the vehicle tracking to demonstrate that damage has not occurred
  - Video footage of the vehicle positioning manoeuvre to demonstrate that no adverse blocking of traffic has occurred.
- 1.2 This information would be provided one month following each production change.
